HOSENSACK NO.4 DAM

PHASE I INSPECTION REPORT
NATIONAL DAM INSPECTION PROGRAM

National Dam Inspection Program. Hosensack Number 4 Dam (NDI ID PA 00786, PA DER 39-4), Delaware River Basin, Indian Creek, Pennsylvania. Phase I Inspection Report.

Name of Dam:	Hosensack No. 4 Dam
State Located:	Pennsylvania
County Located:	Lehigh
Stream:	Indian Creek
Coordinates:	Latitude 40 ^o 27.4', Longitude 75 ^o 31.2'
Date of Inspection:	December 19, 1980

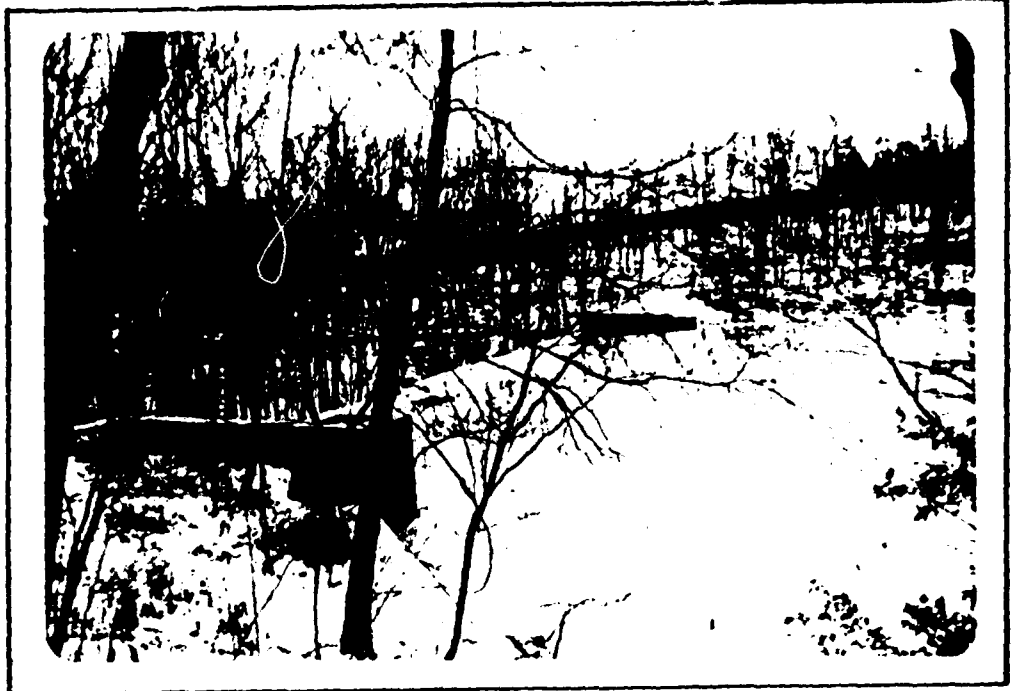
UPSTREAM OVERVIEW FROM THE LEFT ABUTMENT.
