WIGWAM LAKE DAM

NDI ID NO. PA-00990

**PHASE I INSPECTION REPORT
NATIONAL DAM INSPECTION PROGRAM**

Geo-Technical Services, Inc.

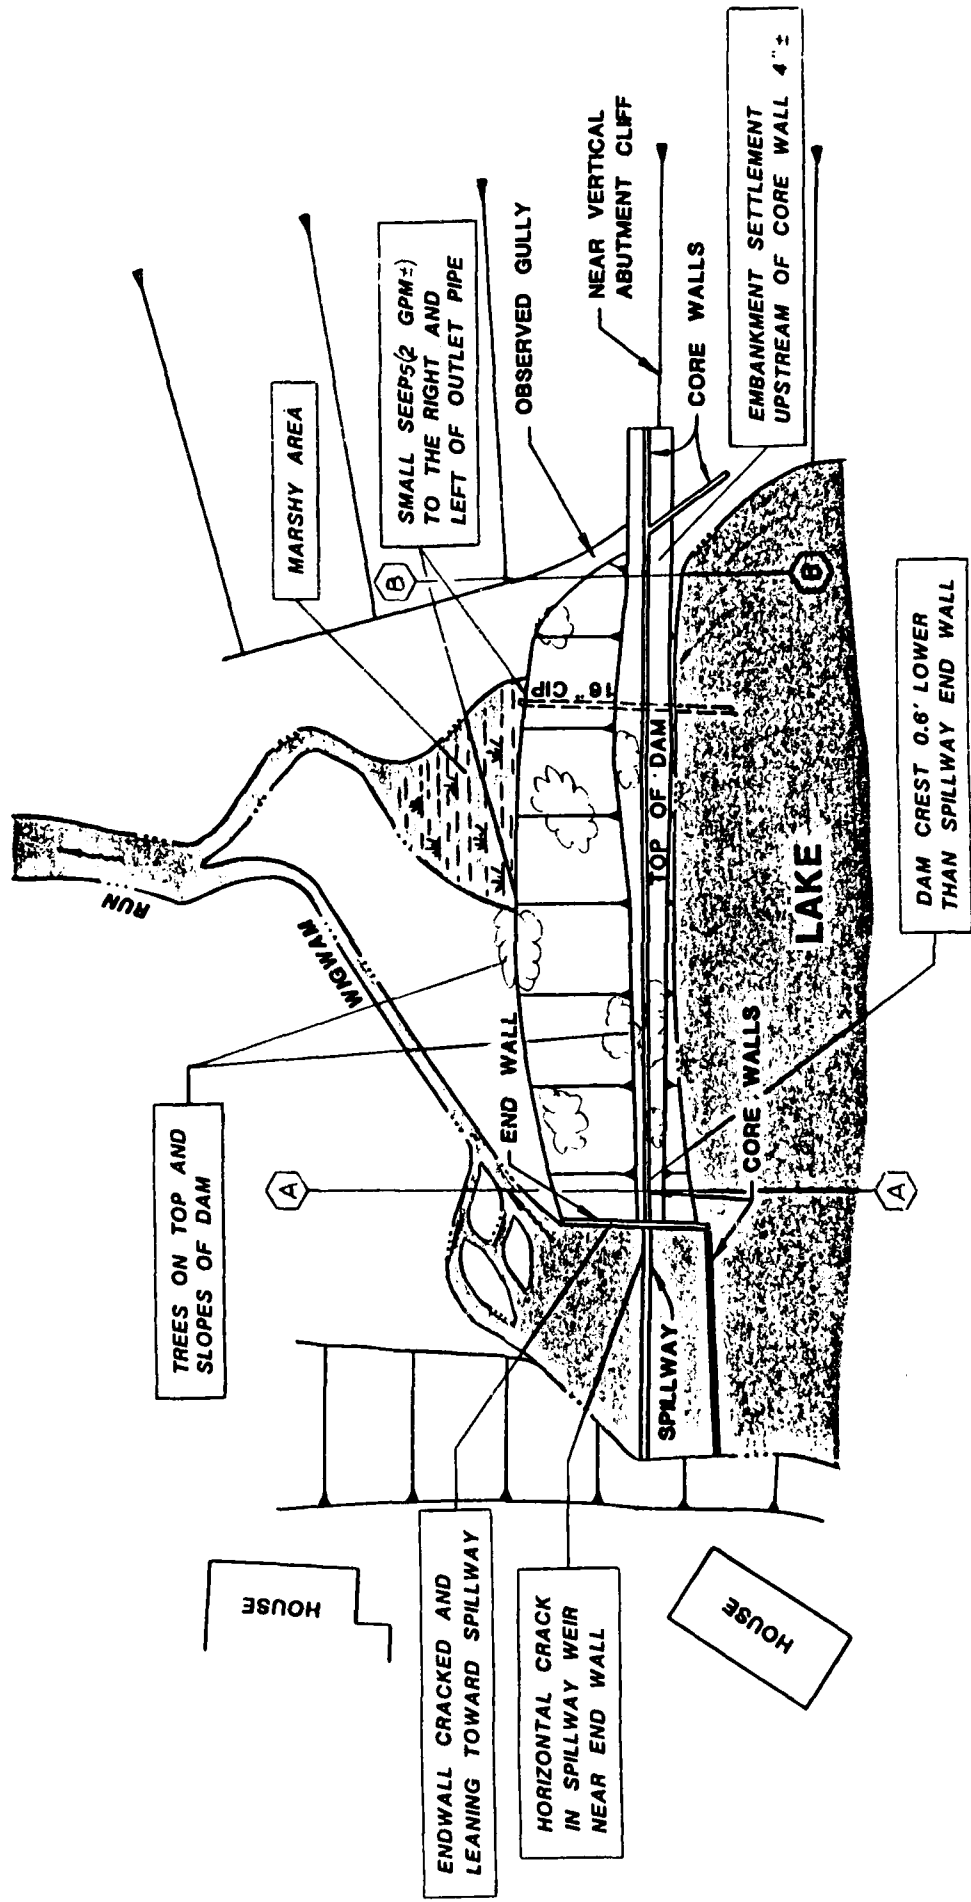
**WIGWAM LAKE DAM
GENERAL PLAN - FIELD INSPECTION NOTES**

(a) General. The overall appearance of the dam and its appurtenant structures is considered to be poor. The locations of observed deficiencies are shown on the Sketch Plan, presented in Exhibit A-1, Appendix A. The profile and typical sections of the dam are presented in Exhibits A-2, A-3, and A-4 and are based on field survey made on the day of inspection. The survey datum for this inspection was an approximate elevation obtained for the spillway crest from a USGS map. The construction drawings for the dam and appurtenant structures are shown in Exhibits E-2 and E-3, Appendix E. The elevations shown on the construction drawings are based on a different datum than that of the USGS map. Therefore, to convert the elevations shown on the appended construction drawings to the elevations used in this report, it is necessary to add 609 feet to the elevations shown on the appended drawings. On the inspection date (11/26/80), the lake level was 0.1 foot above the spillway crest (elevation 708 above mean sea level). Deficiencies observed during the field inspection are described below, and further illustrated in Exhibits A-1, Appendix A. Visible features of the dam are depicted in photographs, presented in Appendix C.
