STARLIGHT LAKE DAM

NDI ID NO. PA-00094  
DER ID NO. 64-35

PHASE I INSPECTION REPORT  
NATIONAL DAM INSPECTION PROGRAM

Prepared by  
Geo-Technical Services, Inc.  
CONSULTING ENGINEERS & GEOLOGISTS  
851 S. 19th Street  
Harrisburg, Pennsylvania 17104

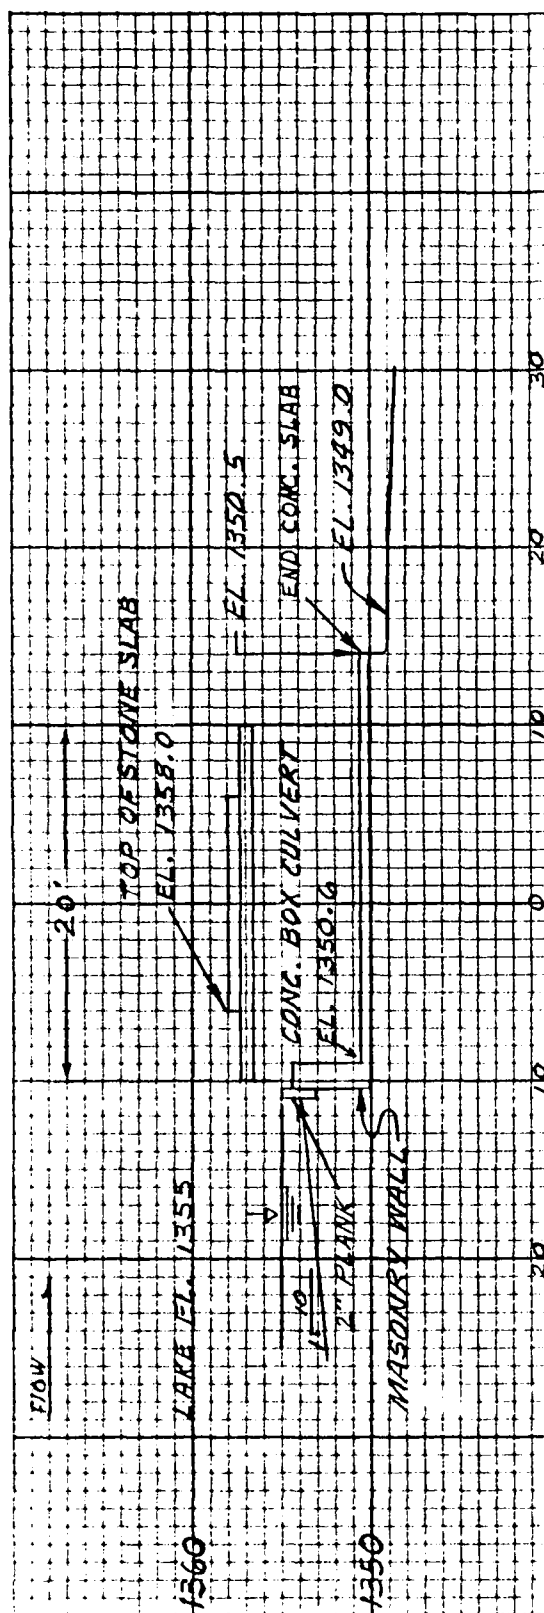
## SPILLWAY SECTION

c. Spillway. The overall appearance of the spillway is fair. Flow over the flashboard drops 4.4 feet to the floor of a rectangular concrete culvert. A large hole 1.0'H x 1.5'L x 1.0'D located near the upstream end of the right concrete wall of the spillway culvert appears to be due to spalling of the concrete (see Exhibits A-1 and A-4). The span between the top of the culvert walls is covered with 6-inch sandstone rock slabs. Additional slabs, varying in thickness from 9 to 11 inches, overlay the first layer of slabs to form the road surfaces on the top of the dam (see Exhibit A-3 and photograph No. 6, Appendix C). Concrete ledges at the

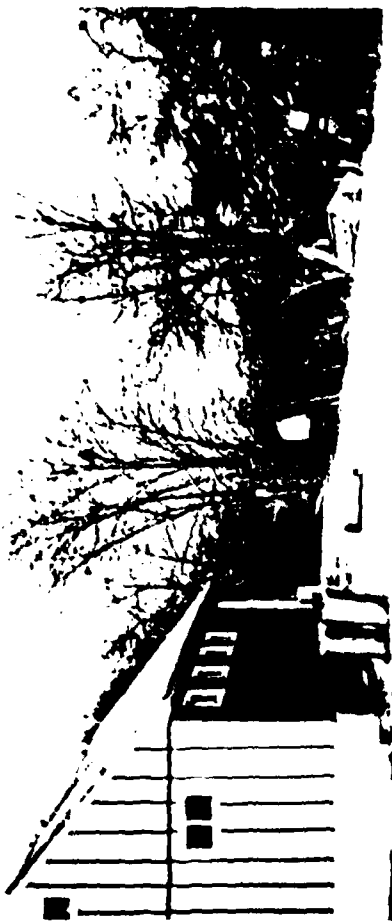
9 600' DOWNSTREAM OF DAM (STREAM AT EDGE OF SNOW)

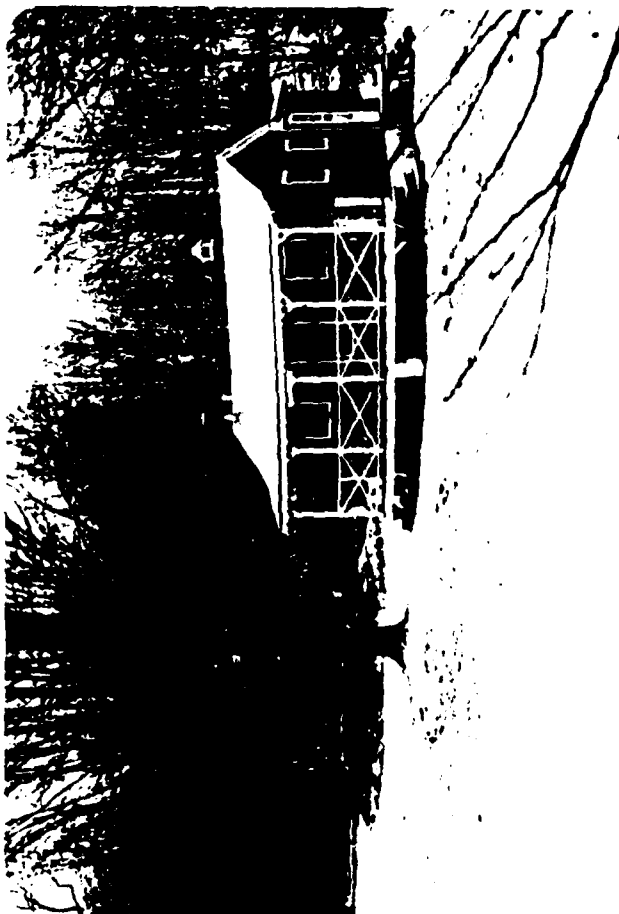
10 STREAM AT REAR OF HOUSE
