FORDS LAKE DAM

NDI ID No. PA-00298
DER ID No. 35-064

PHASE I INSPECTION REPORT
NATIONAL DAM INSPECTION PROGRAM

Prepared by
GEO-Technical Services, Inc.
CONSULTING ENGINEERS & GEOLOGISTS

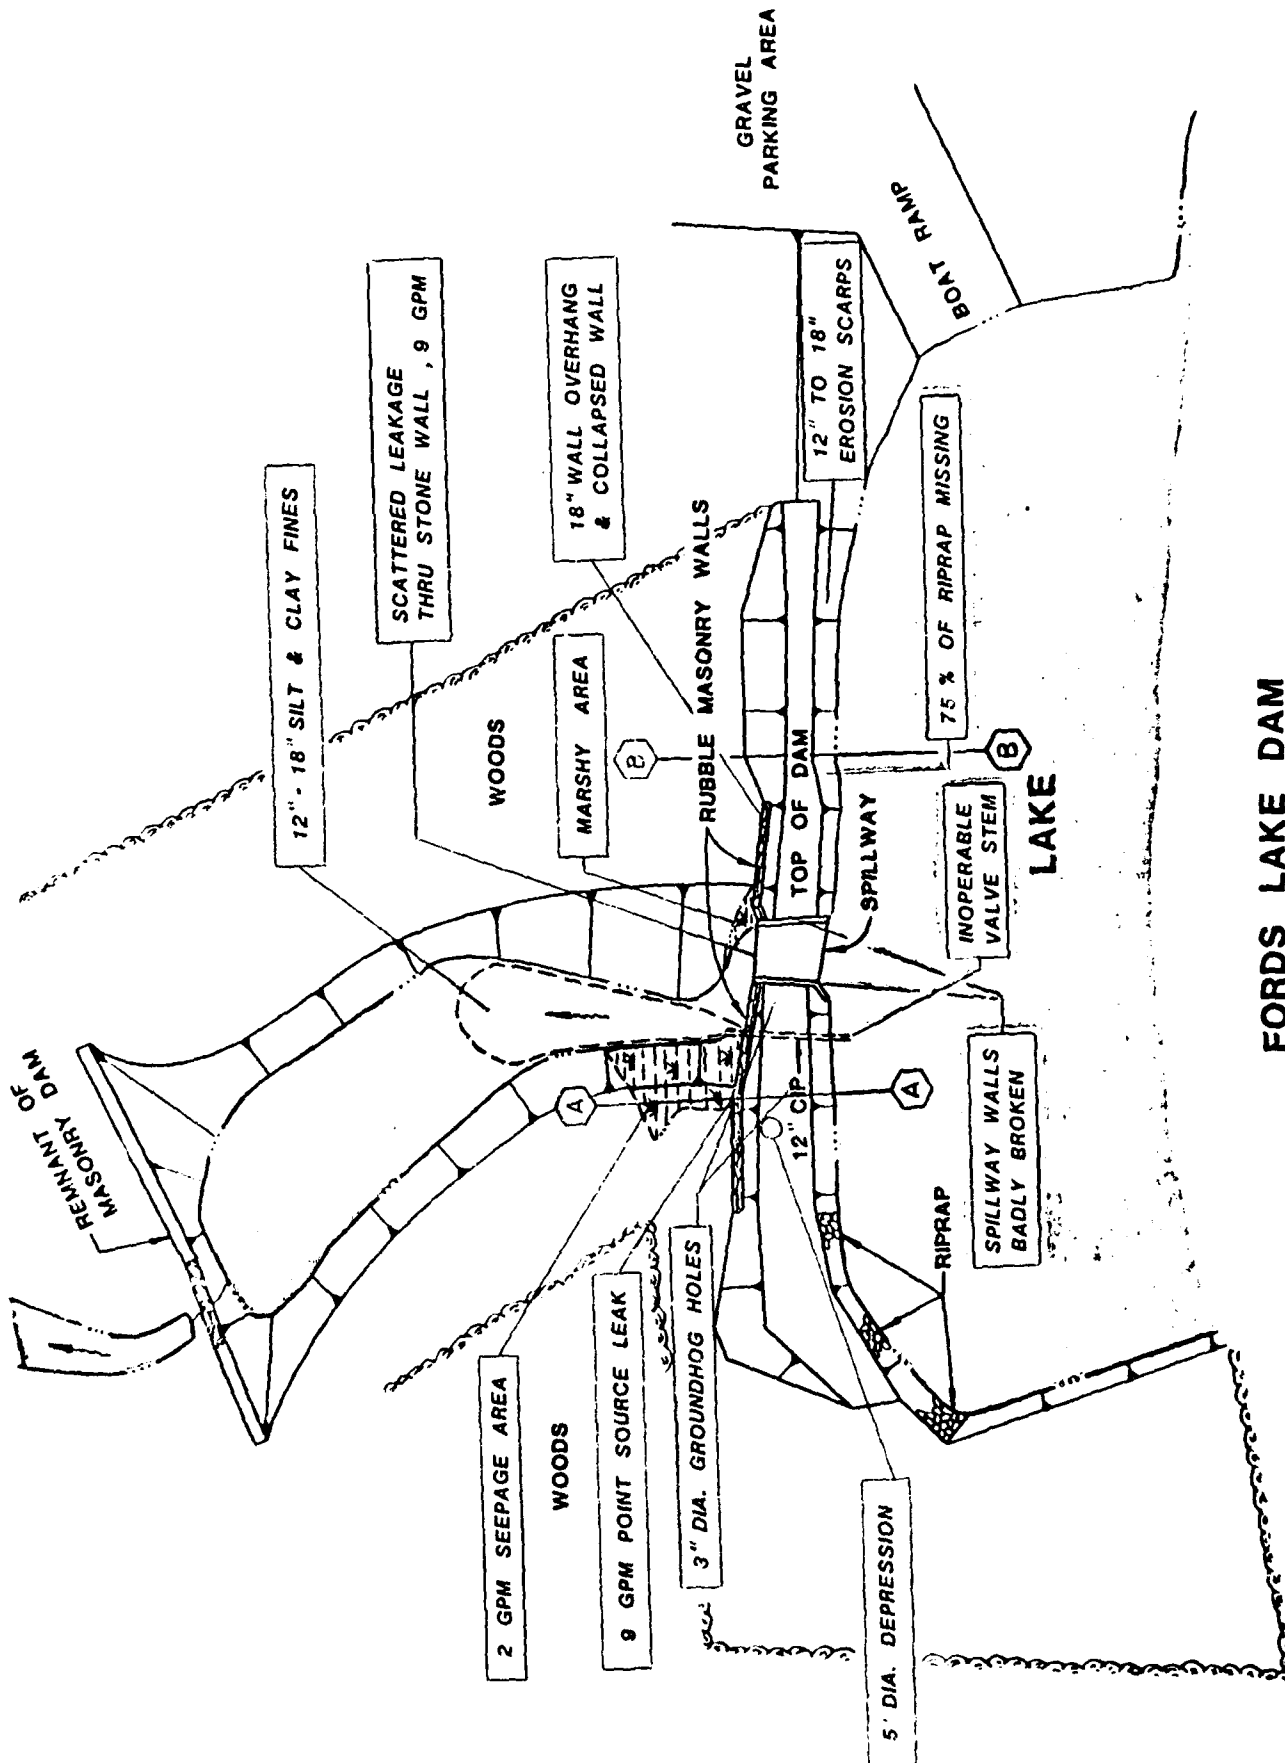
FORDS LAKE DAM
GENERAL PLAN - FIELD INSPECTION NOTES

a. General. The overall appearance of the dam is very poor. Deficiencies observed during the field inspection are illustrated on the General Plan, Exhibit A-1, Appendix A. The profile and typical sections of the dam are presented in Exhibits A-2, A-3, and A-4, and are based on field survey made the day of the inspection. On the inspection date (12/08/80), the lake level was at elevation 1146.8, about 0.2 foot below spillway crest. Pertinent features observed are shown in photographs, presented in Appendix C.

The downstream face of the dam is a vertical dry stone wall that extends about 10 feet above the streambed. The stones are "one and two man" sized sandstone slabs. The total length of standing wall is 92 feet. On the right abutment, the stone wall has bulges and overhangs of 12 to 18 inches. About 20 feet right of the wall end are sandstone slab remnants of a collapsed wall (see photographs No. 4 and No. 5, Appendix C). Scattered leakage through the stone wall extends from streambed to about 3.4 feet below the spillway crest for a distance of about 20 feet across the middle part of the dam (see photographs 2, 5 and 8, Appendix C). This leakage is clear and amounts to about 9 GPM. Downstream of the scattered wall leakage is a small marshy area at the toe of the right abutment (see Exhibit A-1).
