COLEMAN DAM

NDI ID NO. PA-00191
DER ID NO. 35-94

PHASE I INSPECTION REPORT
NATIONAL DAM INSPECTION PROGRAM

MAY 1981

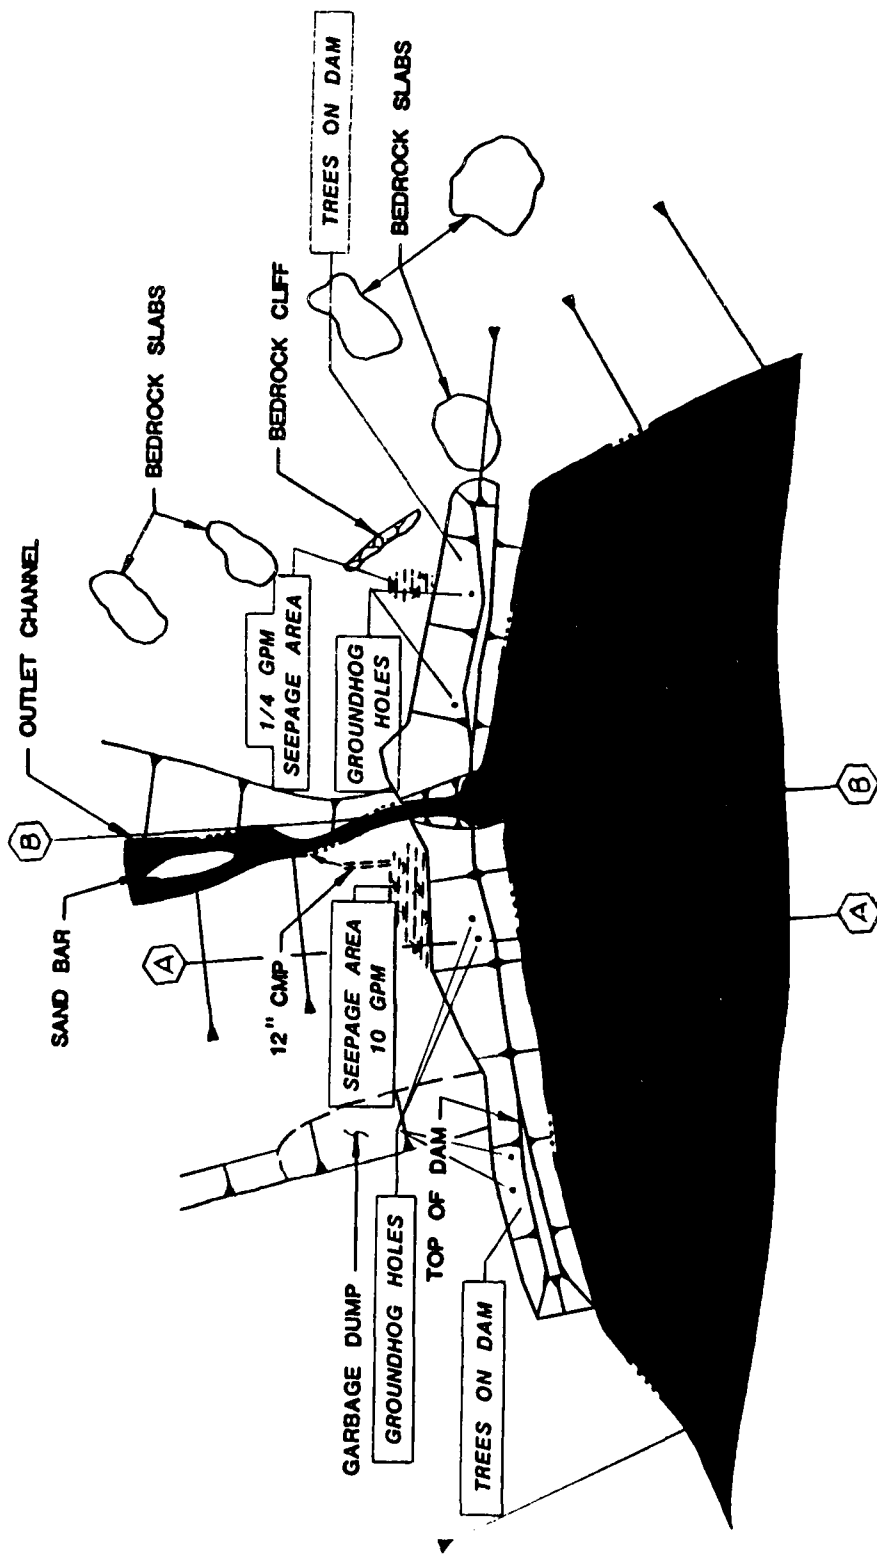
COLEMAN DAM
GENERAL PLAN - FIELD INSPECTION NOTES

a. General. The overall appearance of the dam is very poor. Location of observed deficiencies are shown on the General Plan presented in Exhibit A-1, Appendix A. The profile and typical sections of the dam are presented in Exhibits A-2 and A-3 and are based on field survey made on the day of the inspection. The survey datum for this inspection is elevation 1572 feet above mean sea level for the normal water surface of the Lake (see Exhibit E-1). On the inspection date (3/02/81), the lake level was approximately at elevation 1572, which is also the low point near the middle of the dam crest (see Exhibit A-2). Deficiencies observed during the field inspection are described below, and are illustrated in Exhibit A-1, Appendix A. Visible features are depicted in photographs, presented in Appendix C.

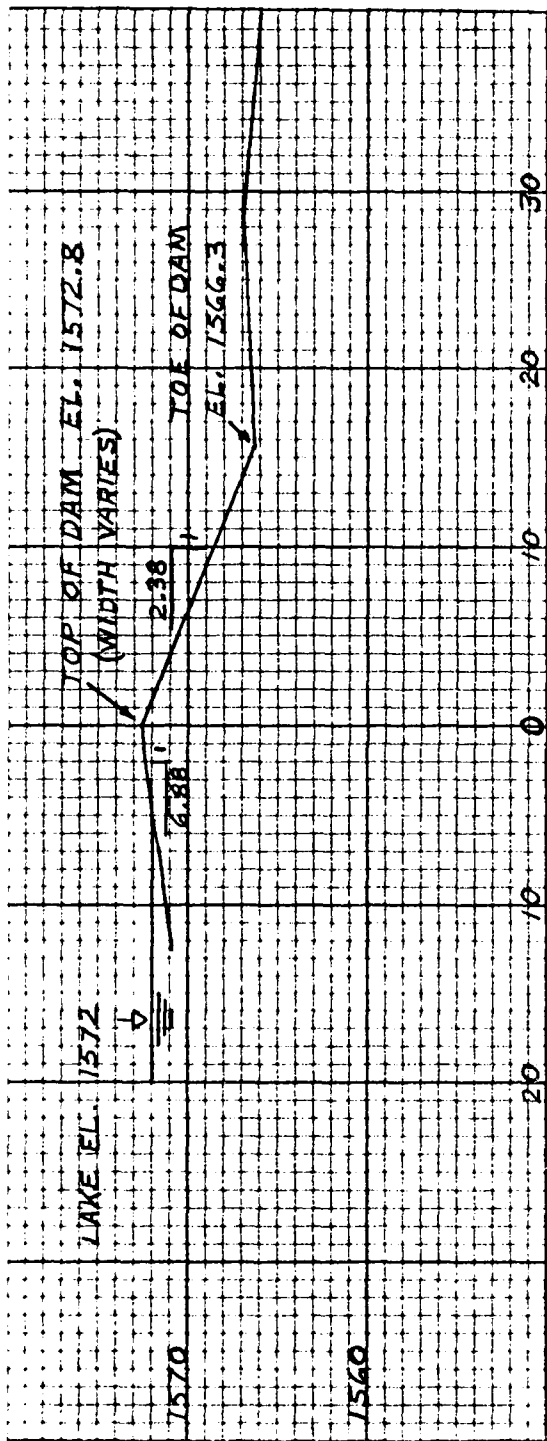
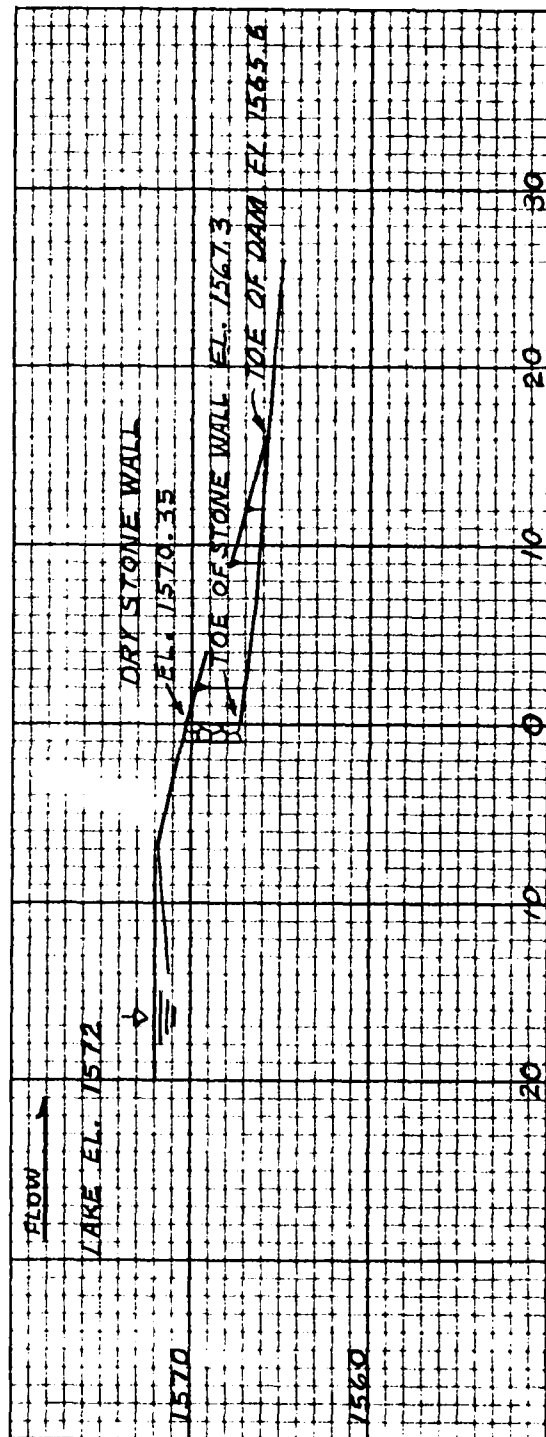
TYPICAL DAM SECTIONS

a. Dam. Irregularities in top of dam elevation are presented in Exhibit A-2. The lowest crest elevation 1572 is located upstream of the exposed dry stone wall (see Section B, Exhibit A-3). On the day of the inspection the reservoir level was approximately $\frac{1}{4}$ -inch above the lowest dam crest elevation, resulting in overtopping of the dam. Water overflowing the crest was observed to flow over and through the exposed downstream stone wall into the stream channel.
