# BEAR POND DAM NJ00773

## PHASE 1 INSPECTION REPORT NATIONAL DAM SAFETY PROGRAM.

REPT. NO: DAEN/NAP-53842/NJ00773-81/07  
JULY 1981

Name of Dam Bear Pond Dam Fed ID# NJ 00773

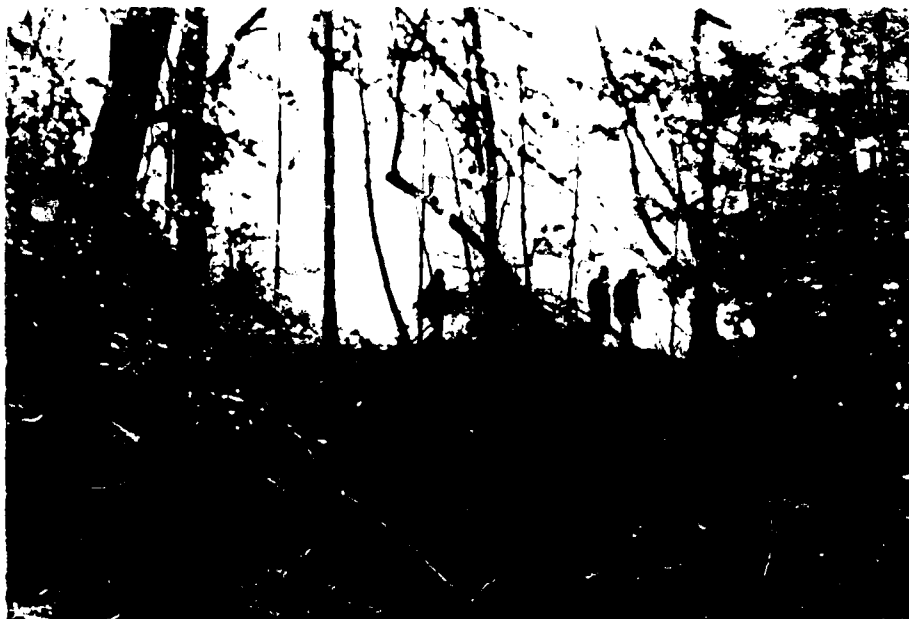
This earth dam lies across a saddle in the bedrock on the northwest rim of the lake. Although maintenance has apparently been neglected for a great many years, the dam appears quite sound, structurally, and in fair condition. The crest is uniform in a horizontal plane although its width varies from 20 to 50 feet at the abutments. The downstream slope is relatively steep with little grass cover, but no signs of slumping, settlement, or erosion were noted. A great many trees are growing along the edges of the crest and on the downstream slope. The dam grades smoothly into the abutments making it difficult to determine where the embankment begins and ends. Light seepage was observed at the center of the dam's downstream toe. About 100 feet further downstream the seepage and ground water from the steep side walls of the valley form a small stream that joins the main channel 550 feet downstream of the spillway. The seepage contains a heavy iron precipitate, suggesting that it may be coming from the 3-inch-diameter outlet pipe, which was not located and whose exit is believed buried and overgrown by 50 years of inattention. The pipe has probably corroded closed, reducing flow to an orange-colored, iron-rich seep.

View of Downstream Slope of Dam

(3) Bare patches of the embankment should be reseeded and a firm grass cover established.
