HERZENBERG DAM

NJ 00146

PHASE 1 INSPECTION REPORT
NATIONAL DAM SAFETY PROGRAM

REPT. NO: DAEN/NAP-53842/NJ00146-81/07
JULY 1981

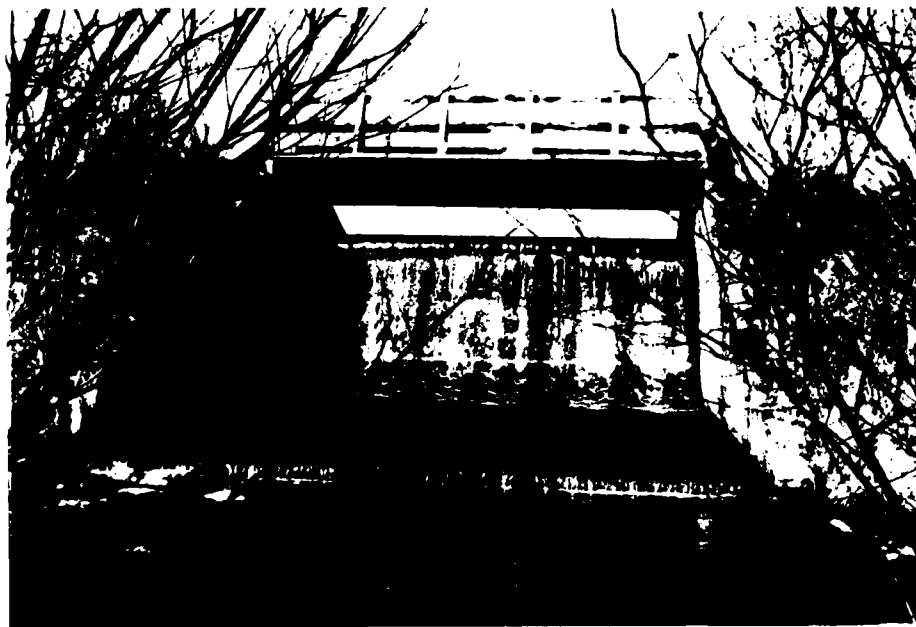
The discharge capacity of the principal spillway has been reduced by the installation of a 12-inch-high flashboard on the crest of the ogee weir and the construction of a girder-supported wood plank bridge over the crest. The bridge soffit extends 8 inches down into the spillway, reducing the clear opening from 4 feet by 24.5 feet to 2.33 feet by 24.5 feet. A spalled line 4 to 8 inches wide and up to 1 inch deep has developed along the entire length of the crest where the discharge over the flashboard hits the weir. Another, lighter line of spalling was noted about one-third of way down the spillway apron and sporadic light spalling and efflorescence were observed on both wingwalls. Light seepage was noted emanating from a lightly spalled area about midway down the right downstream wingwall. The right wingwalls are both displaced one-half inch from the sidewall toward the spillway channel, and light erosion and undercutting were observed at the toe of the left downstream wingwall.

Principal Spillway

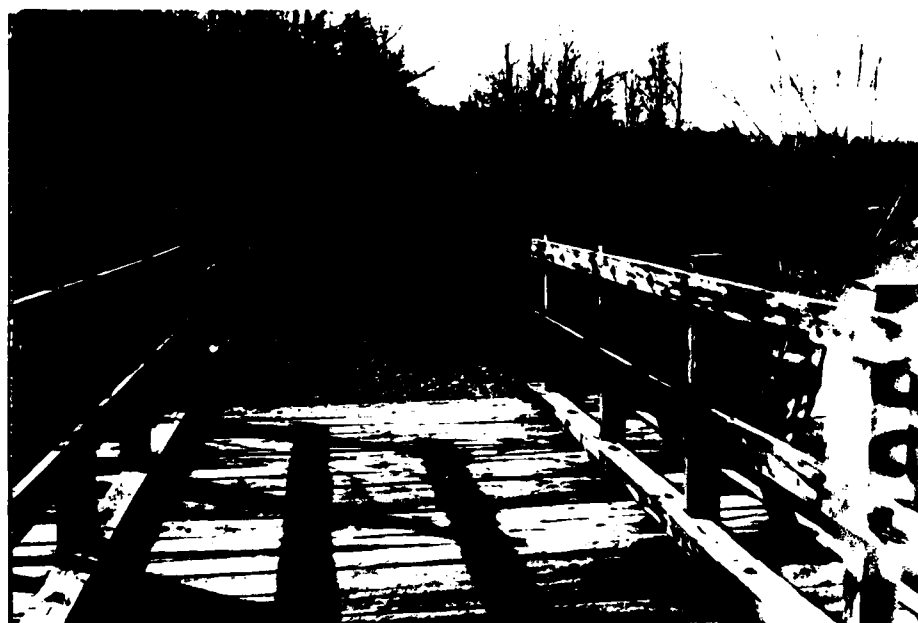
The auxiliary spillway has a thick grass cover with very light sporadic brush noted on the downstream slope. However, a gravel road has been constructed from the right abutment across the control section to the primary spillway. The road embankment, which is 2 to 3 feet high, completely and effectively seals the channel and precludes its use as a spillway.

View of Road Obstructing Auxiliary Spillway

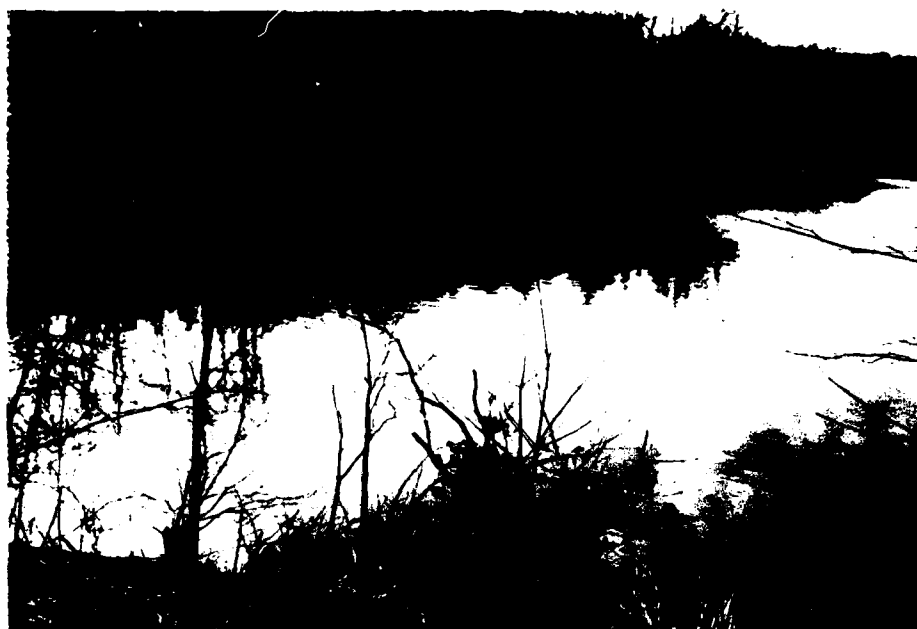
March, 1981
Crest of Dam Looking West
