6 National Dam Safety Program. N.J. No Name Dam Number 58 (NJ00653), Wallkill River Basin, Tributary to Papakating Creek, Sussex County, New Jersey. Phase I Inspection Report.

NEW JERSEY NO NAME DAM NO. 58 (NJ00653)

PHASE I REPORT  
NATIONAL DAM INSPECTION PROGRAM

Name of Dam N.J. No Name Dam No. 58 Fed ID# NJ 00653

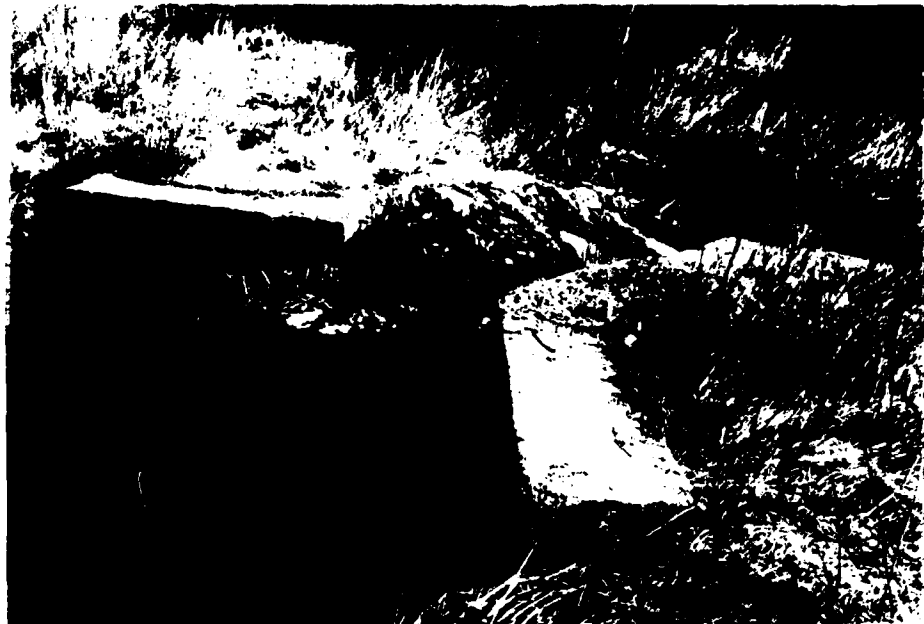
March, 1981  
Upstream View of Spillway 300' North of Dam

The spillway consists of a small concrete weir located about 300 feet to the north of the left abutment. Minor spalling of the concrete wing-walls was noted and the downstream ends of the sidewalls were slightly undercut. A layer of coarse sand and gravel has built up in front of the concrete sill of the weir to an elevation slightly higher than the sill itself. The opening of the weir is 30 percent constricted by a pile of earth. It is apparent that someone recently dumped earth across the entire weir in order to block the spillway and raise the lake surface elevation. The makeshift earth dam has been breached and the water elevation has returned to the normal pool elevation. The earth remaining in the spillway channel is considered inconsequential since the next large storm will clear the spillway completely.

VISUAL EXAMINATION OF	OBSERVATIONS	REMARKS OR RECOMMENDATIONS
CONCRETE WEIR	Fair condition. Light spalling on edges of the wingwalls. Slight undercutting of downstream sidewalls. Spillway was filled with earth in attempt to raise water elevation. Earth was breached but weir is still partially blocked.	Concrete deterioration should be repaired and undercut areas refilled. Earth remaining in spillway should be cleared.
APPROACH CHANNEL	Sand and gravel lake bottom between wingwalls. Partially constricted by earth.	Earth should be removed.
DISCHARGE CHANNEL	Clear natural channel.	No constrictions observed
BRIDGE AND PIERS	None

1. The gate valve for the 24-inch outlet pipe should be located and the control tested to ensure its proper functioning.
2. The silt should be removed from the outlet pipe.
3. The trees and brush should be removed from the embankment, the crest should be regraded, the crest and back slope should be reseeded, and the animal burrows should be filled.
4. The earth in the spillway channel should be removed, the deteriorated concrete repaired, and the undercut portions of the sidewalls refilled.
