PASSAIC RIVER BASIN,  
TROY BROOK, MORRIS COUNTY  
NEW JERSEY

LAKE INTERVALE DAM  
NJ00769

PHASE 1, INSPECTION REPORT  
NATIONAL DAM SAFETY PROGRAM

MAY 1981

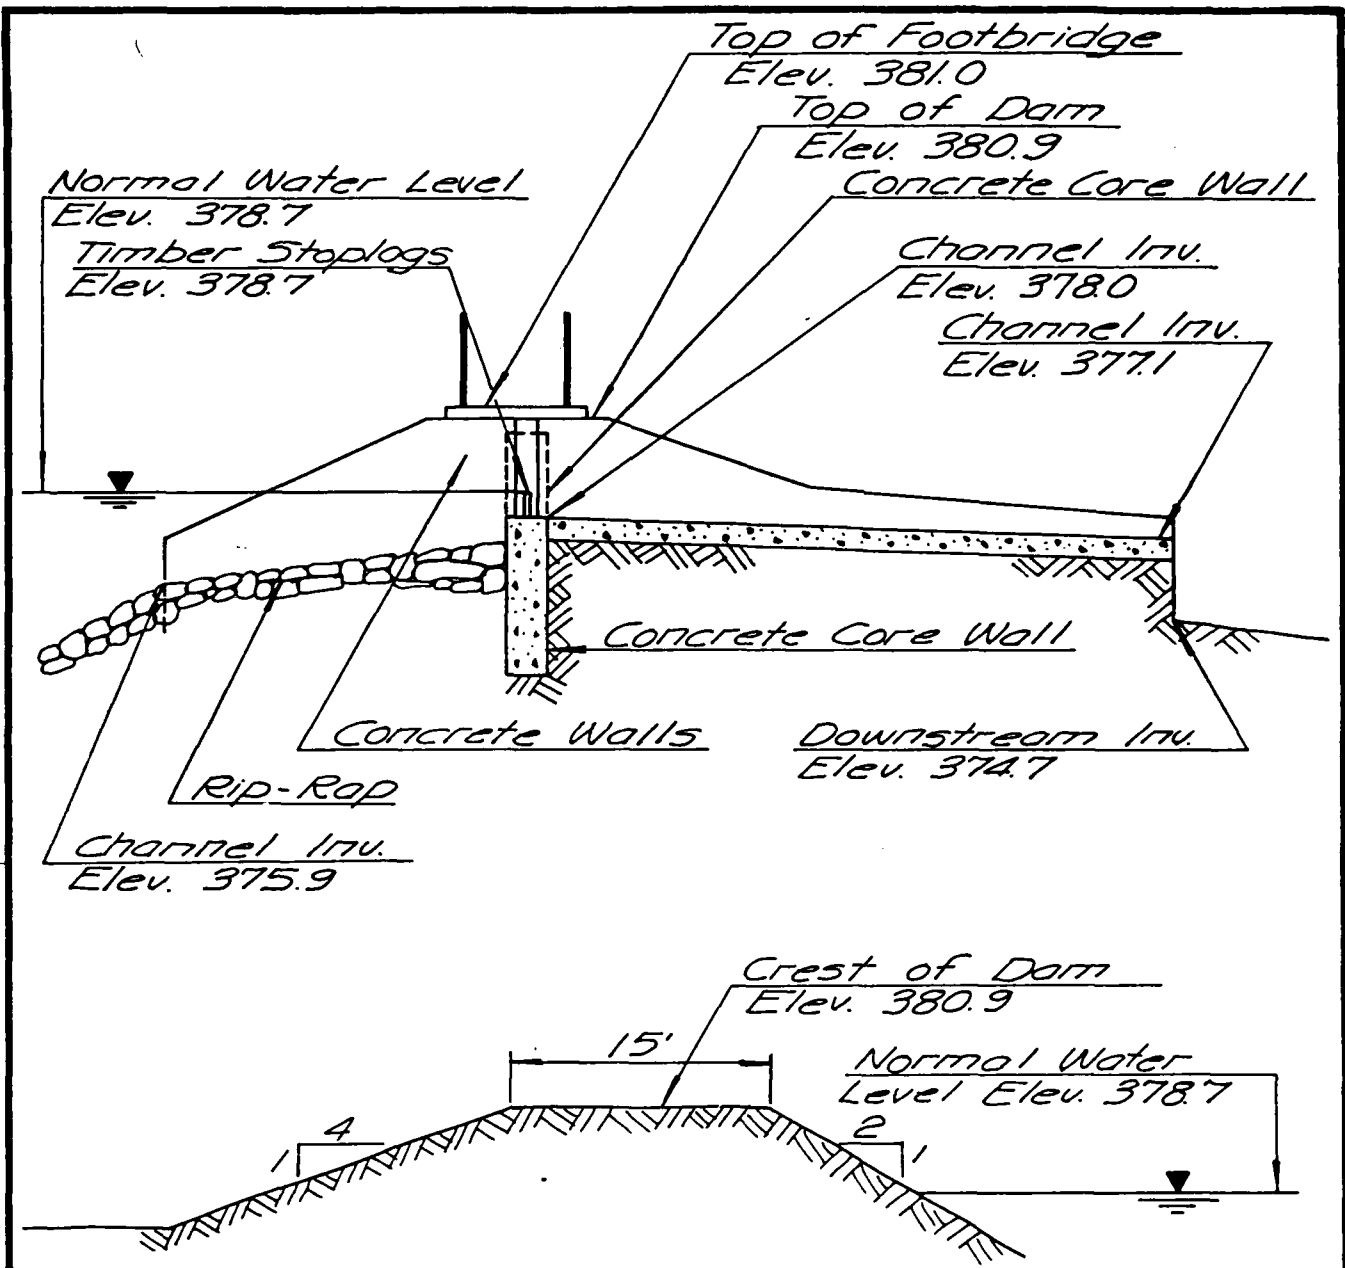
PLATE 6

1. Information taken from field inspection December 18, 1980.
2. Lake was drawn down at time of inspection.

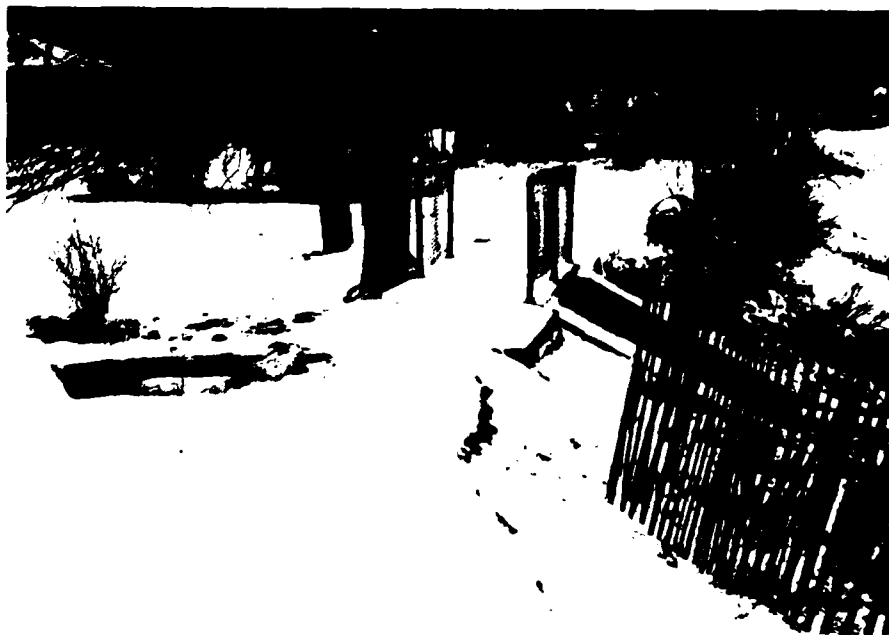
PHOTO 4

CREST OF DAM

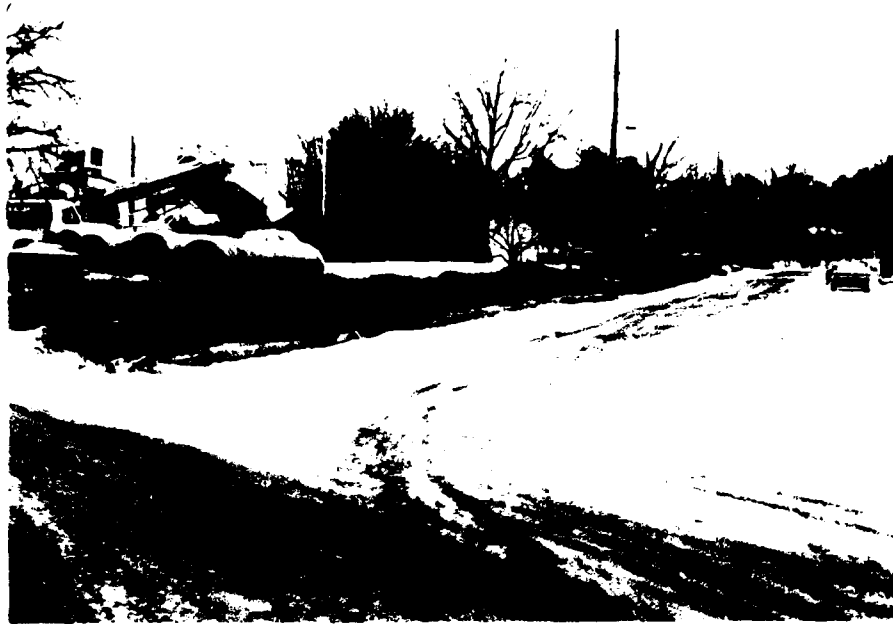
PHOTO 5

DOWNSTREAM SIDE OF DAM-LEFT SECTION
