JUNIOR LAKE DAM
CALLAWAY COUNTY, MO.
MO 11526

**PHASE 1 INSPECTION REPORT
NATIONAL DAM SAFETY PROGRAM**

PREPARED BY
HOSKINS-WESTERN-SONDEREGGER, INC.
CONSULTING ENGINEERS
LINCOLN, NEBRASKA

OCTOBER, 1980

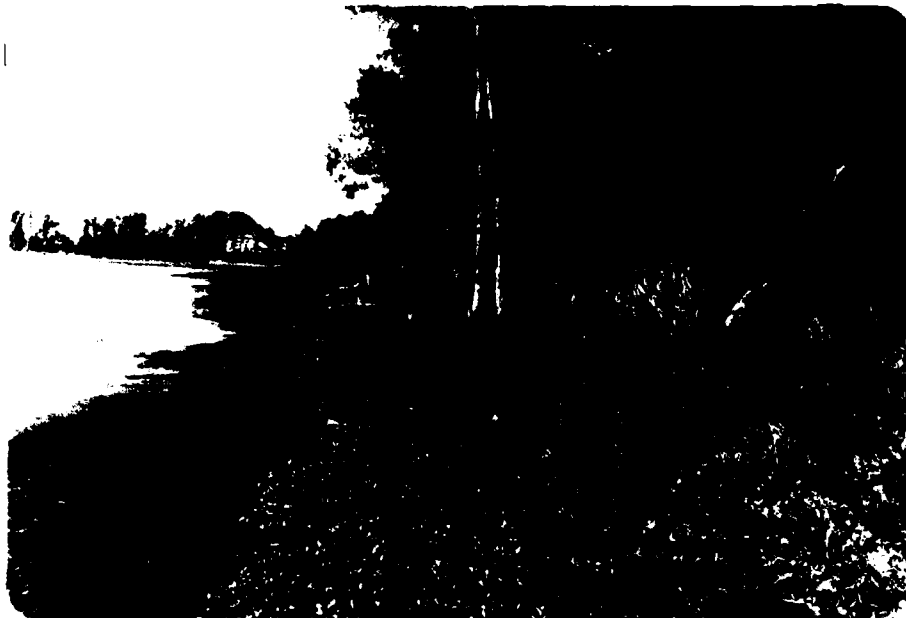
The embankment is in very poor condition. Wave erosion has removed much of the upstream slope of the east leg and has reduced the crest width to 2 or 3 feet in some sections. Most of the embankment is covered with trees and brush, and tree roots extend from the upstream slope through sections of the crest. Rodent holes have contributed to erosion of the crest. Some of the low spots on the crest line of the east leg are only 1.6 feet \pm above the spillway elevation. No evidence of any recent overtopping was observed. However, the depths of flow over the spillway, as reported by Mr. Martin, would indicate that the low points along the east leg of the dam have been very near to overtopping. The spillway is in fair condition. However, the major cracks and spalling should be repaired to minimize future deterioration. Trees in the spillway outlet section should be removed.

PHOTO NO. 6 - THE UPSTREAM SLOPE AND CREST OF THE EAST LEG
LOOKING NORTH. THE UPSTREAM SLOPE IS BADLY
ERODED
