**HIGHWAY 21 LAKE DAM
JEFFERSON COUNTY, MISSOURI
MO 31402**

**PHASE 1 INSPECTION REPORT
NATIONAL DAM SAFETY PROGRAM**

HORNER & SHIFRIN, INC.
5200 OAKLAND AVENUE
ST. LOUIS, MISSOURI 63110

Name of Dam:	Highway 21 Lake Dam
State Located:	Missouri
County Located:	Jefferson
Stream:	Tributary of Heads Creek
Date of Inspection:	8 October 1980

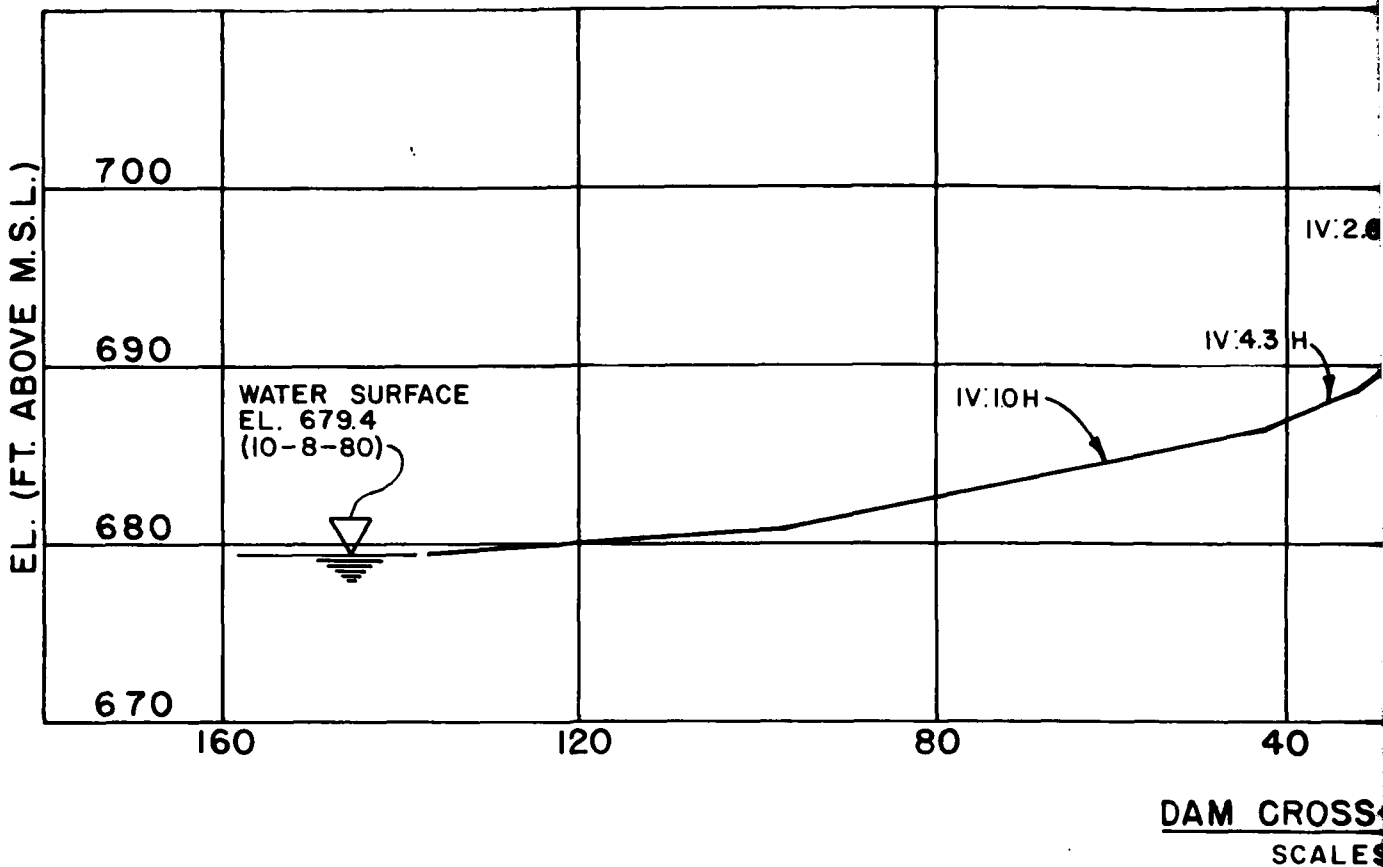
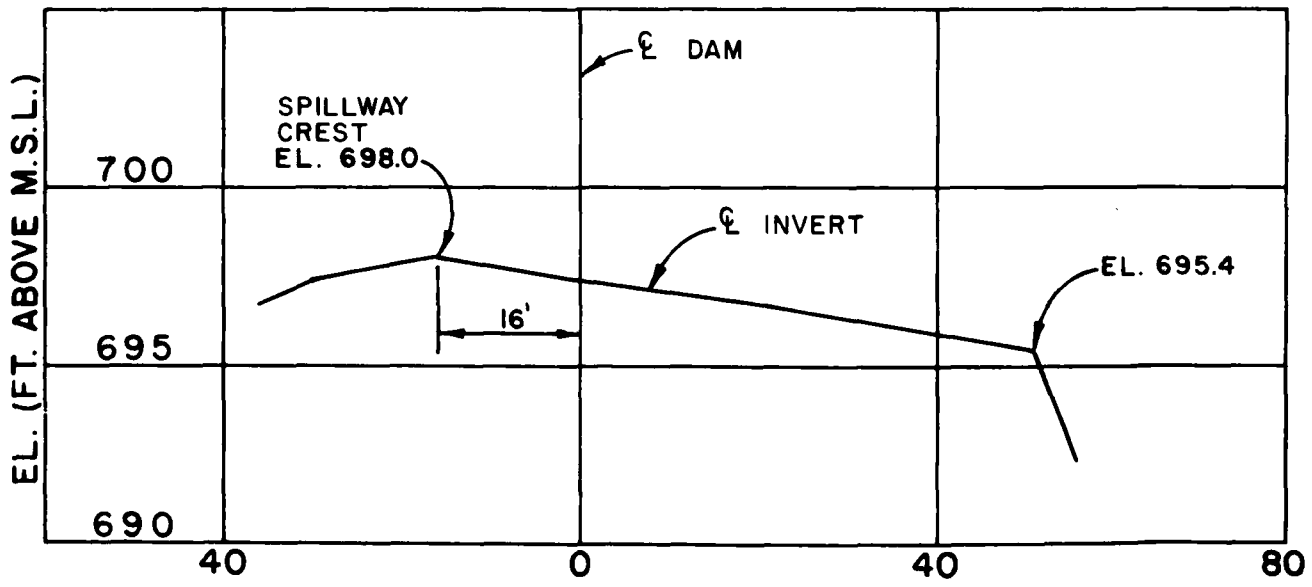
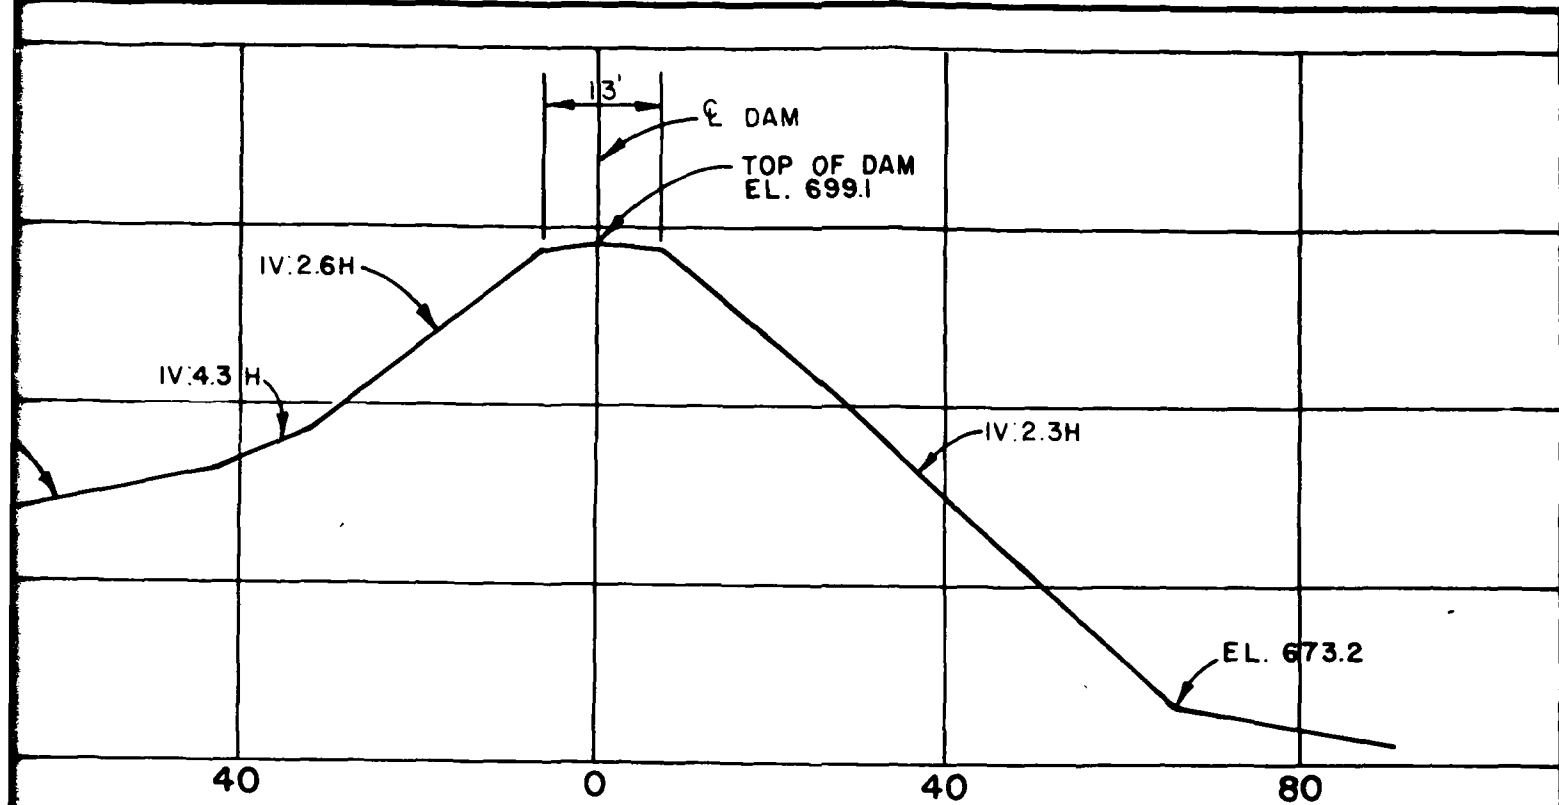
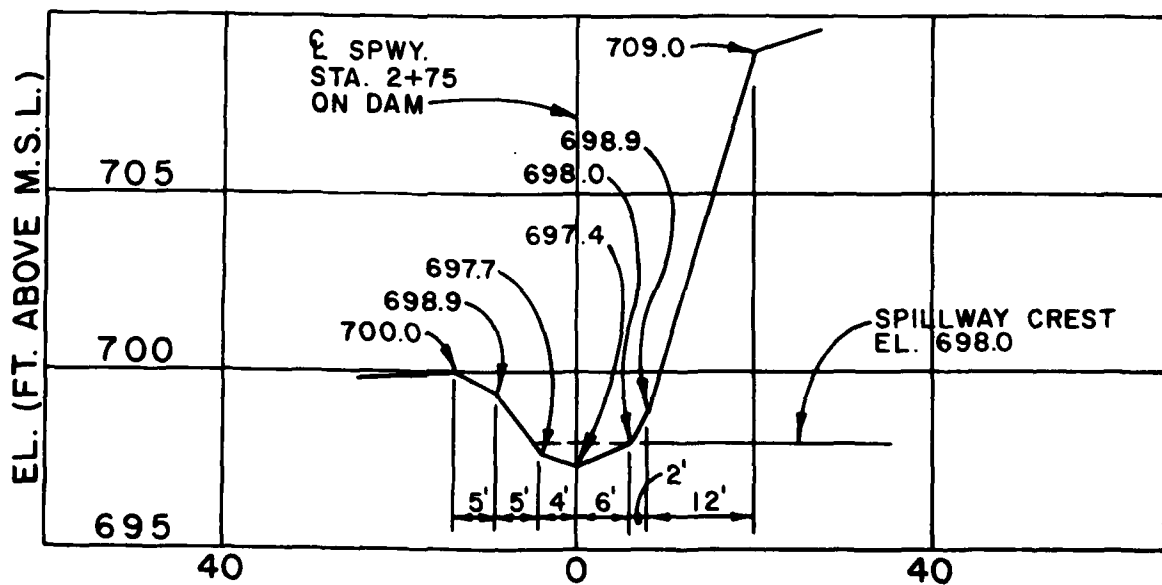
**HIGHWAY 21 LAKE
 DAM CROSS-SECTION
 SPILLWAY PROFILE & SECTION**
 Horner & Shifrin, Inc. Oct. 1980

Elevation 699.1 was found to be the lowest point in the dam crest. The velocity of spillway discharge corresponding to elevation 699.1 was determined to be 4.6 feet per second, which is less than the assumed maximum permissible (non-erosive) velocity of 5.0 feet per second.
