LAC CATALINA DAM

MO 30286

PHASE 1 INSPECTION REPORT NATIONAL DAM SAFETY INSPECTION

LAC CATALINA DAM - MISSOURI INVENTORY NO. 30286

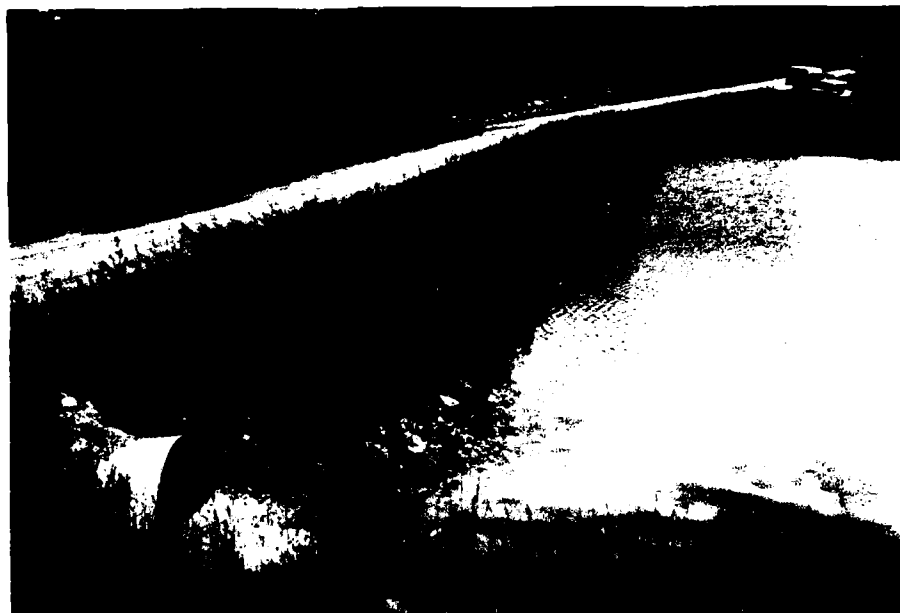
NO. 1: UPSTREAM FACE OF DAM

4. The upstream face of the dam has a grass cover to prevent erosion. However, at the lake waterline, some minor erosion of the slope has occurred. Continued erosion of the embankment could result in loss of section that may lead to instability of the slope and possible failure of the dam.

c. Dam. The visible portions of the upstream and downstream faces of the dam (see Photos 1 and 2) appeared to be in sound condition although some minor erosion of the unprotected upstream slope at the waterline was noticed. The downstream slope had a dense cover of grass that was about 30 inches high at the time of the inspection. The roadway that traverses the dam crest was surfaced with gravel that was thinly distributed and some rutting of the surface was observed.
