4. TITLE (and Subtitle) Phase I Dam Inspection Report National Dam Safety Program Bayless Taylor Dam (MO 31091) Bollinger County, Missouri		5. TYPE OF REPORT & PERIOD COVERED Final Report

BAYLESS TAYLOR DAM  
BOLLINGER COUNTY, MISSOURI  
MISSOURI INVENTORY NO. 31091

PHASE I INSPECTION REPORT  
NATIONAL DAM SAFETY PROGRAM

MARCH 1980

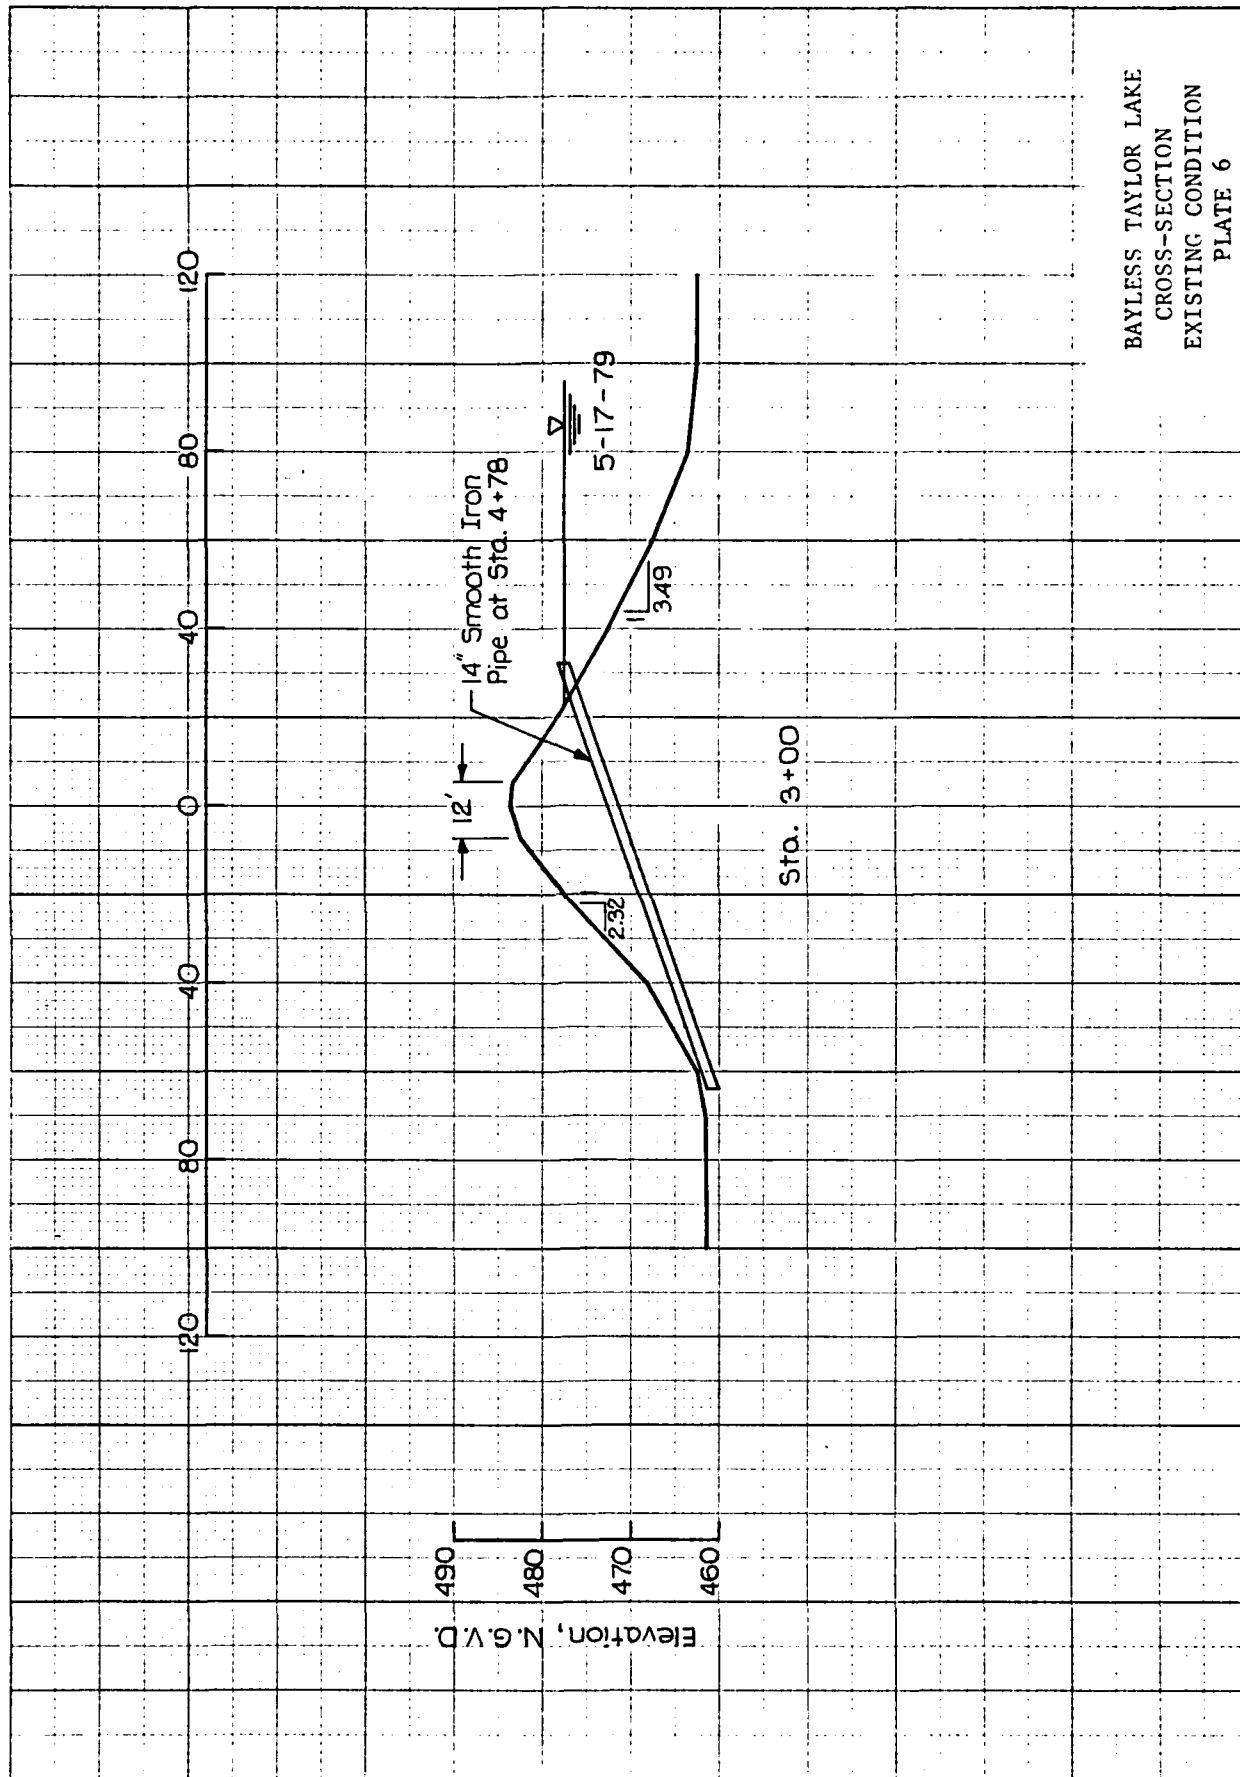
BAYLESS TAYLOR LAKE  
CROSS-SECTION  
EXISTING CONDITION  
PLATE 6

b. Dam. No detrimental settlement, cracking, slides, or animal burrows were observed in or near the earthen embankment. A typical existing cross-section of the embankment is shown on Plate 6. This section is consistent with the cross-section presented in the Soil Conservation Service 1974 drawings (See Plate 5) except the downstream slope is 1V on 2.32H and the upstream slope is 1V on 3.49H. The top width was measured to be 12 feet. The maintenance of the upstream slope, crest, and downstream slope was satisfactory. (See Photo's 1, 2, 3, 4, 5) About 1½ feet of wave wash occurs near the left abutment (See Photo 5). Minimal willow tree growth occurs on both the upstream slope and on the downstream toe of the embankment (See Photos 4 and 6). Also small tree and bush growth was observed on the right downstream abutment.
