TRIPOLI VALLEY DAM
PHELPS COUNTY, MISSOURI

MISSOURI INVENTORY NO. 30435

PHASE I INSPECTION REPORT
NATIONAL DAM SAFETY PROGRAM

PREPARED BY: ST. LOUIS DISTRICT CORPS OF ENGINEERS
FOR: GOVERNOR OF MISSOURI

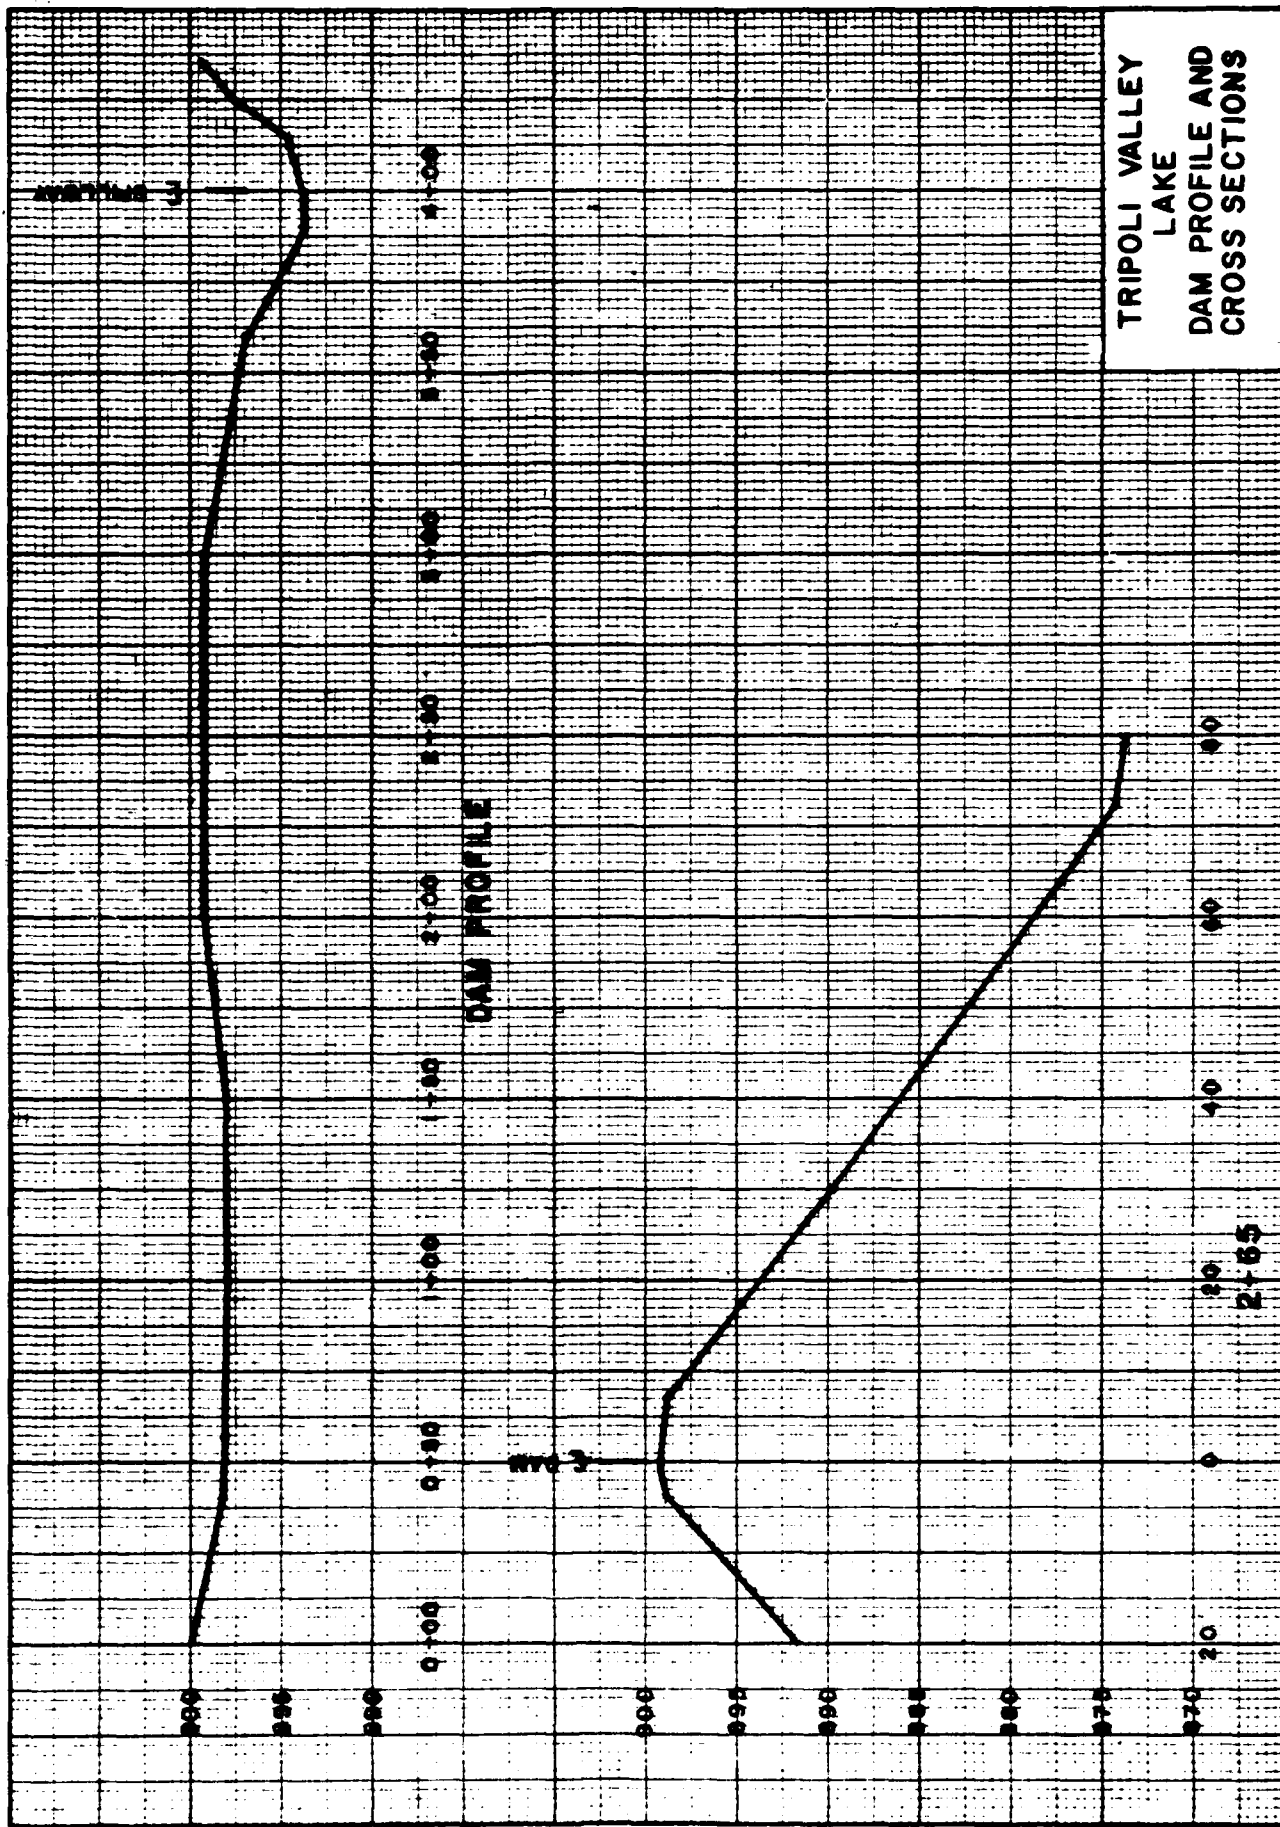
TRIPOLI VALLEY
LAKE
DAM PROFILE AND
CROSS SECTIONS

(1) No detrimental settlement, cracking, or sinkholes were observed in or near the earth embankments. An embankment cross section at the maximum height section for the dam is shown on PLATE 2. No animal burrows were noted at the dam.
