TYWAPPITY COMMUNITY DAM  
SCOTT COUNTY, MISSOURI

MISSOURI INVENTORY NO. 40006

PHASE I INSPECTION REPORT  
NATIONAL DAM SAFETY PROGRAM

AUGUST 1978

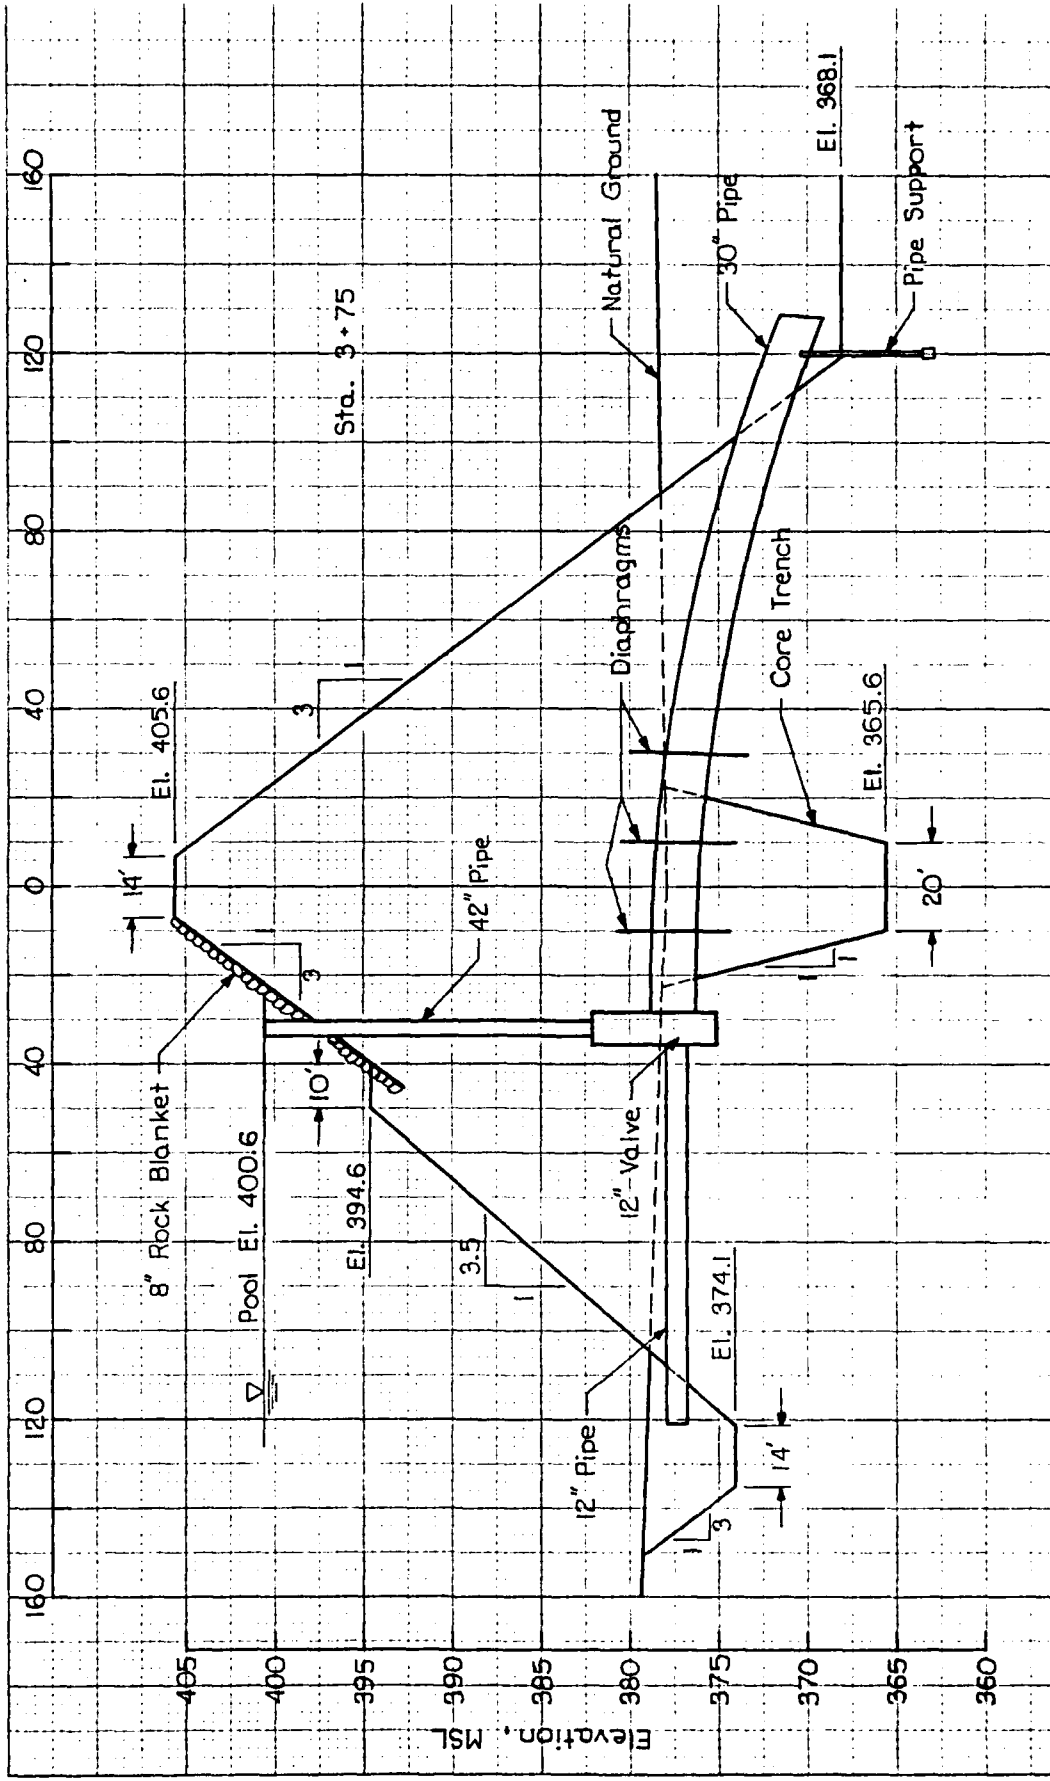
PLATE 4

The stilling basin has scoured to elevation 366.2 m.s.l. approximately 2 feet below the stilling basin elevation specified in the 1956 contract drawings (see Plates 4 and 5). The stilling basin erosion has apparently stabilized.

A lake drain consisting of a 12-inch diameter steel pipe is specified in the contract drawings (see Plate 4). This structure is junctioned by a valve to the 36-inch diameter discharge pipe mentioned above. Because of the unaccessible location of the drain, it could not be inspected. Reportedly the lake was drained by the lake drain several years ago.

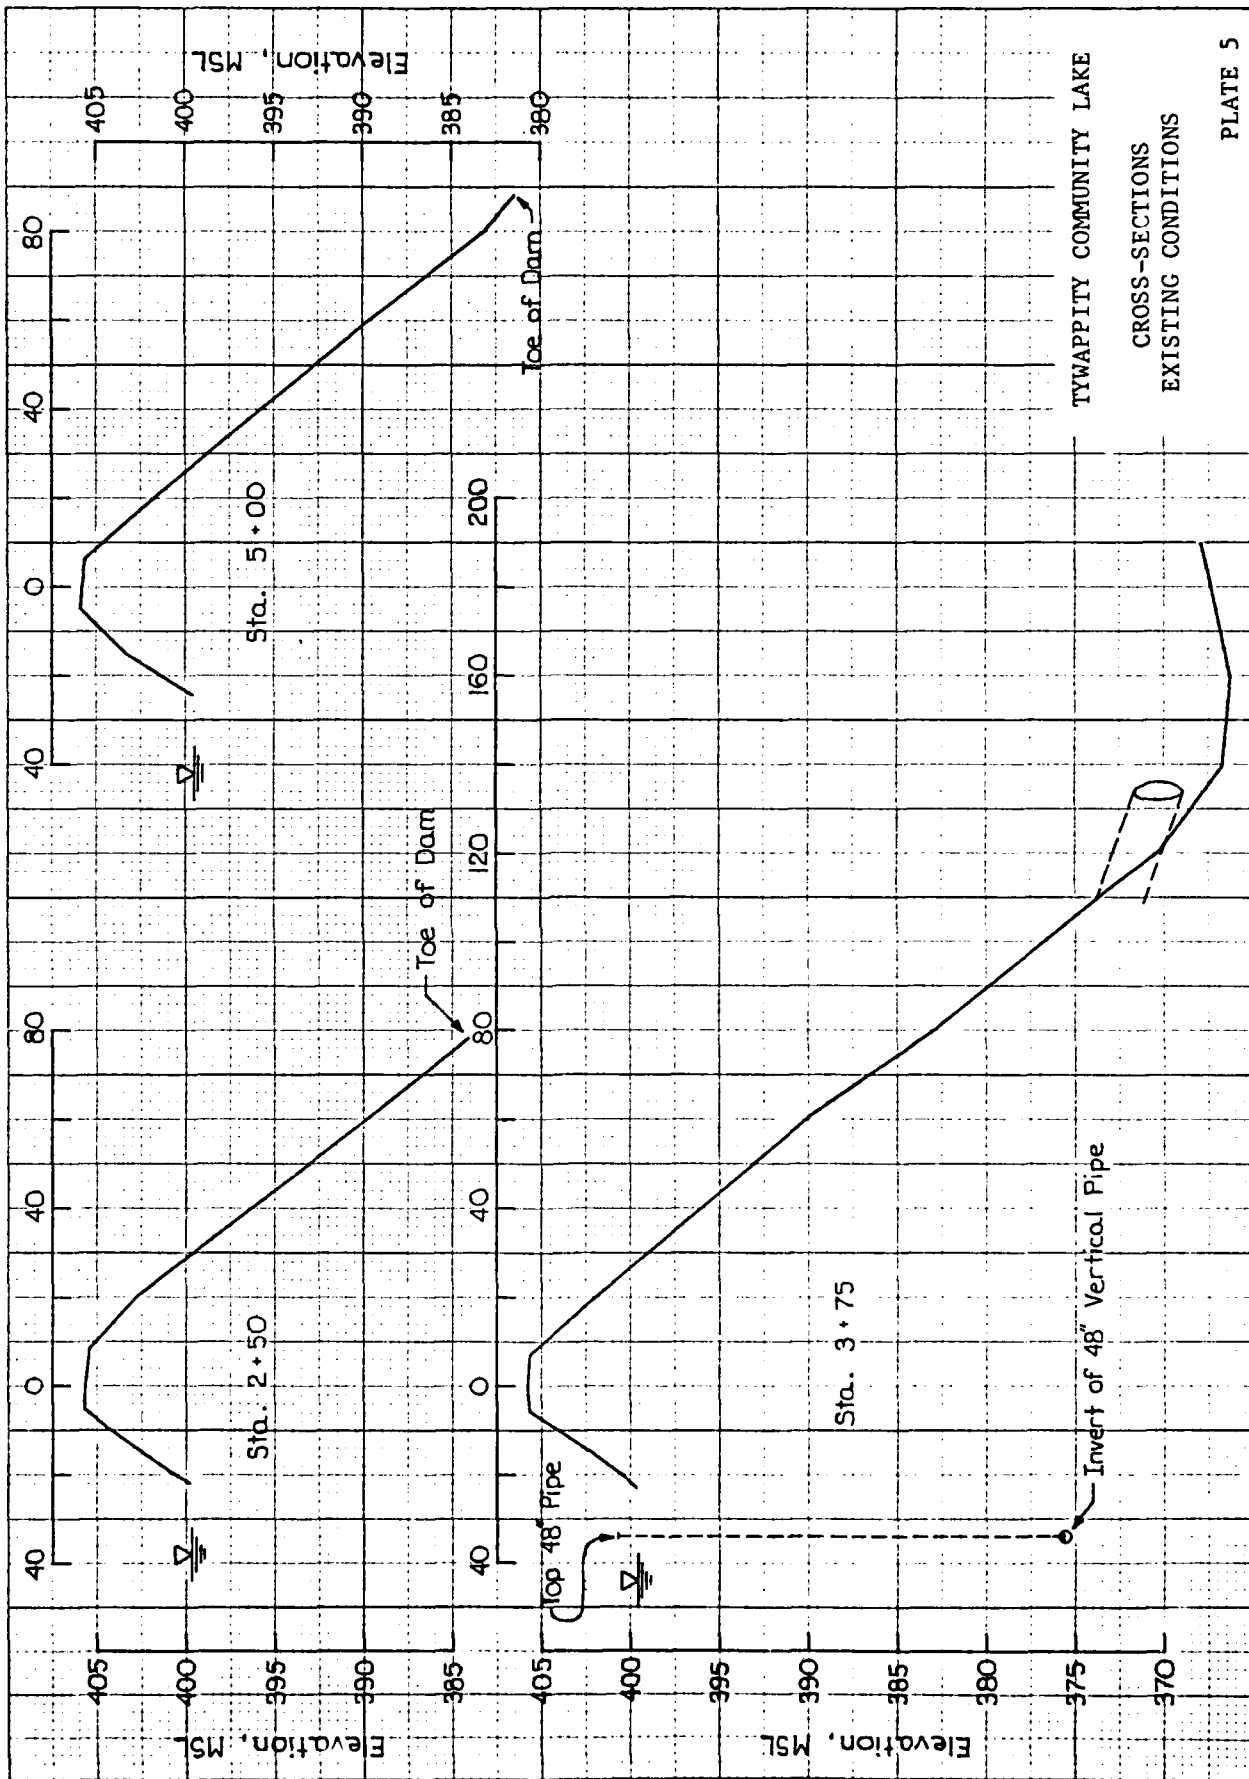
TYWAPPITY COMMUNITY LAKE  
 CROSS-SECTIONS  
 EXISTING CONDITIONS

c. Dam. No detrimental settlement, cracking, slides or animal burrows were observed in or near the earth embankment. Typical existing cross-sections of the embankment are shown on Plate 5. These sections are consistent with the cross-sections presented in the Missouri Department of Conservation 1956 contract drawings except the existing downstream slope is a 1V on 3.25H instead of the specified 1V on 3H (see Plate 4 for a typical dam section from the 1956 contract drawings). The dam embankment appears to be well maintained and is clear of bushes and trees except for a few small bushes growing on the upstream slope along the lake edge (see Photo 5). The slopes had recently been mowed and cleared of small brush growth (see Photo 6). The lower portion of the downstream slope had been dressed with a dozer blade (see Photo 7). The upstream slope of the dam is faced with a riprap blanket from the crown to below the lake level (see Photo 4). On the 1956 contract drawings the riprap blanket is specified to be 8 inches thick and to extend from 2 feet below

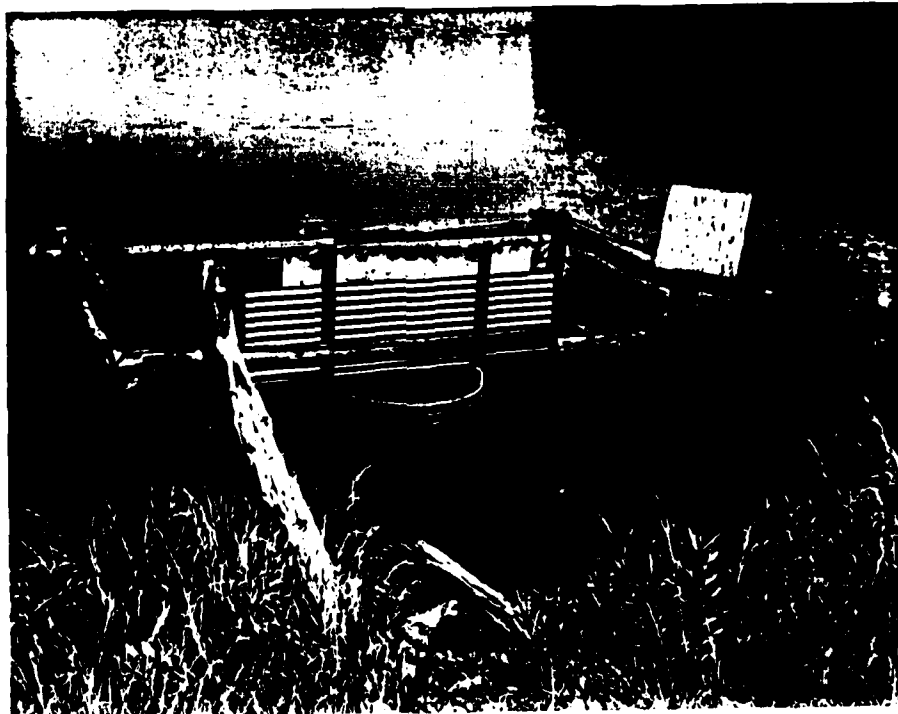
PHOTO 8: Inlet of Vertical Structure

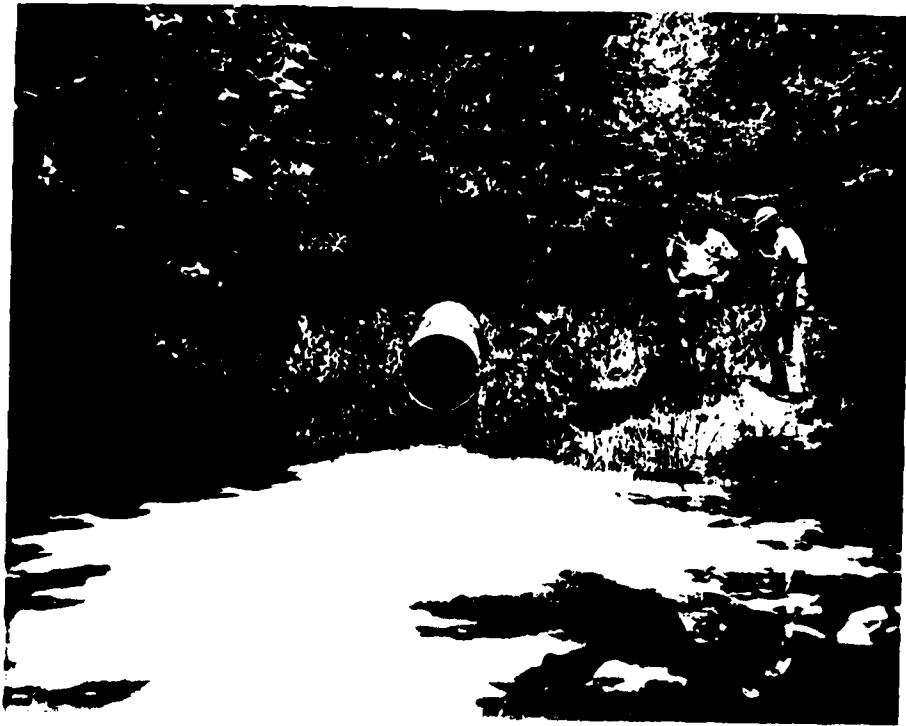
d. Appurtenant Structures. A vertical inlet constructed of 48-inch diameter, bituminous coated, corrugated metal pipe junctioned with a 36-inch diameter, bituminous coated, corrugated metal pipe is the primary means of discharge. A 2.1-foot by 7.5-foot corrugated metal baffle is mounted on the vertical inlet. A trash rack composed of timber posts and strands of barbed wire surrounds the inlet (see Photo 8). The outlet pipe discharges into an earth stilling basin located approximately 134 feet downstream of the dam center line (see Plate 5 and Photo 9).

PHOTO 9: Discharge of Vertical Structure

(5) The stilling basin should be monitored for active erosion.

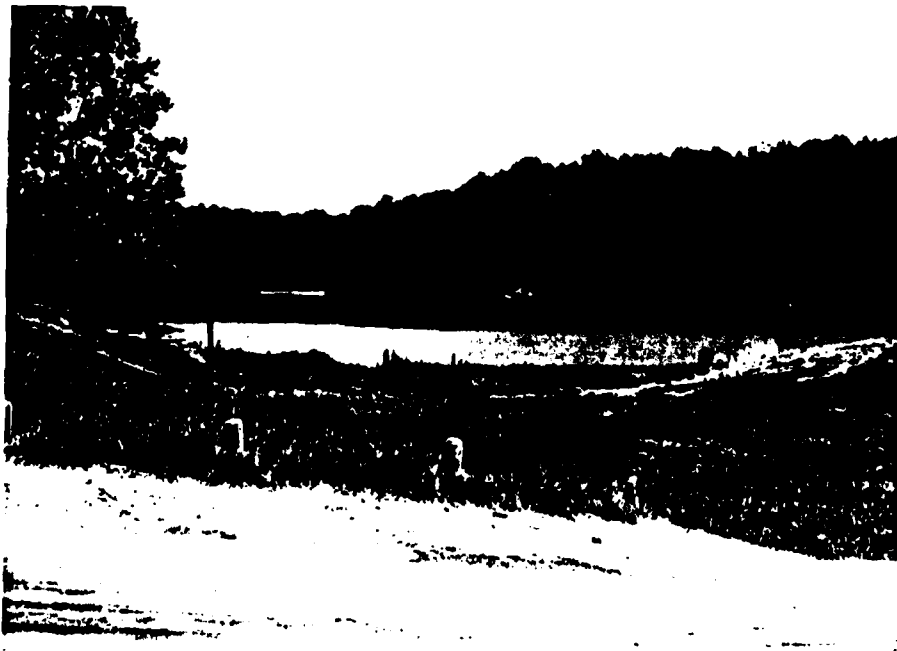
A grass covered, earth, emergency spillway is cut in the right abutment. The spillway is a trapezoidal section with a 50-foot bottom width and side slopes of 1V on 3H. The spillway is 125 feet long and is intersected at right angles by a 20-foot wide asphalt road. No erosion was observed in the emergency spillway area (see Photo 10).

PHOTO 10: Emergency Spillway
