**ALFRED B. BUHL, JR. LAKE DAM
JEFFERSON COUNTY, MISSOURI
MO 30464**

PHASE 1 INSPECTION REPORT NATIONAL DAM SAFETY PROGRAM

HS-7848

Name of Dam: Alfred B. Buhl, Jr.
State Located: Missouri
County Located: Jefferson
Stream: Tributary La Barque Creek
Date of Inspection: 28 June 1978

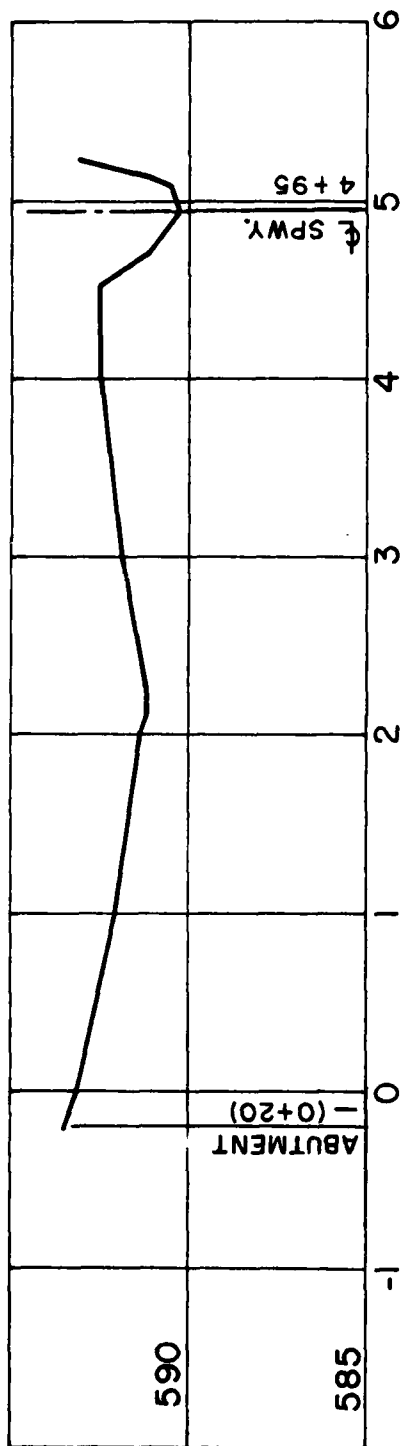
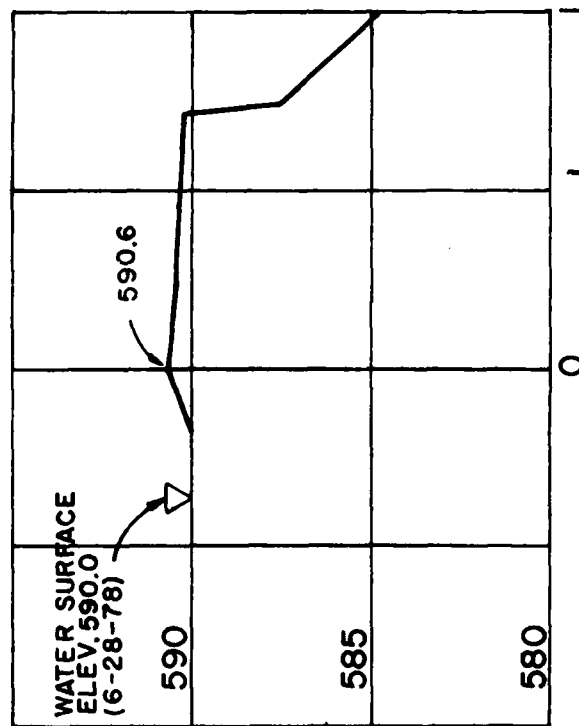
BUHL LAKE
 DAM & SPILLWAY PROFILES
 Horner & Shiffrin, Inc. July 1978

The elevation of the top of the dam, as determined by survey, was found to be approximately 1.4 feet lower at a location near the center of the dam than the top of the dam in the area adjacent to the spillway. Also, the elevation of the spillway crest was determined by survey to be about 0.5 foot lower than the low point of the dam. A profile of the dam crest centerline is shown on Plate 2.

(2) It is recommended that the low area located near the center of the dam be raised such that it no longer governs spillway capacity. Since the low area at the center of the dam is considered to be a result of settlement due to consolidation of the embankment and foundation soils, and since it is not known if all or nearly all of the settlement that is obtainable has taken place (the dam is about 25 years old), it is recommended that settlement (future) of the dam be monitored in order to determine overtopping potential and conditions affecting the operation of the spillway.
