CROGHAN DAM (NORTH & SOUTH)

LEWIS COUNTY, NEW YORK

INVENTORY NO. N.Y. 694

PHASE I INSPECTION REPORT NATIONAL DAM SAFETY PROGRAM

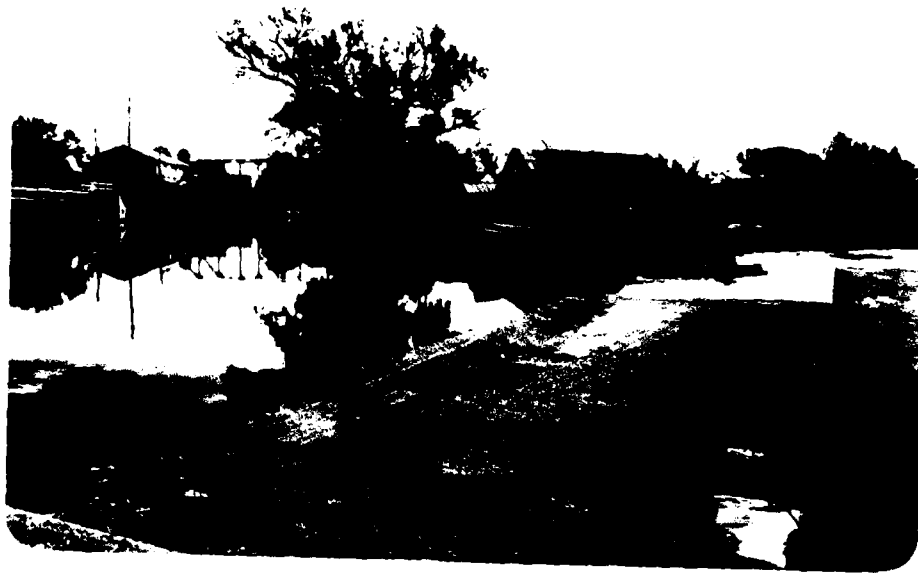
Visual observations revealed that there are a number of structural problems with this dam. The most serious deficiency was that one end of the log sluice structure was tilting downstream. It appeared to have separated from the dam, however, water flowing over the stop logs prevented a close inspection. There was a void up to 2 feet wide between the pier and the dam.

Photo 1 Tilting Pier of Log Sluice on North
Segment of Dam.

1. Modify the structure as necessary based on the stability analyses.
2. Repair the tilting pier at the right end of the log sluice.
3. Replace missing concrete on walls supporting the stop log structures on either end of both dam segments.
4. Repair deteriorated concrete on all spillway segments.
5. Repair scoured concrete at base of the pier at the right end of log sluice.
6. Repair spalled concrete on the retaining wall adjacent stoplog structure #1.
7. Investigate seepage through the left abutment wall adjacent to stop log structure #2.

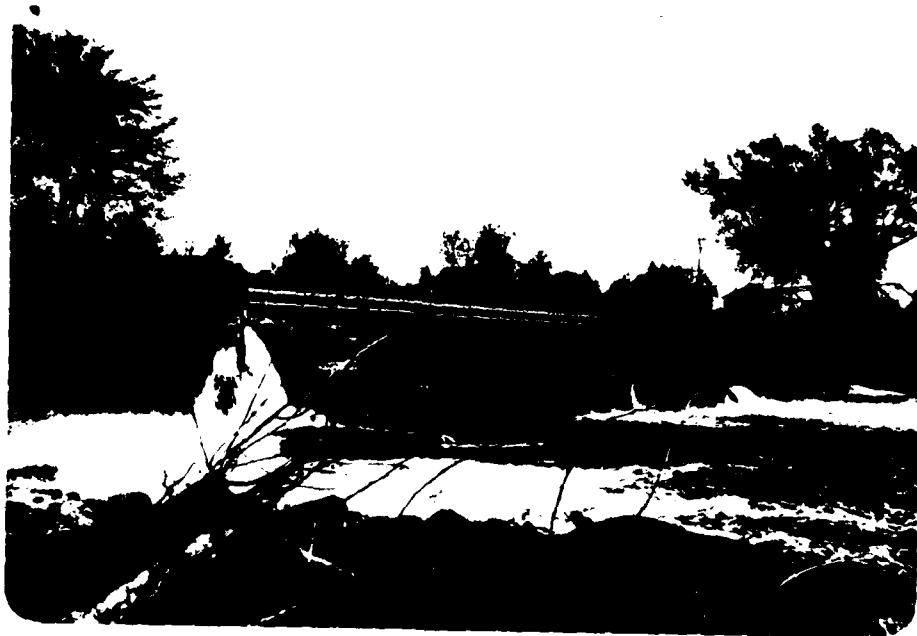
Photo 2 Tilting Pier at Right End of Log Sluice

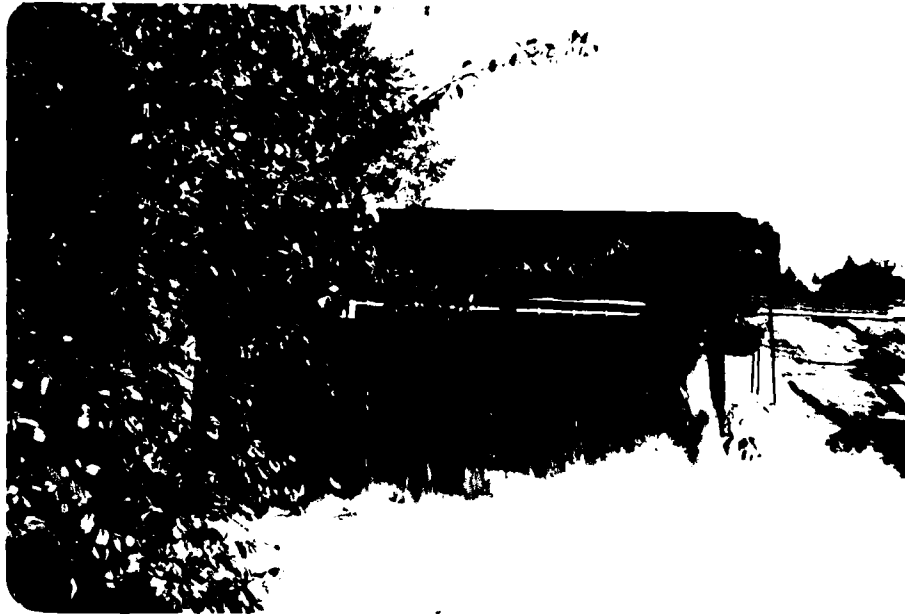
Photo 3 Deteriorated Concrete and Exposed Re-bar at
Right End of North Segment

RIGHT INTAKE STRUCTURE - CONCRETE SERIOUSLY DETERIORATED - REBAR IS ALL THAT SUPPORTS LEFT END OF WALL - LEAKAGE THROUGH WALL AT LEFT END

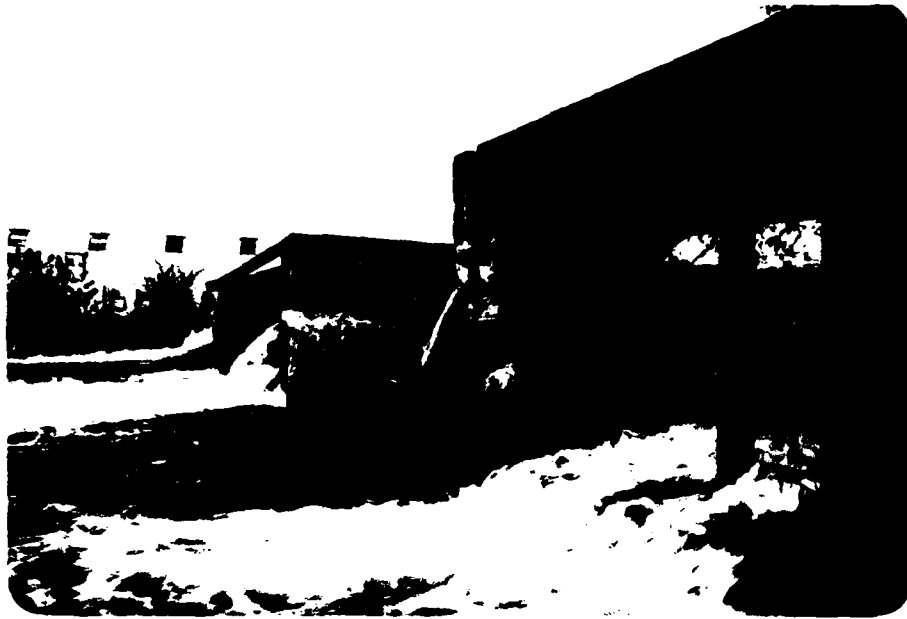
Photo 5 Intake Structure at Left End of North Segment
Note Structure Being Supported by Re-bar.

LEFT INTAKE STRUCTURE - REBAR IS ALL THAT IS LEFT ON LOWER PORTION OF WALL OVERALL DETERIORATION AS WELL.

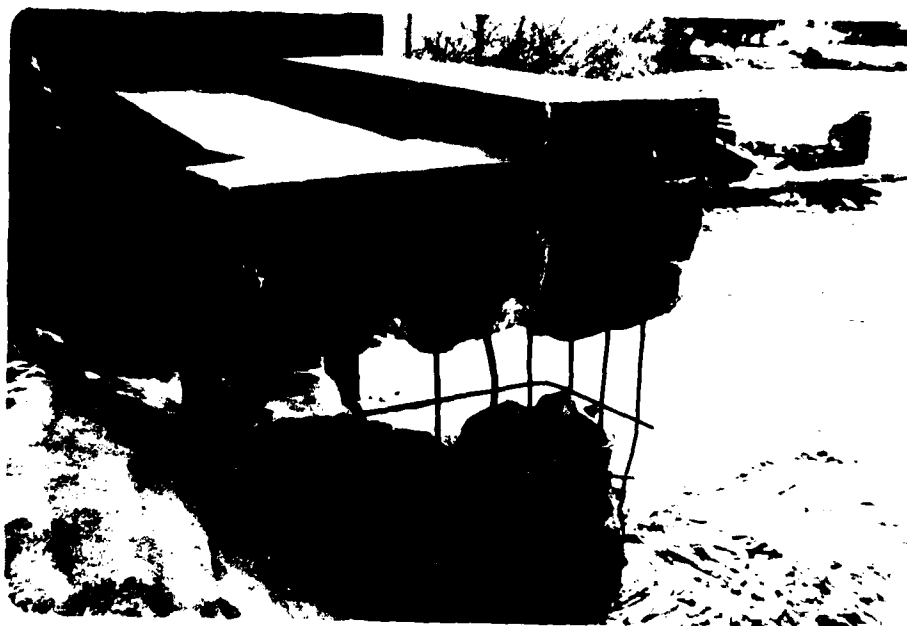
Photo 6 Deteriorated Concrete on Intake Structure at Left end
of North Segment

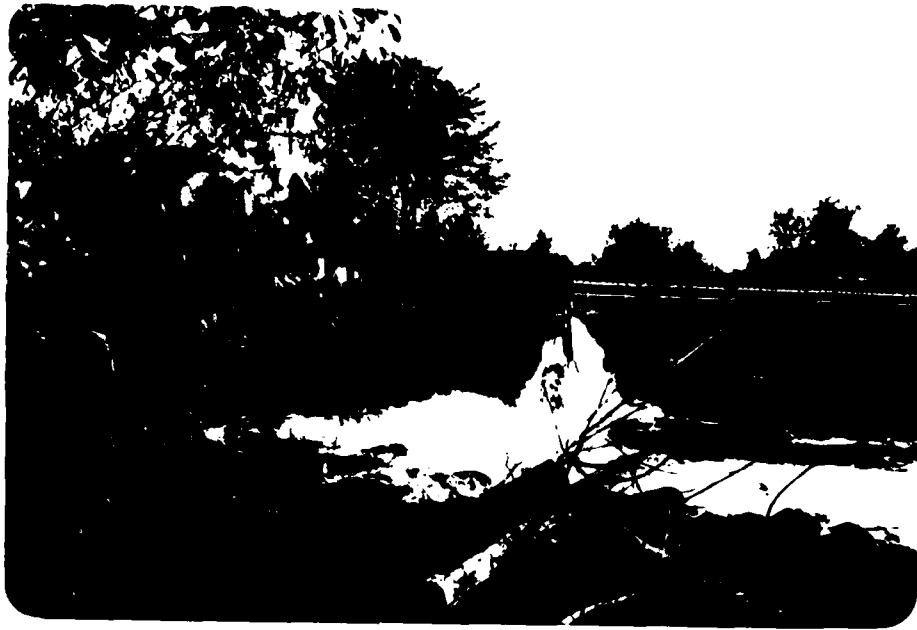
In addition to these three areas, there was less serious concrete deterioration in several other areas. There was a void on the downstream slope of the spillway #1 along the first construction joint from the right hand end (photo 7). The concrete at the base of the pier at the right end of the log sluice was scoured, partially undermining the pier (photo #8). Finally, the concrete retaining wall at the right end of the segment was spalling and cracked (photo 9).

Photo 7 - Deteriorated Concrete and Void along
Construction joint on North Segment

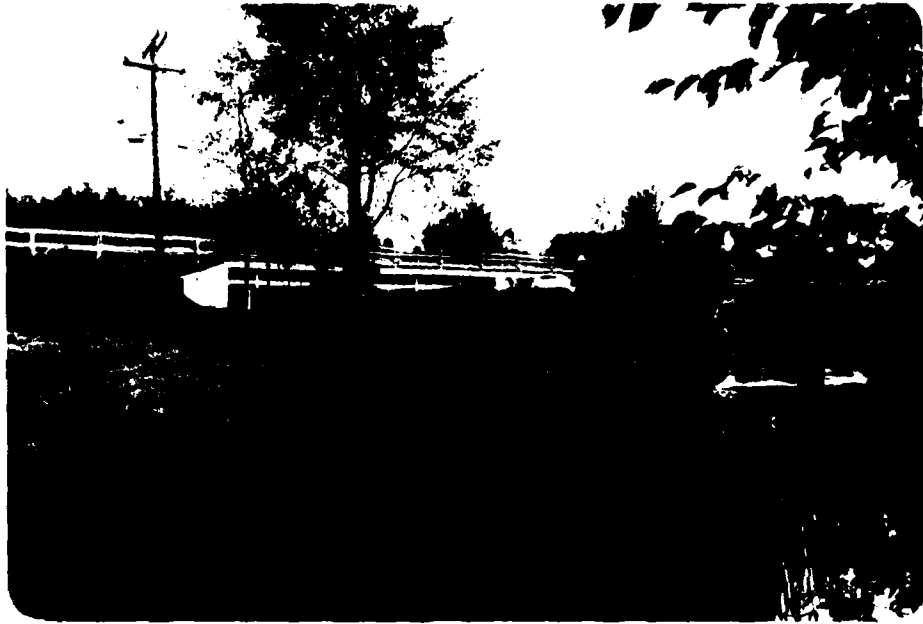
Photo 9-Spalled and Deteriorated Concrete
at Right End of North Segment
