KEARNEY LAKE DAM
JEFFERSON COUNTY, MISSOURI
MO 11099

PHASE 1 INSPECTION REPORT
NATIONAL DAM SAFETY PROGRAM

Name of Dam:	Kearney Lake Dam
State Located:	Missouri
County Located:	Jefferson
Stream:	Tributary of Sugar Creek
Date of Inspection:	22 September 1980

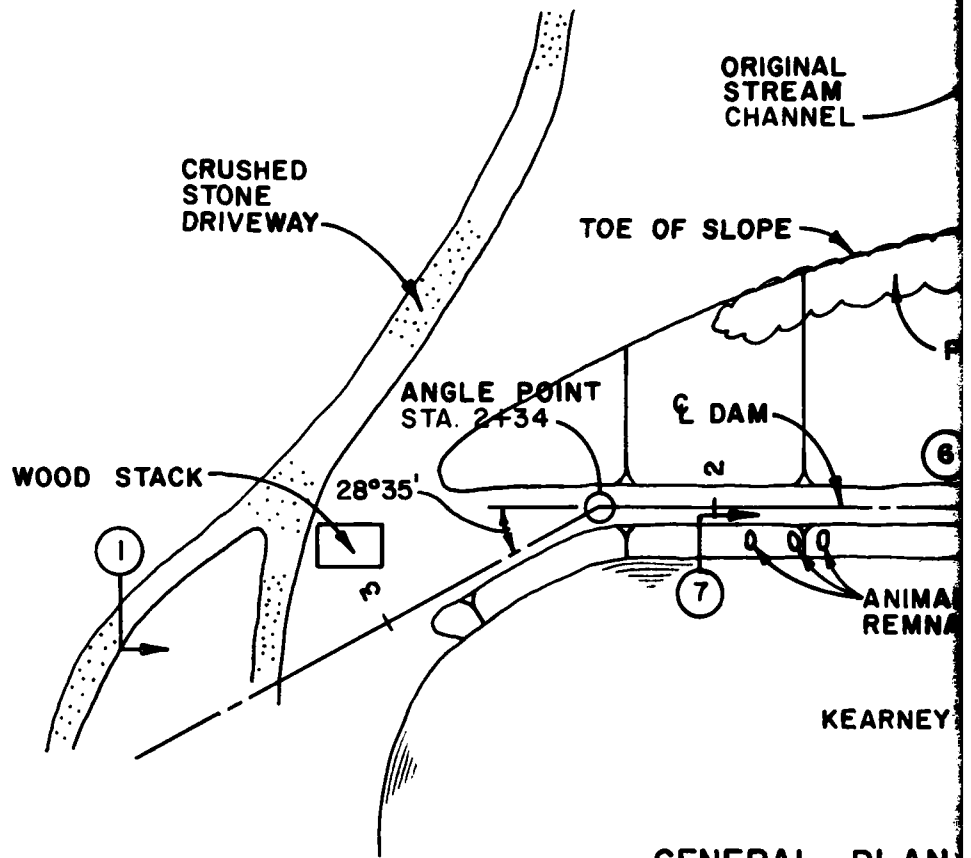
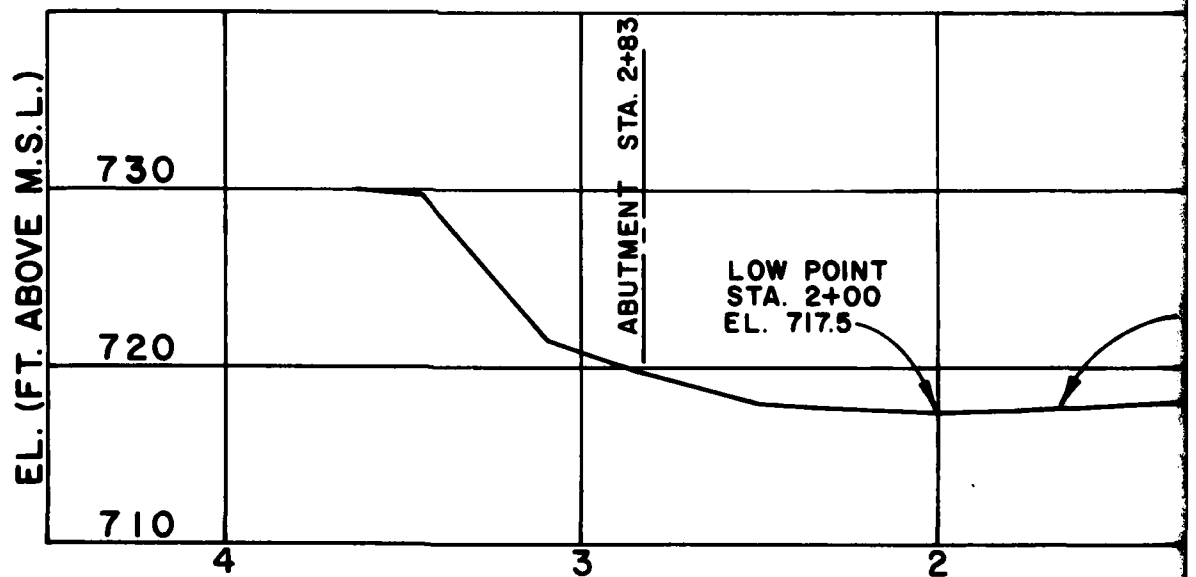
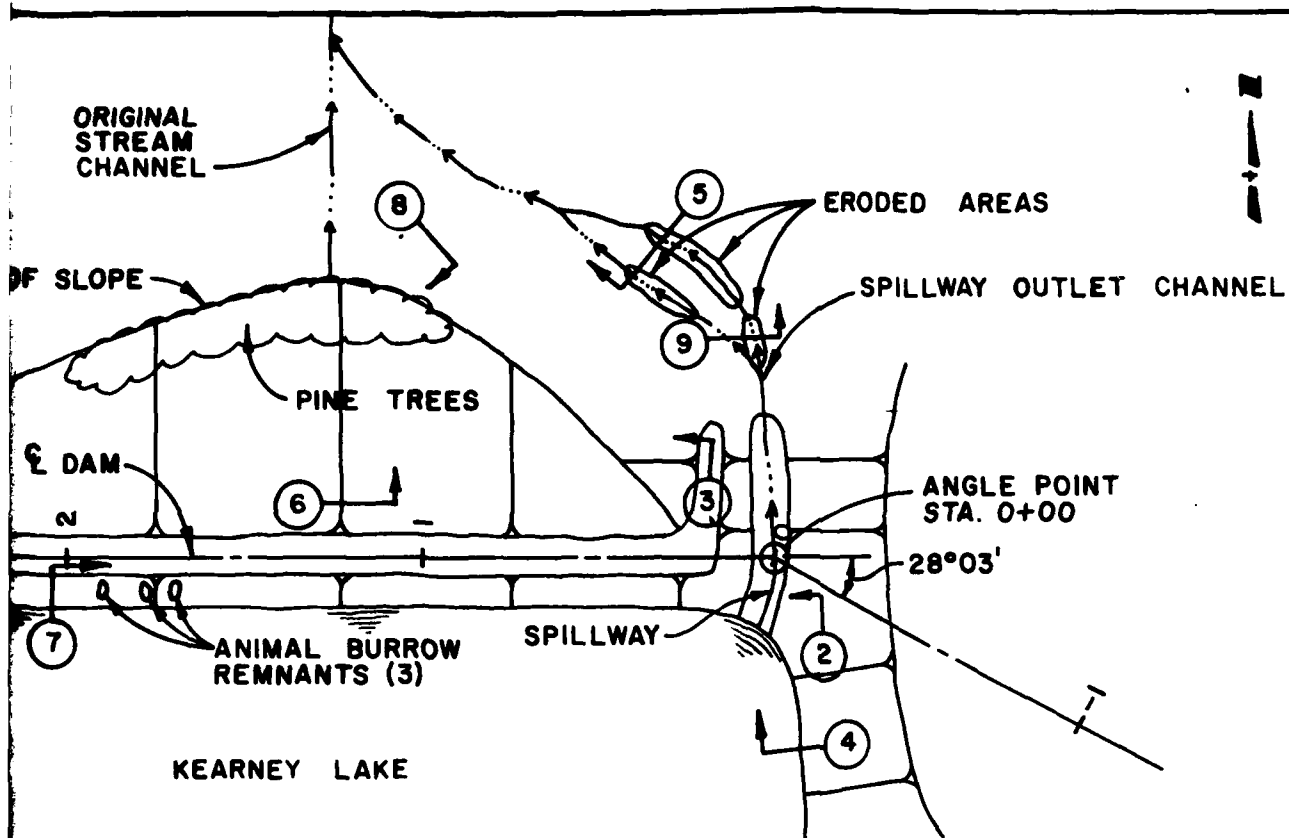
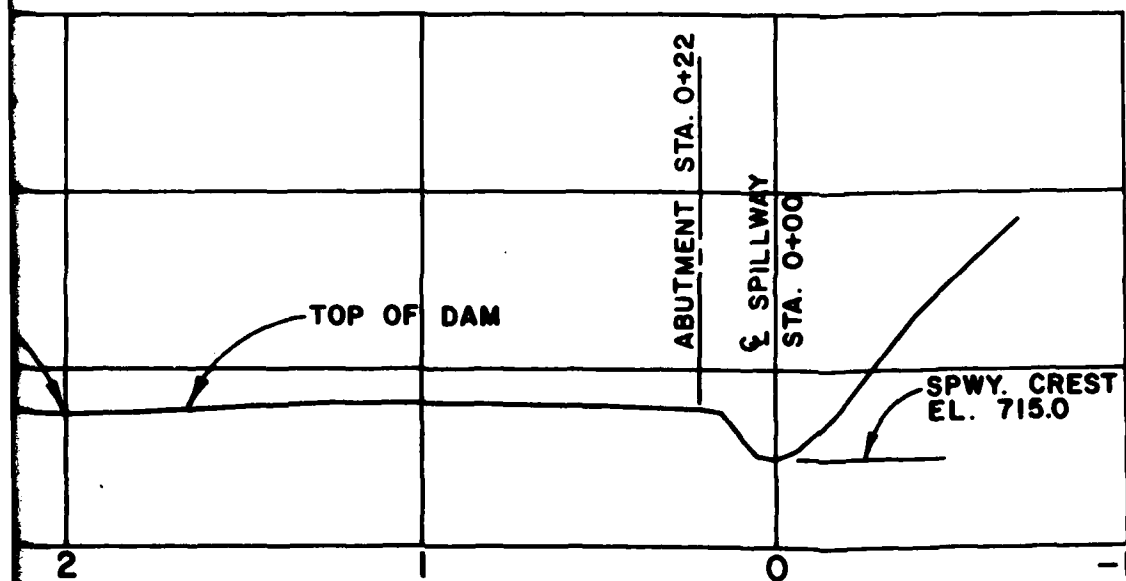
**KEARNEY LAKE
DAM PLAN & PROFILE**

PHOTO LOCATION & KEY
 (SEE APPENDIX A)
