**KLONDIKE LAKE DAM
ST. CHARLES COUNTY, MISSOURI
MO 30019**

**PHASE 1 INSPECTION REPORT
NATIONAL DAM SAFETY PROGRAM**

KLONDIKE LAKE DAM - MISSOURI INVENTORY NO. 30019

AUGUST 1980

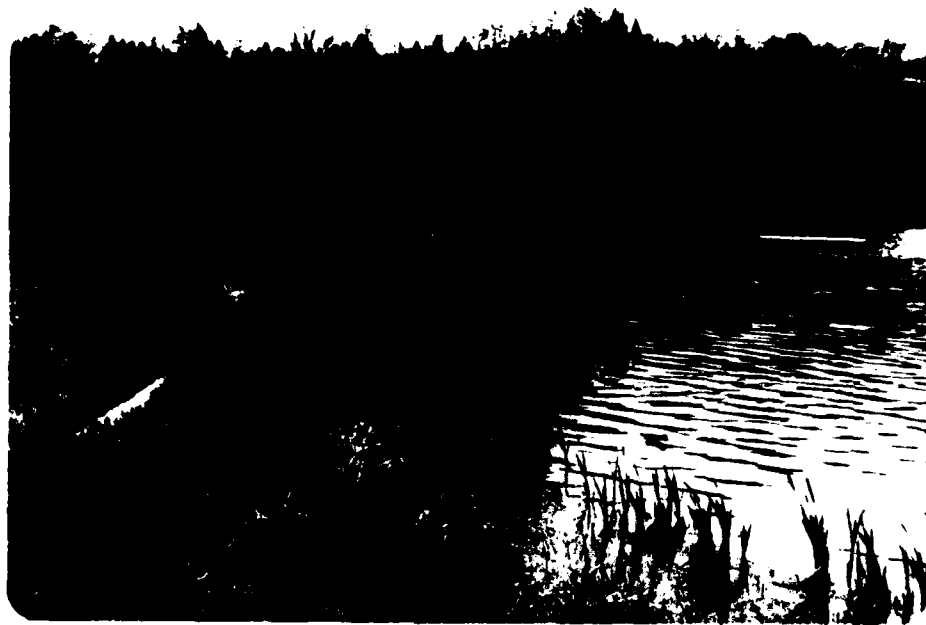
3. Erosion of the grass covered upstream face of the dam apparently by wave action and/or by fluctuations of the lake surface level has created a near vertical bank approximately 6-to-12 inches high at the normal waterline. A grass covered slope is not considered adequate protection to prevent erosion by wave action or fluctuations of the lake level.

c. Dam. The visible portions of the upstream and downstream faces of the dam (see Photos 1 and 2) were examined and appeared to be in sound condition, although erosion of the unprotected upstream slope has created a near vertical face about 6-to-12 inches high at the normal pool waterline at locations where the wave berm is submerged. No cracking of the surface, sloughing of the embankment slopes, or undue settlement of the dam crest was evident. The downstream slope and the upstream slope above normal pool level were well covered by a thick stand of fescue type grass that was about 12 inches high at the time of the inspection. Near the waterline, the upstream face was covered with brush and trees up to 3 inches in diameter. Numerous small trees and some undergrowth also existed on the downstream face of the dam. Fescue type grass about 6 inches high covered the crest of the dam. A V-shaped gully about 18 inches deep had been eroded into the downstream slope of the embankment near the right abutment apparently by stormwater runoff. Examination of a soil sample obtained from the downstream face of the embankment indicated the surficial material to be a lean clay (CL) of low-to-medium plasticity.

NO. 1: UPSTREAM FACE OF DAM

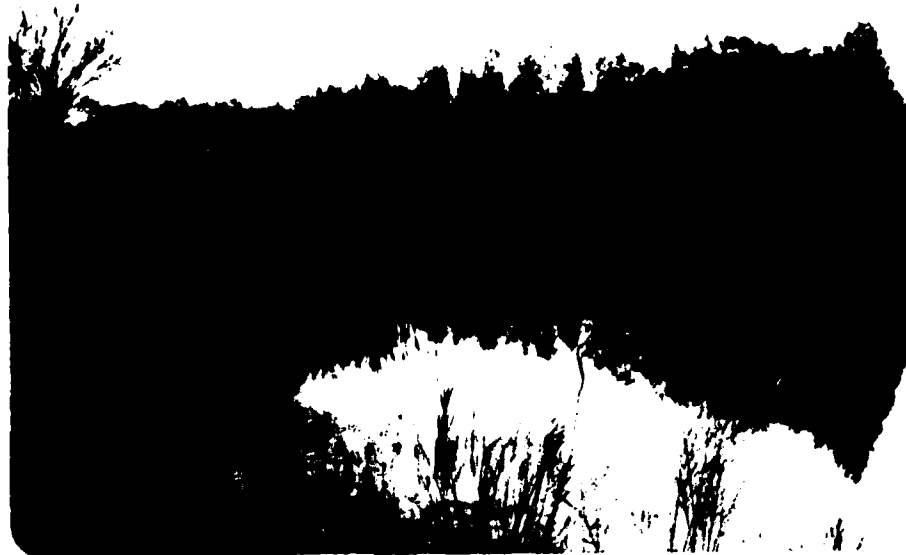
The emergency spillway channel, including the crest area and outlet channel (see Photos 5 and 6) appeared to be in sound condition, with the exception of one portion of the right bank of the outlet channel near the dam (see Photos 7 and 8) which was eroded. Except for the eroded area, the spillway channel was well covered with fescue type grass.

NO. 5: EMERGENCY SPILLWAY

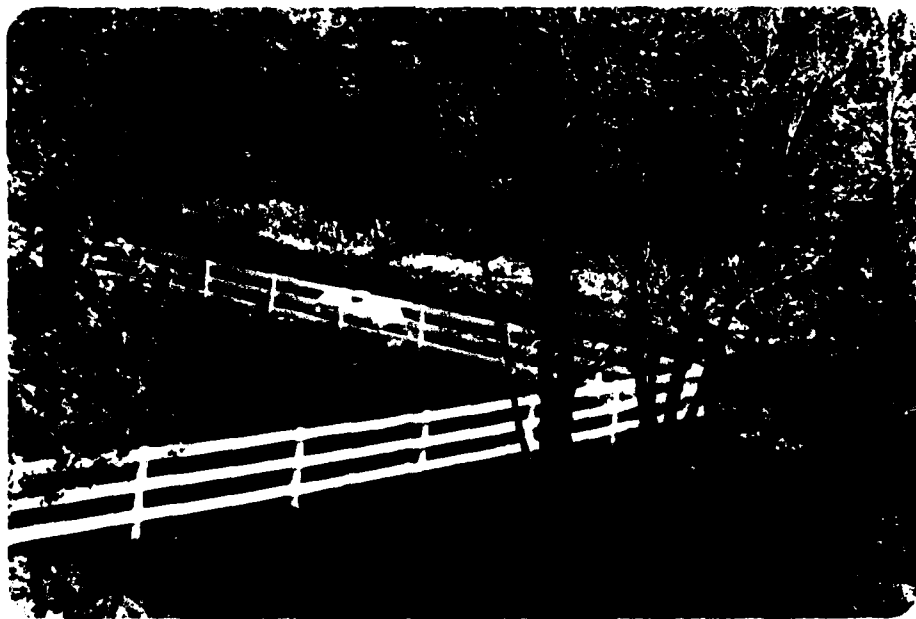
1. Evidence of seepage, soft and wet ground near the toe of the center of the dam; soft ground and flowing water at the intersection of the toe of the dam and the right abutment; and running and standing water and cattails downstream of the toe of the dam was observed. Uncontrolled seepage could develop into a piping condition that can lead to failure of the dam. Saturation of the soil adjacent to the dam can weaken the foundation and impair the stability of the dam.

A marshy area (see Photo 10) as evidenced by cattails and standing and flowing water, was observed downstream of the toe of the dam. It appeared that most of the water within the marsh was discharged to the area by a spring located downstream of the dam. Flow from the spring was estimated to be less than 2 gpm. Although there was no visible flow, the soil in the area between the downstream toe of the dam and the spring outlet (see Photo 9) was soft and damp. Some minor seepage was also evident along the right abutment, with water flowing from an area located about one-third of the distance between the downstream toe and the crest of the dam. The flow appeared to be less than 0.5 gpm.

NO. 10: MARSHY AREA DOWNSTREAM OF DAM

(1) Provide some means of controlling seepage evident in the area adjacent to the downstream toe near the center of the dam and at the junction of the embankment and the right abutment. Uncontrolled seepage can lead to a piping condition which could result in the failure of the dam. Drainage of the areas affected by seepage including elimination of the marshy area just downstream of the dam should be one of the objectives of the seepage control measures since saturation of the soil weakens the foundation which could impair the stability of the dam.
