**LAKE SAINTE LOUISE DAM
ST. CHARLES COUNTY, MISSOURI
MO 10490**

PHASE 1 INSPECTION REPORT NATIONAL DAM SAFETY PROGRAM

**PREPARED BY: U. S. ARMY ENGINEER DISTRICT, ST. LOUIS
FOR: STATE OF MISSOURI**

SEPTEMBER 1978

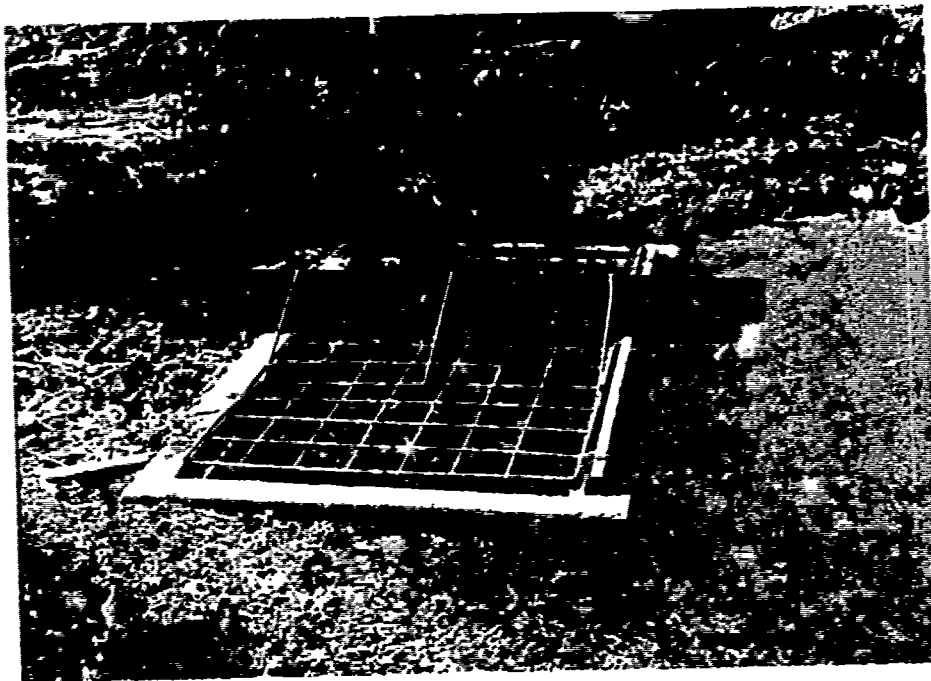
d. 48-Inch by 102-Inch Rectangular Spillway. The 48-inch by 102-inch drop inlet type spillway (see Photo 3) located at the east end of the dam appeared to be in good condition. The 2-foot high section of stop-log planks on the lake side of the inlet were leaking a negligible amount. An anti-vortex plate and a screen to prevent trash from entering the inlet had been installed above the open top of the inlet. Both the plate and screen appeared to be in good condition. A 36-inch diameter corrugated metal pipe serves as an outlet for this inlet. The 36-inch pipe appeared to be in good condition although the type of joints used could not be determined. The pipe discharges into an open concrete manhole (see Photo 4) located approximately 150 feet from the centerline of the dam near the right abutment. A 15-inch diameter pipe extends approximately 28 feet from the manhole and terminates at an unimproved ditch (see Photo 5). An accumulation of construction debris was observed at the upstream end of the ditch. The ditch continues for about 420 feet before it joins Lake Saint Louis (see Photo 6). The ditch at the upstream and downstream (Lake Saint Louis) ends was extensively eroded, apparently by flow being discharged from the 36-inch diameter outlet pipe.

NO. 3: 48"x102" DROP INLET SPILLWAY

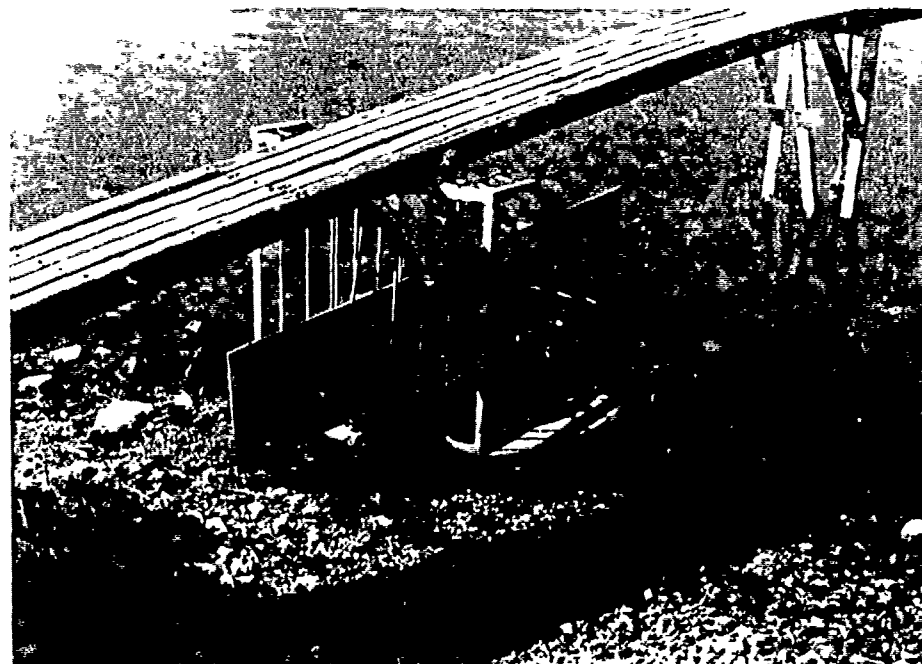
c. 42-Inch Diameter Spillway. The 42-inch diameter drop inlet type spillway (see Photo 7) located near the center of the dam appeared to be in good condition although it did have an accumulation of small stones and/or debris lying in the bottom of the inlet. An anti-vortex baffle plate and a screen to prevent trash from entering the inlet had been installed above the open top of the inlet. Both the plate and screen appeared to be in good condition. The operating stem for the gate on a pipe line located out in the

lake and leading to the inlet was disconnected and not operable. Water was standing in the inlet to the same level as the lake. The outlet pipe for this spillway had been modified as indicated in the preceding paragraph. The condition of this pipe could not be determined since only the top of the pipe at one location (near the 10-inch valve) could be seen.

No. 7: 42" DIAMETER DROP INLET SPILLWAY

(4) Restore the 42-inch spillway to its original condition by closing the valve on the lake inlet pipe and unblocking the outlet pipe. This will allow the spillway to function as originally intended (as long as the valve on the pump connecting line is closed or the line blocked) and will eliminate the condition of having the 12-inch outlet pipe under permanent head. The purpose of this recommendation is to eliminate a condition considered undesirable under any circumstances and will not increase spillway capacity as recommended in paragraph 7.2a(1). It will, however, improve the reliability of this spillway since it will not be necessary to open the valve on the pump connecting line in order to allow the outlet pipe to be serviceable.

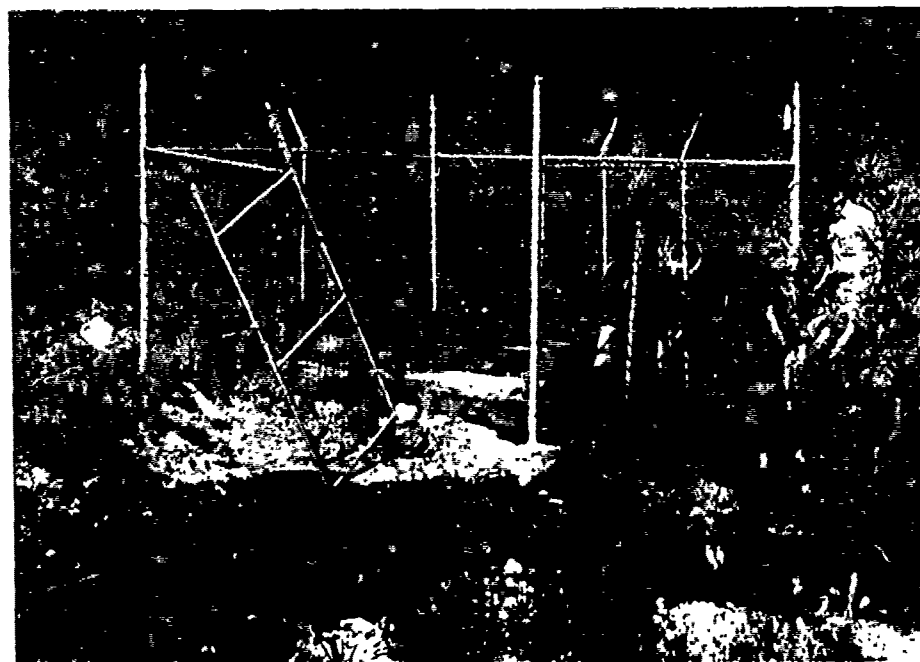
NO. 8: PUMP BASE

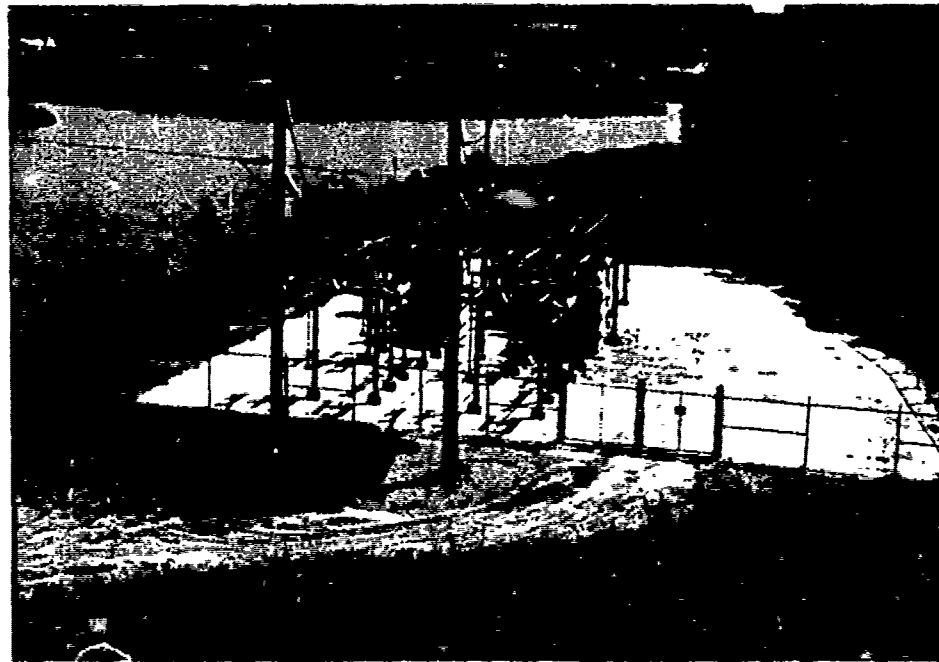
Also present on the downstream area immediately adjacent to the dam is an electric substation. Failure of the dam would undoubtedly damage or destroy this installation. Explosions caused by sparks igniting leaking LP gas may cause damages above the level of the floodwaters.

NO. 13: ELECTRIC SUBSTATION
