LAKE ARROWHEAD DAM  
FRANKLIN COUNTY, MISSOURI  
MO 30572

# PHASE 1 INSPECTION REPORT NATIONAL DAM SAFETY PROGRAM

PHASE I INSPECTION REPORT  
NATIONAL DAM SAFETY PROGRAM

DECEMBER 1978

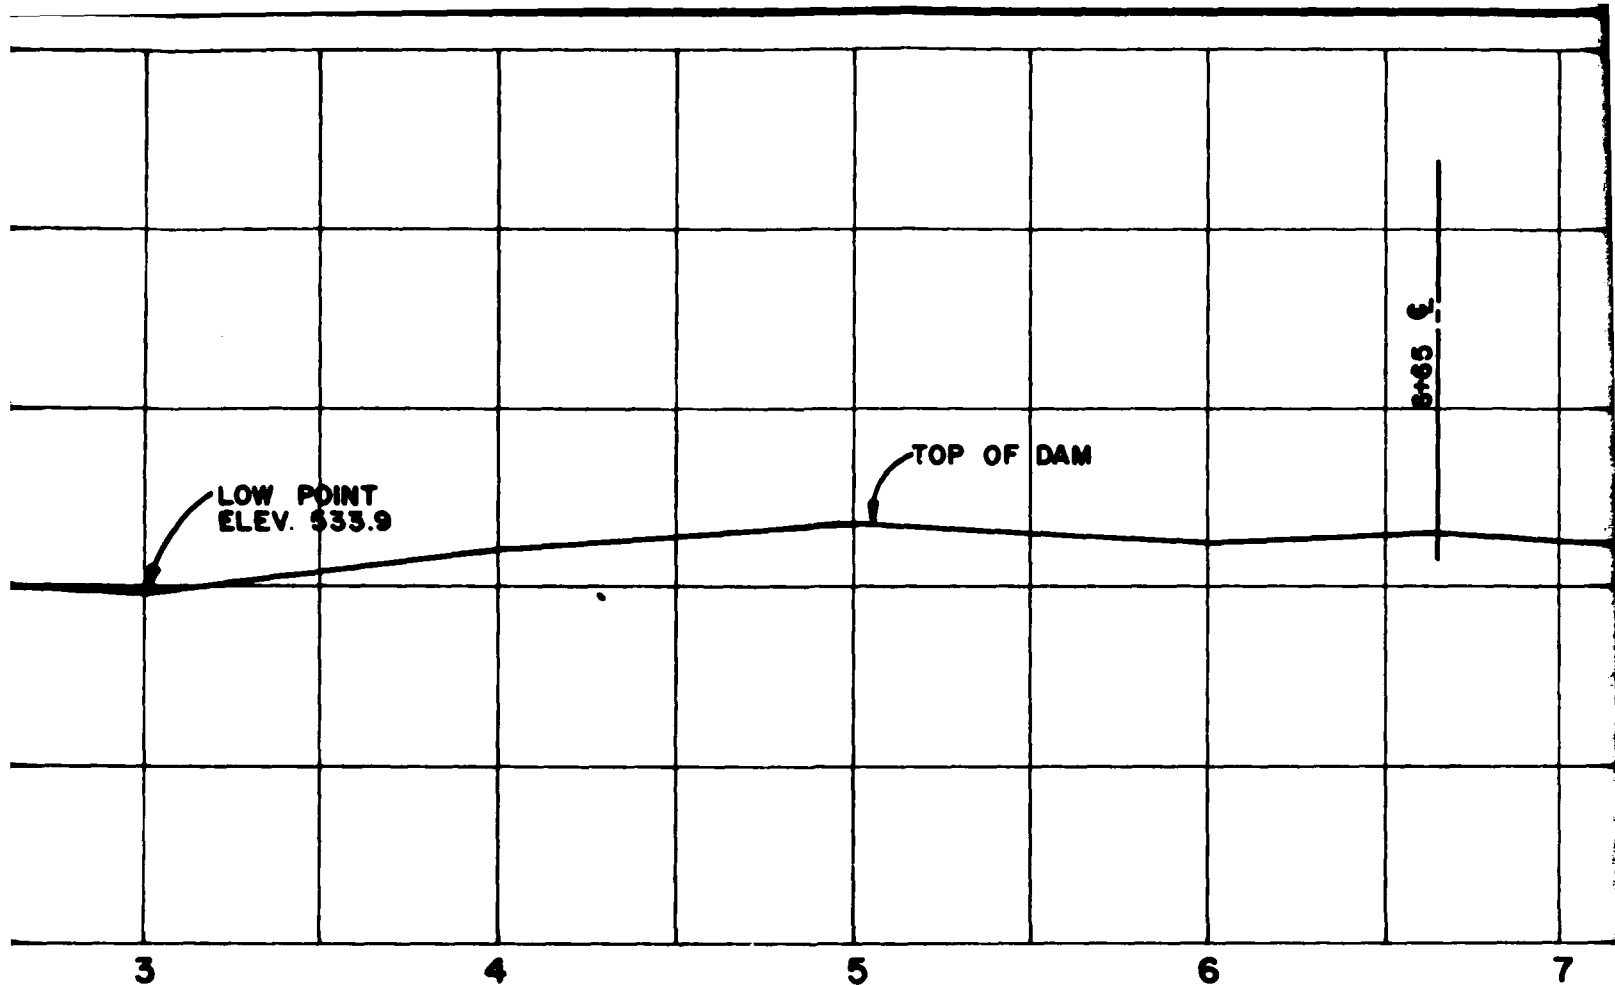
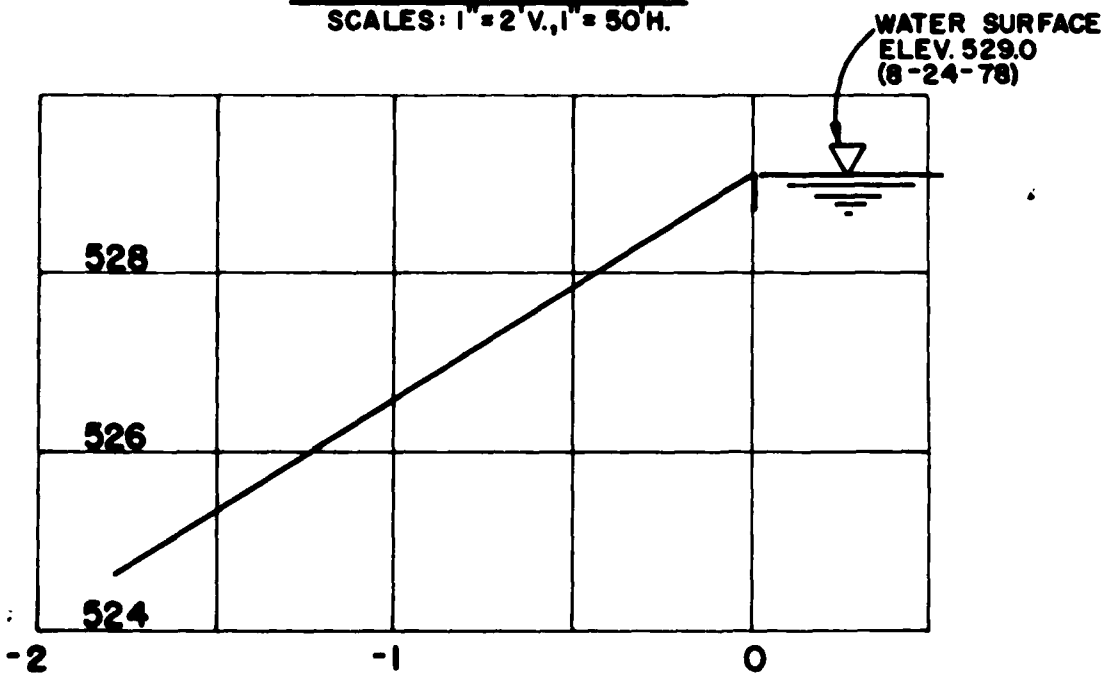
**LAKE ARROWHEAD  
DAM & SPILLWAY PROFILES**

The top of the dam was found to be about 2 feet lower at a point near the center of the dam than in the area adjacent to the principal spillway. The low point of the dam is approximately 5 feet higher than the principal spillway crest and 4 feet higher than the emergency spillway crest. A profile of the top of the dam extending through the crests of the principal and emergency spillways and based on survey data obtained during the inspection is shown on Plate 3.

(1) Based upon criteria set forth in the recommended guidelines, alterations to this design of the dam should be made in order to pass lake outflow resulting from a storm of probable maximum flood magnitude. In any event, it is recommended that the low area located near the center of the dam be raised such that it no longer restricts spillway capacities.
