**BRONX RIVER DAM**

**BRONX COUNTY, NEW YORK  
INVENTORY NO. N.Y. 1500**

**PHASE I INSPECTION REPORT  
NATIONAL DAM SAFETY PROGRAM**

**AUGUST 1981**

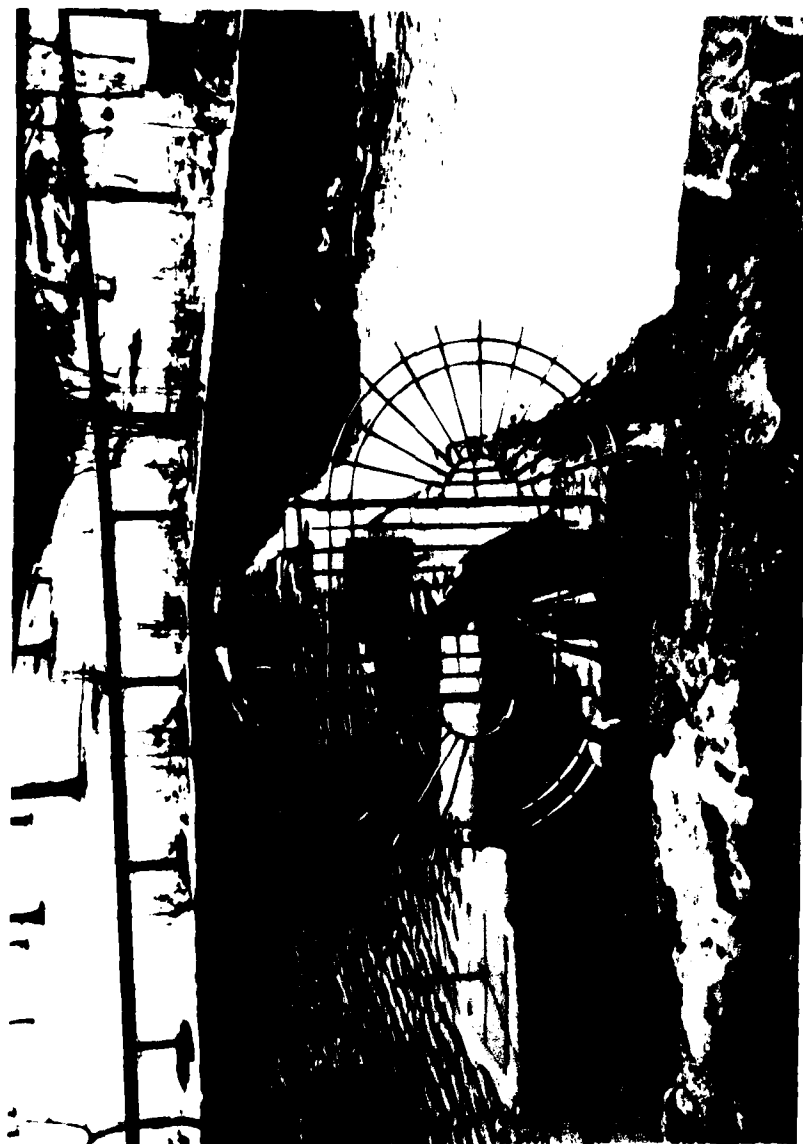
Overall View of Dam  
Bronx River Dam  
I.D. No. NY 1500  
7 March 1981

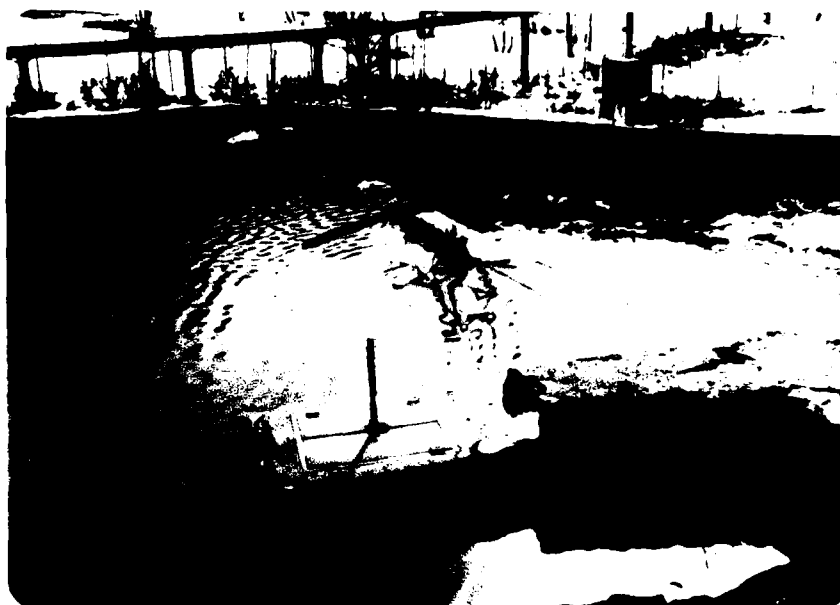
Photo 1. View of Upstream Side of Dam  
Outlet Gate Valve Stem Located in Foreground  
7 March 1981

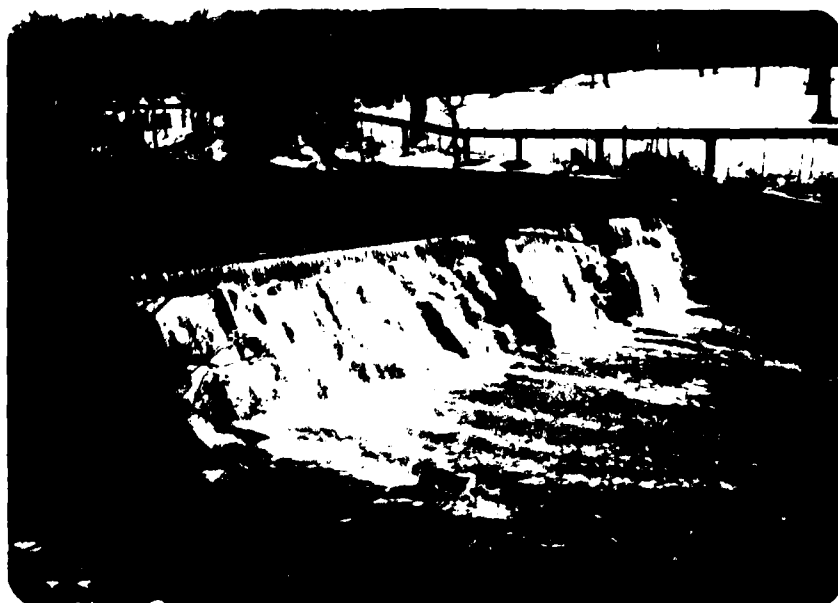
Photo 2. View of Downstream Face of Dam  
Outlet Pipe Located at Bottom Left of Photo in Spillway Discharge Area  
7 March 1981

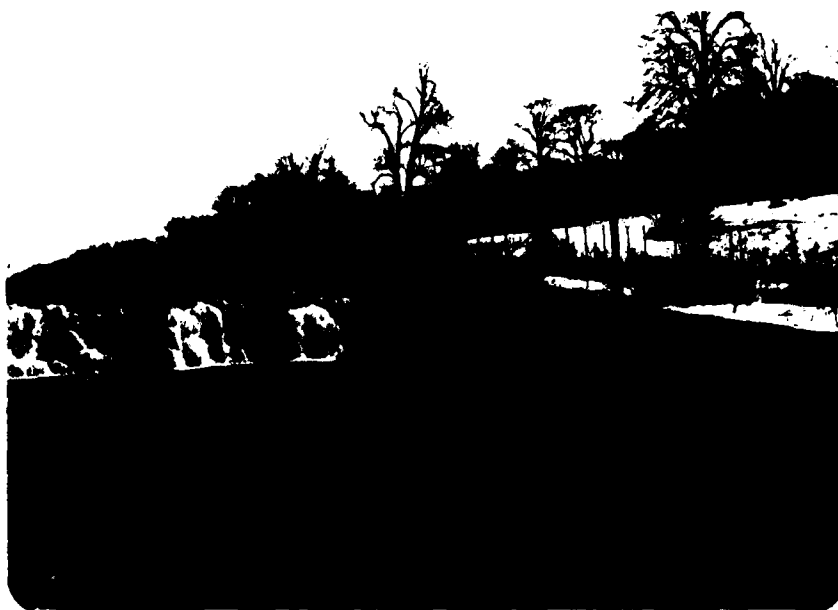
- 1. A clear seep (less than 0.5 g.p.m.) was observed exiting the dam 3 feet above the toe and 10 feet right from the outlet channel.
- 2. The left training wall is under cut about 15 feet downstream from the spillway.
- 3. An area of erosion was observed behind the left training wall.

Photo 7. View of Left Training Wall of Spillway  
7 March 1981

1. Fill beneath the left training wall and protect with riprap.
2. Fill, compact, and seed the area of erosion behind the left training wall.
3. Repair the mortar joints on the crest of the dam.
4. Clear the debris from the spillway crest.
