Structures Technical Memorandum 328

RESONANCE TESTS ON A PIPER PA-32R TAILPLANE  
BEFORE AND AFTER DAMAGE

Investigations have been carried out, on the tailplane of a Piper PA-32R aircraft, to determine the effect of damage, in the form of a split in the underside skin, on the modes of vibration of the tailplane. Details and results of the investigations are described.

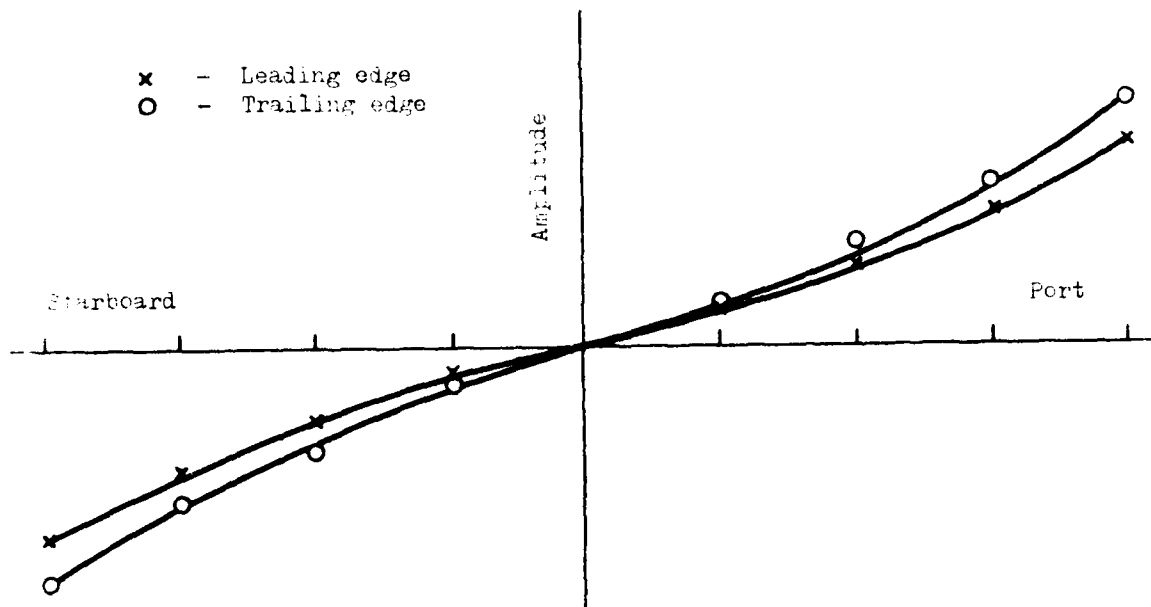
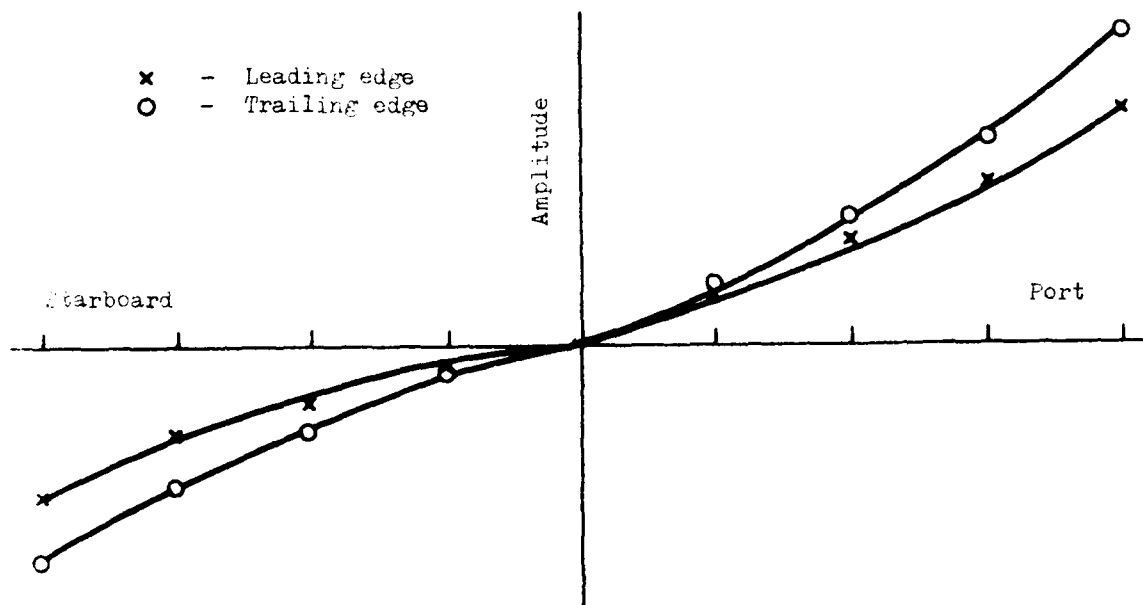
The modes of vibration up to 50 hertz have been plotted for the undamaged and damaged tailplane; the changes brought about by the reduced stiffness are slight.

FIG.5 (a) UN DAMAGED TAILPLANE MODE AT 16.85 Hz

FIG.5 (b) DAMAGED TAILPLANE MODE AT 16.2 Hz

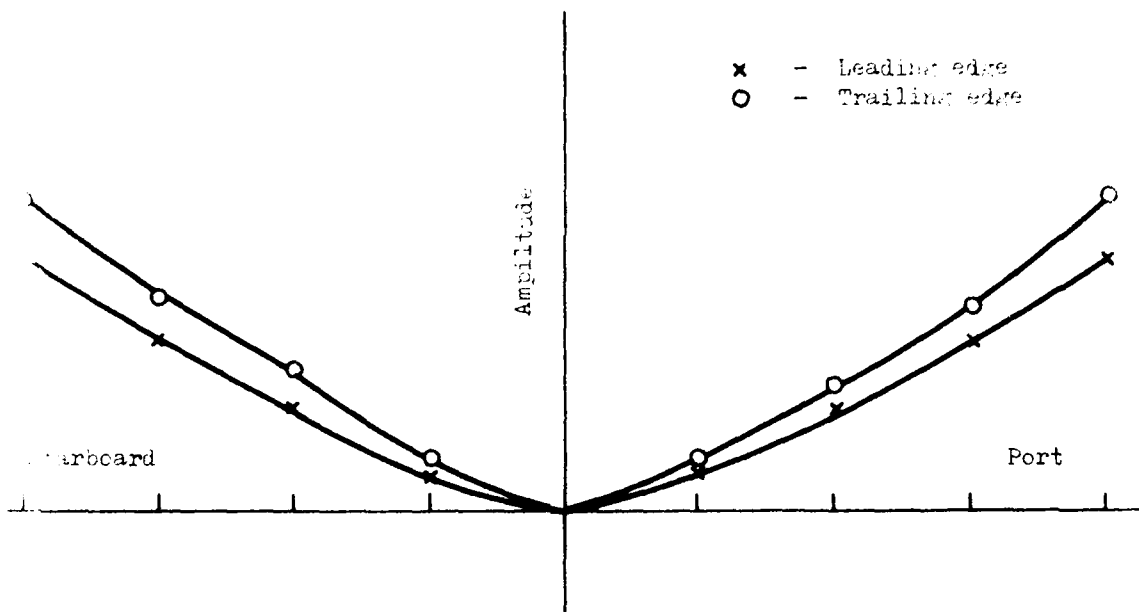
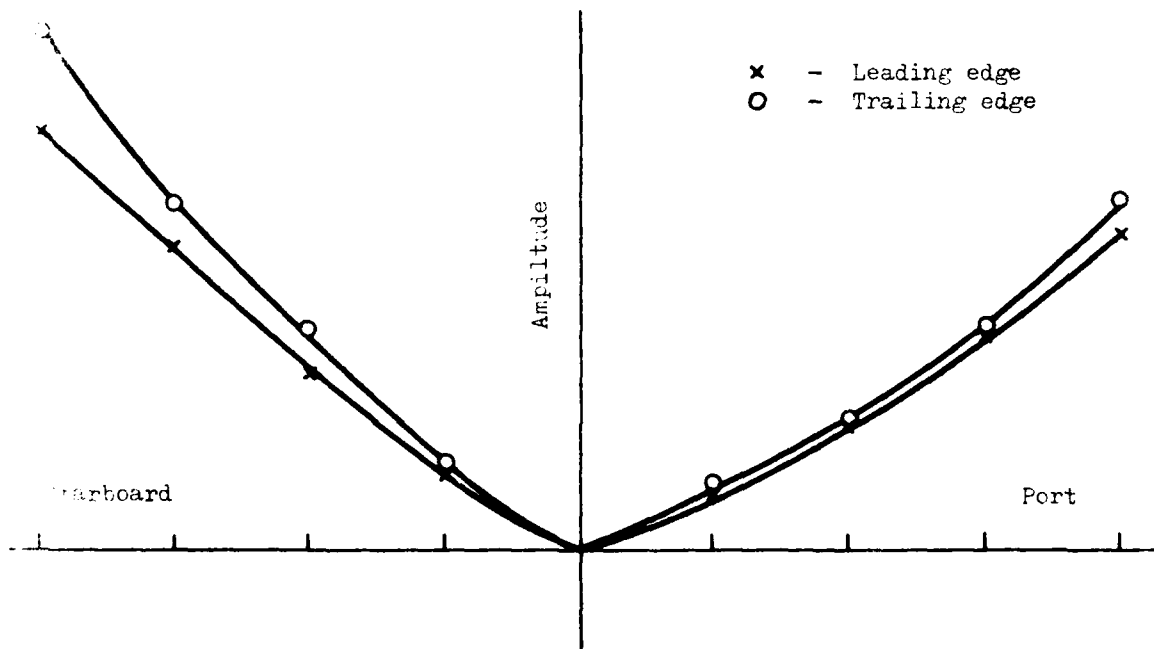
FIG. 6 (a) UNDAMAGED TAILPLANE MODE AT 18.55 Hz

FIG. 6 (b) DAMAGED TAILPLANE MODE AT 18.25 Hz

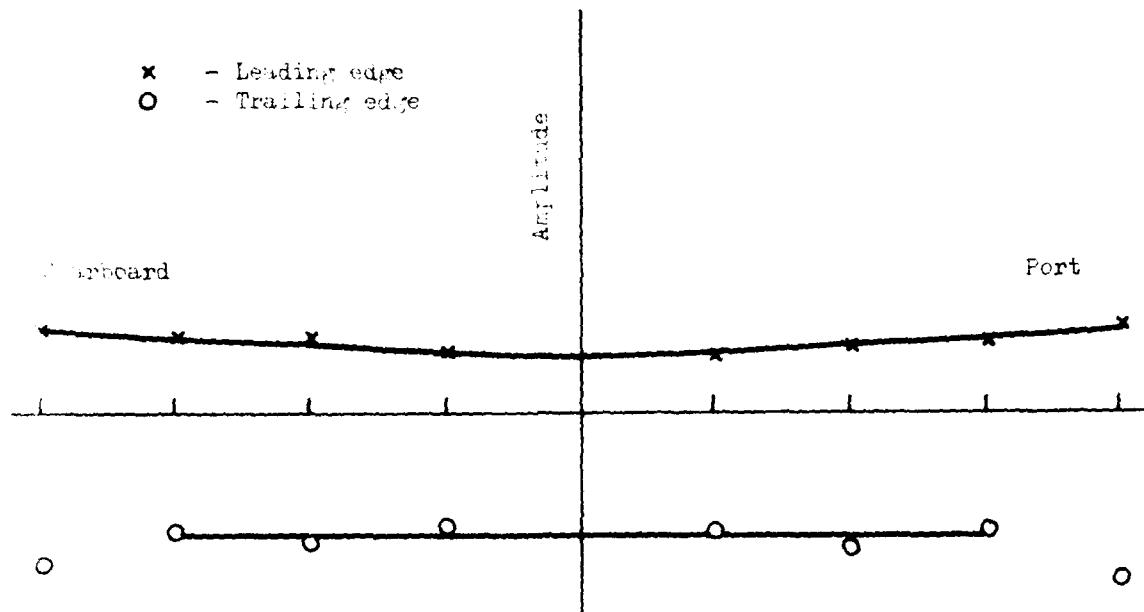
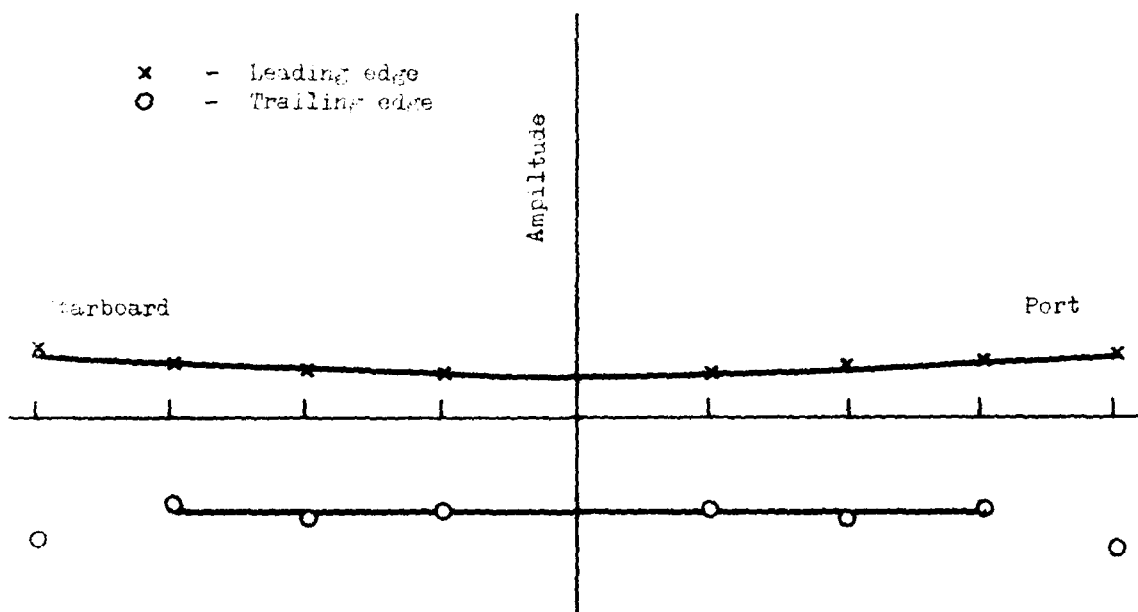
The frequencies of the various mode shapes plotted were well separated with the exception of the pitch mode where two identical modes were found quite close together by varying the force input. This was probably caused by non-linearity in the supporting rig.

FIG. 7 (a) UNDAMAGED TAILPLANE MODE AT 30.4 Hz

FIG. 7 (b) DAMAGED TAILPLANE MODE AT 29.5 Hz

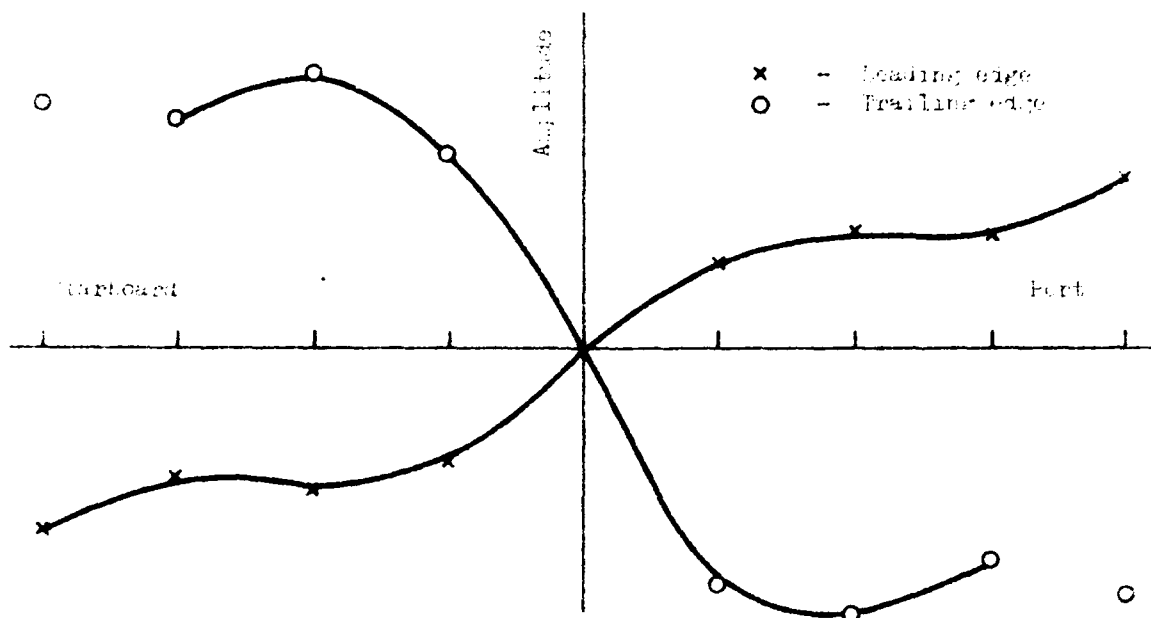
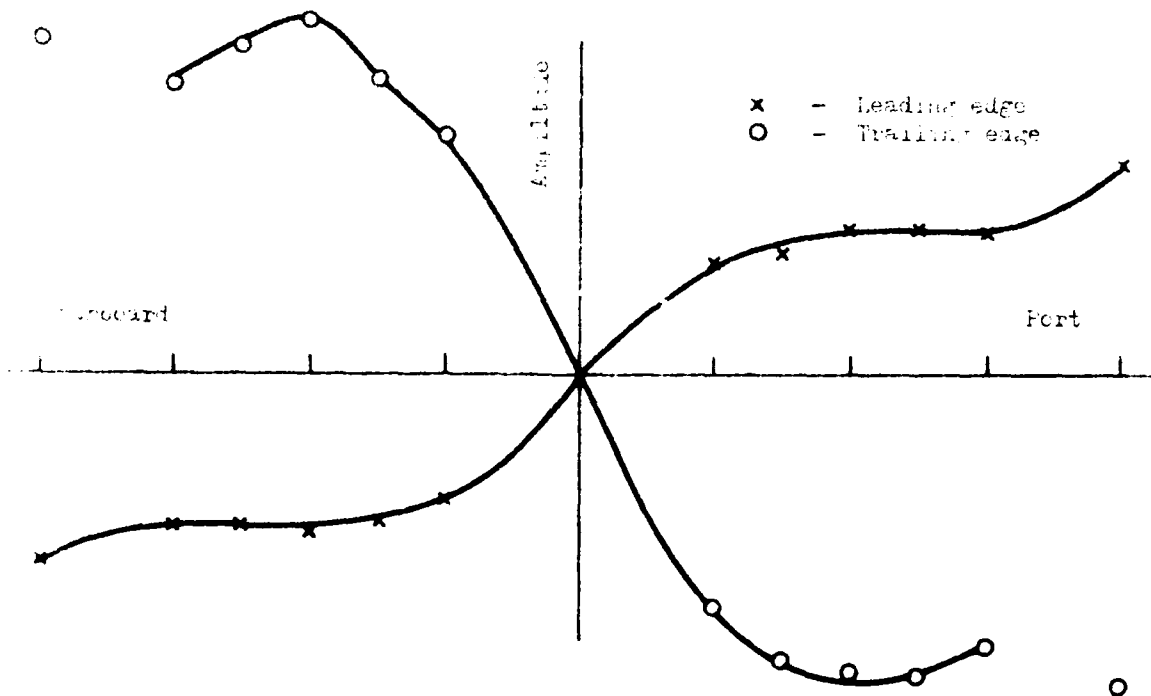
FIG. 8 (a) UNDAMAGED TAILPLANE MODE AT 50.03 Hz

FIG. 8 (b) DAMAGED TAILPLANE MODE AT 48.8 Hz
