**KERNODLE LAKE DAM NO. 2**

**JACKSON COUNTY, MISSOURI**

**MO 20374**

# **PHASE 1 INSPECTION REPORT NATIONAL DAM SAFETY INSPECTION**

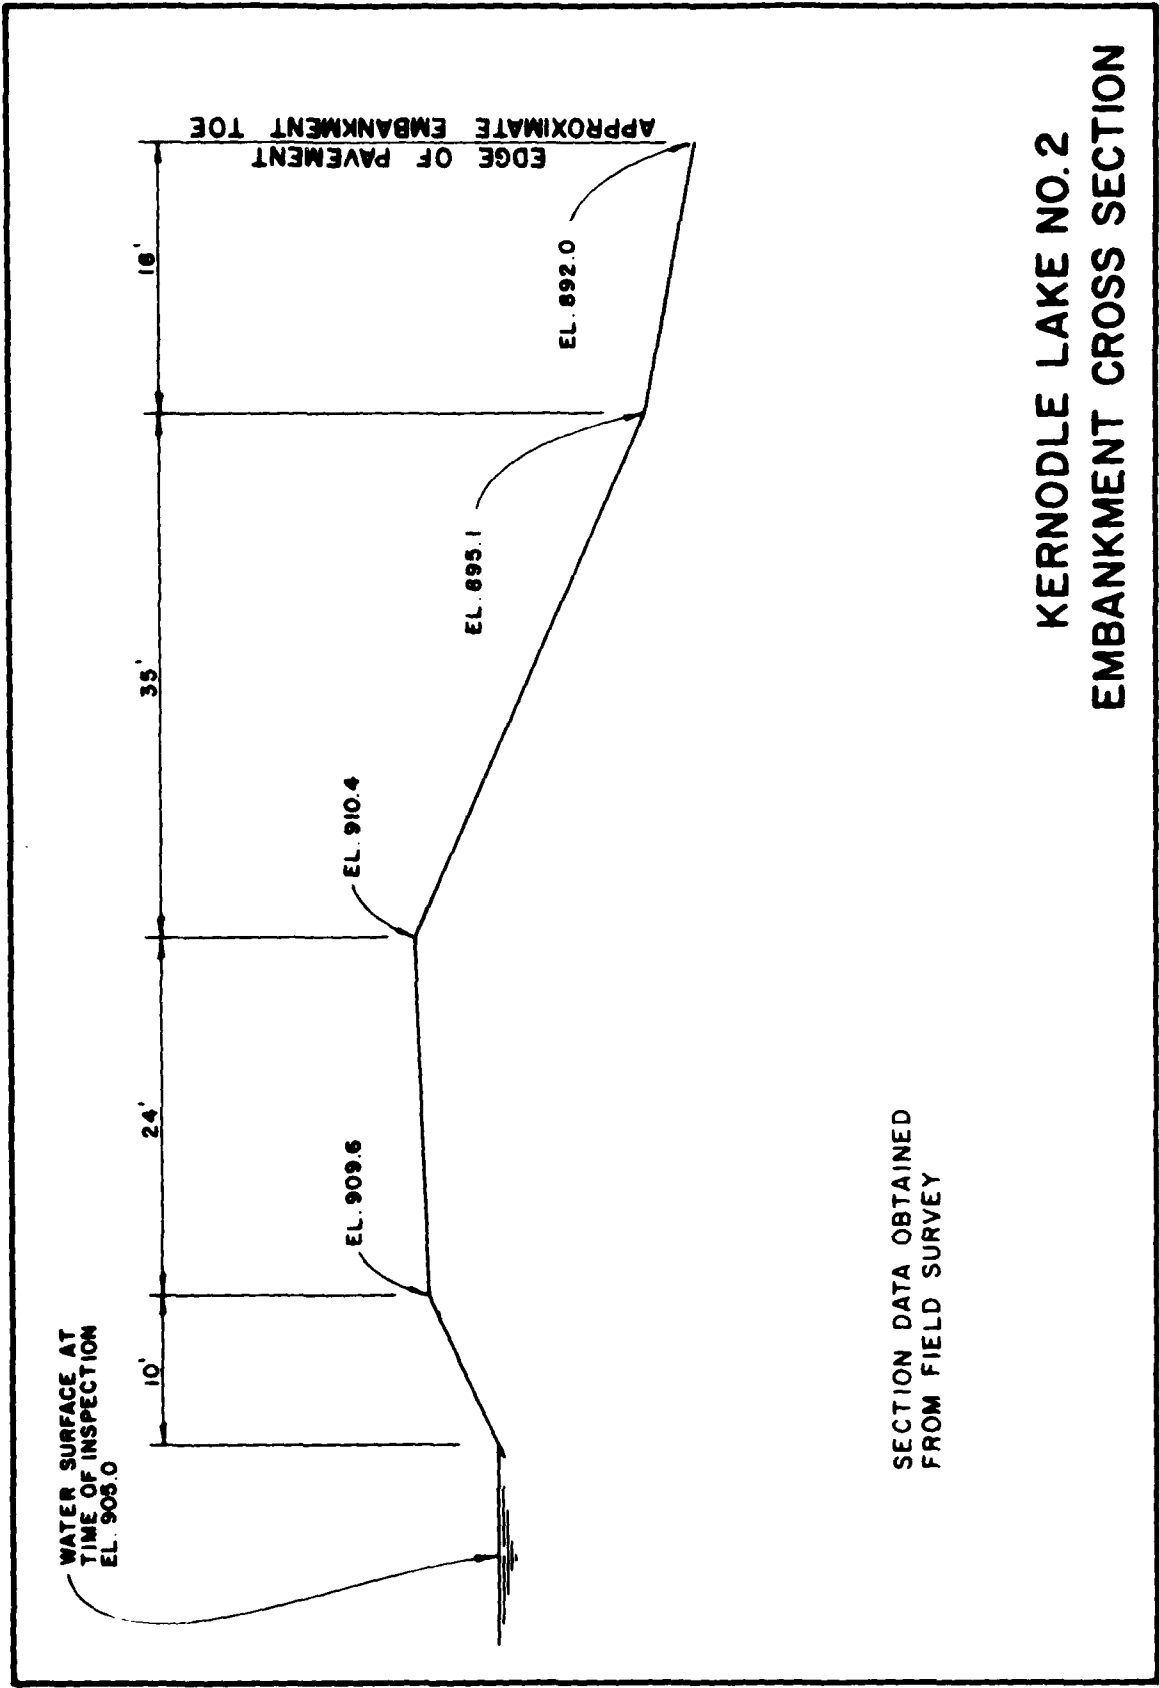
**KERNODLE LAKE NO. 2  
EMBANKMENT CROSS SECTION**

SECTION DATA OBTAINED  
FROM FIELD SURVEY

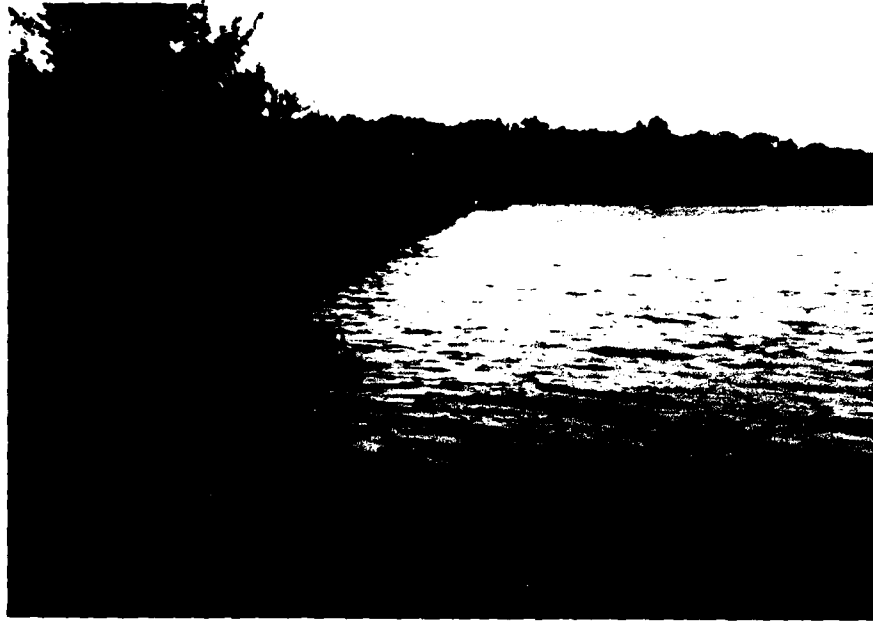
The only erosion observed was at several isolated spots in the riprap slope protection on the upstream face where clay (CL) material was being eroded. The upstream face is covered with a heavy growth of brush and small trees which hindered the inspection. The upstream face near the right abutment is protected by a concrete wall extending 1 to 2 feet above normal pool level with a sand beach area downstream and to the right of the wall. No evaluation could be made of erosion protection on the upstream face in those areas where observations were hindered.

PHOTO 3: FACE OF DAM

The maintenance program should be expanded to repair riprap in the areas of erosion and to control brush and tree growth on the embankment. Mowing of the embankment should be continued to discourage animal burrowing.
