DRESSER NO. 1 DAM
WASHINGTON COUNTY, MISSOURI
MO 31117

**PHASE I INSPECTION REPORT
NATIONAL DAM SAFETY PROGRAM**

MISSOURI INVENTORY NO. 31117

JUNE 1979

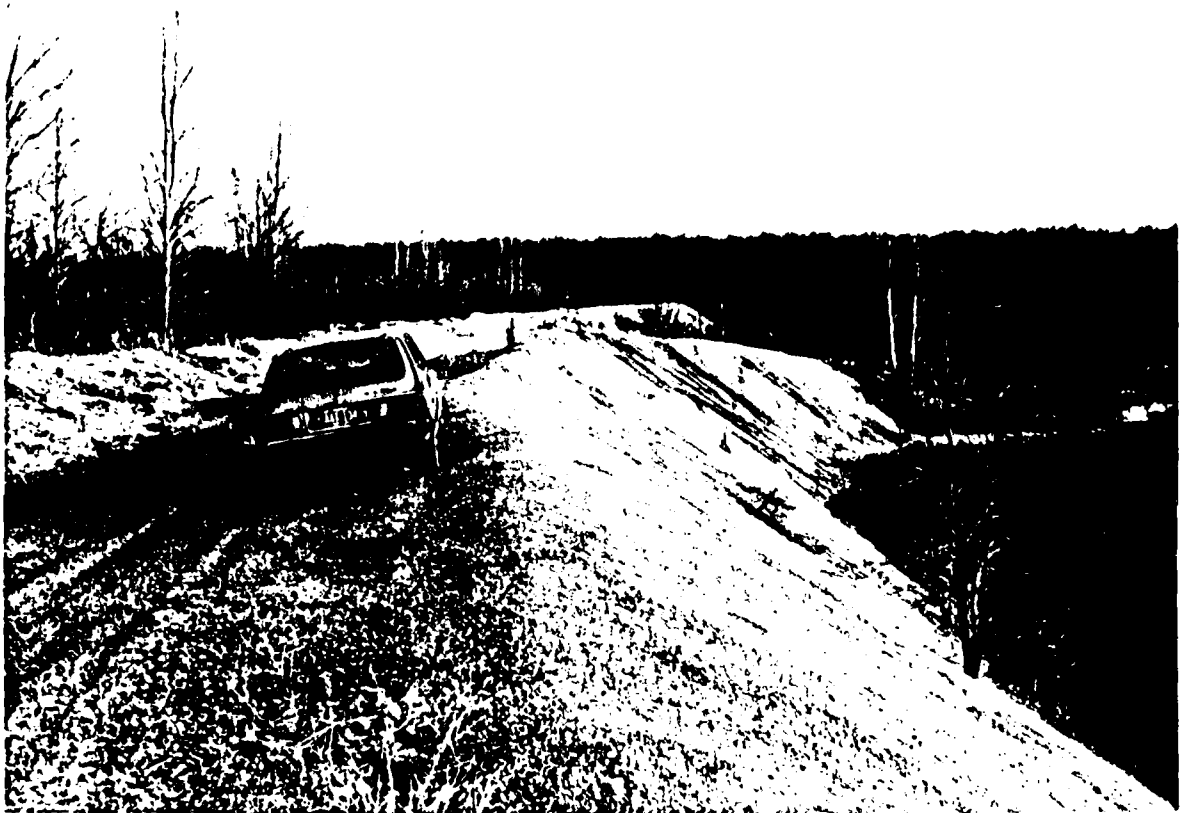
OVERVIEW OF THE EAST END OF THE TAILINGS
IMPOUNDMENT OF DRESSER NO. 1 DAM AND DOWNSTREAM POND
