**CEDAR LAKE DAM**

**BOONE COUNTY, MISSOURI**

**PHASE 1 INSPECTION REPORT  
NATIONAL DAM SAFETY PROGRAM**

**JULY 1980**

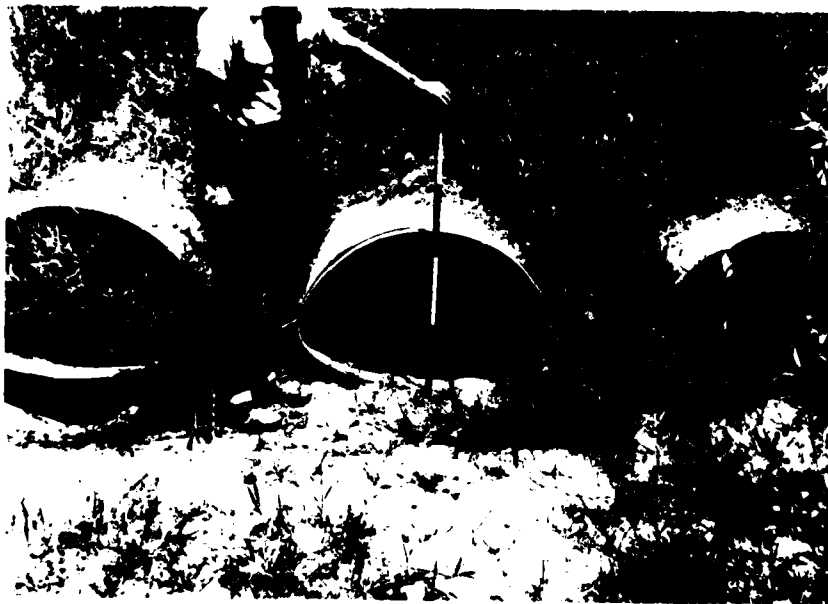
PHOTO 8: OUTLET END OF SPILLWAY PIPES
