**LAKE WINNEBAGO DAM
CASS COUNTY, MISSOURI
NO 20012**

**PHASE 1 INSPECTION REPORT
NATIONAL DAM SAFETY INSPECTION**

SUBJECT: Lake Winnebago Dam, Mo. ID No. 20312
Phase I Inspection Report

Name of Dam	Lake Winnebago Dam
State Located	Missouri
County Located	Cass County
Stream	Middle Big Creek
Date of Inspection	24 May 1979

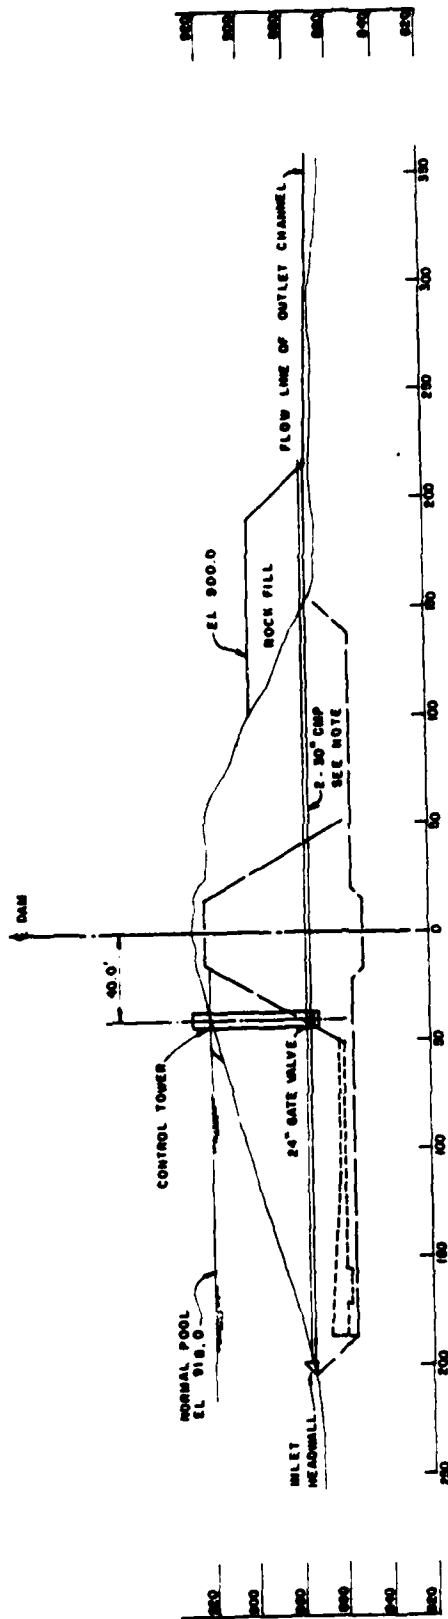
LAKE WINNEBAGO OUTLET WORKS SECTION

NOTES WEST PIPE GROUTED FULL
 2. 24" STEEL LINER PIPE PLACED
 INSIDE EAST PIPE. GROUT BETWEEN
 LINER AND 30" CMP.
