4. TITLE (and Subtitle) Phase I Inspection Report National Dam Safety Program Spring Lake Dam Warren County, VA	5. TYPE OF REPORT & PERIOD COVERED Final

NAME OF DAM: SPRING LAKE DAM
LOCATION: WARREN COUNTY, VIRGINIA
INVENTORY NUMBER: VA. NO. 18703

PHASE I INSPECTION REPORT
NATIONAL DAM SAFETY PROGRAM

Name of Dam: Spring Lake Dam
State: Virginia
Location: Warren County
USGS Quad Sheet: Linden
Coordinates: Lat 38° 59.1' Long 78° 02.1'
Stream: Tributary of Venus Branch
Date of Inspection: May 5, 1981

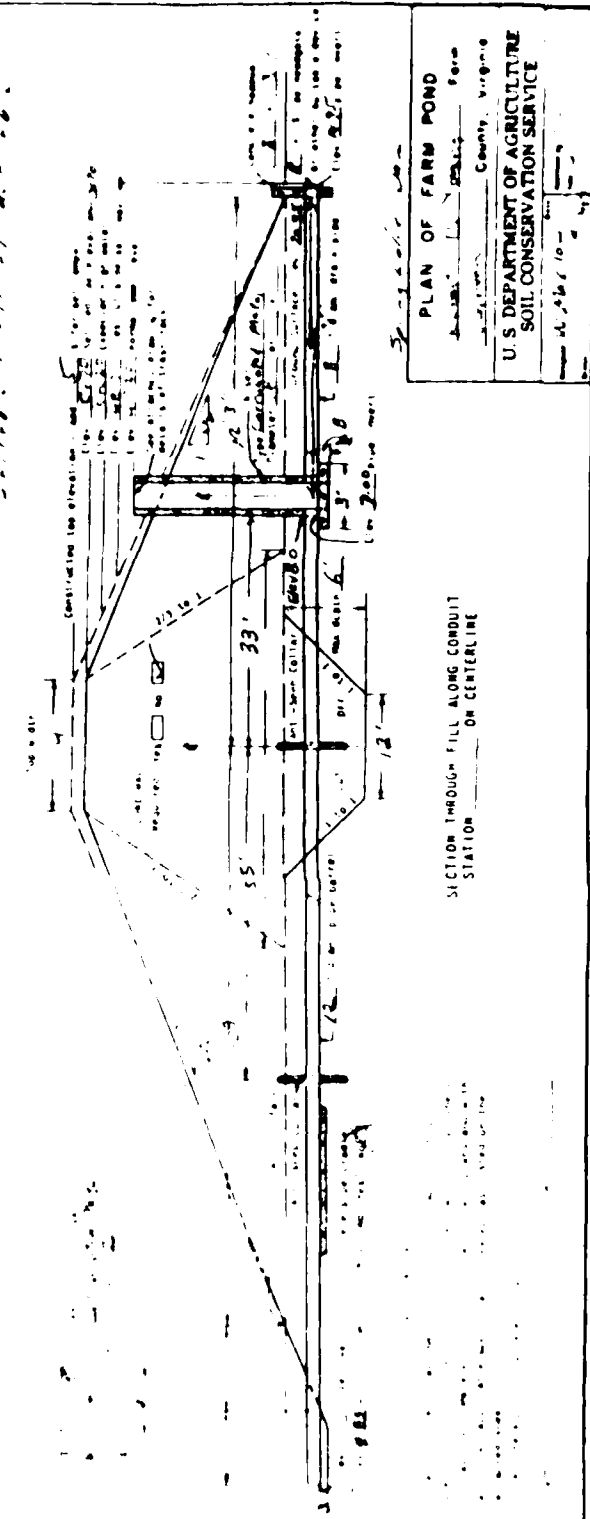
PLATE 2

The principal spillway consists of a 15 inch diameter corrugated metal pipe (CMP) riser inlet. The riser is connected to a 12 inch diameter CMP outlet which runs through the dam. The riser crest is at elevation 850 msl. An 8 inch diameter sluice gate in the riser at an invert elevation of 818 msl is used to drain the lake. The outlet pipe has a length of 142 ft with an invert elevation at the outlet structure of 810 msl. (See Plate 2, Appendix I).

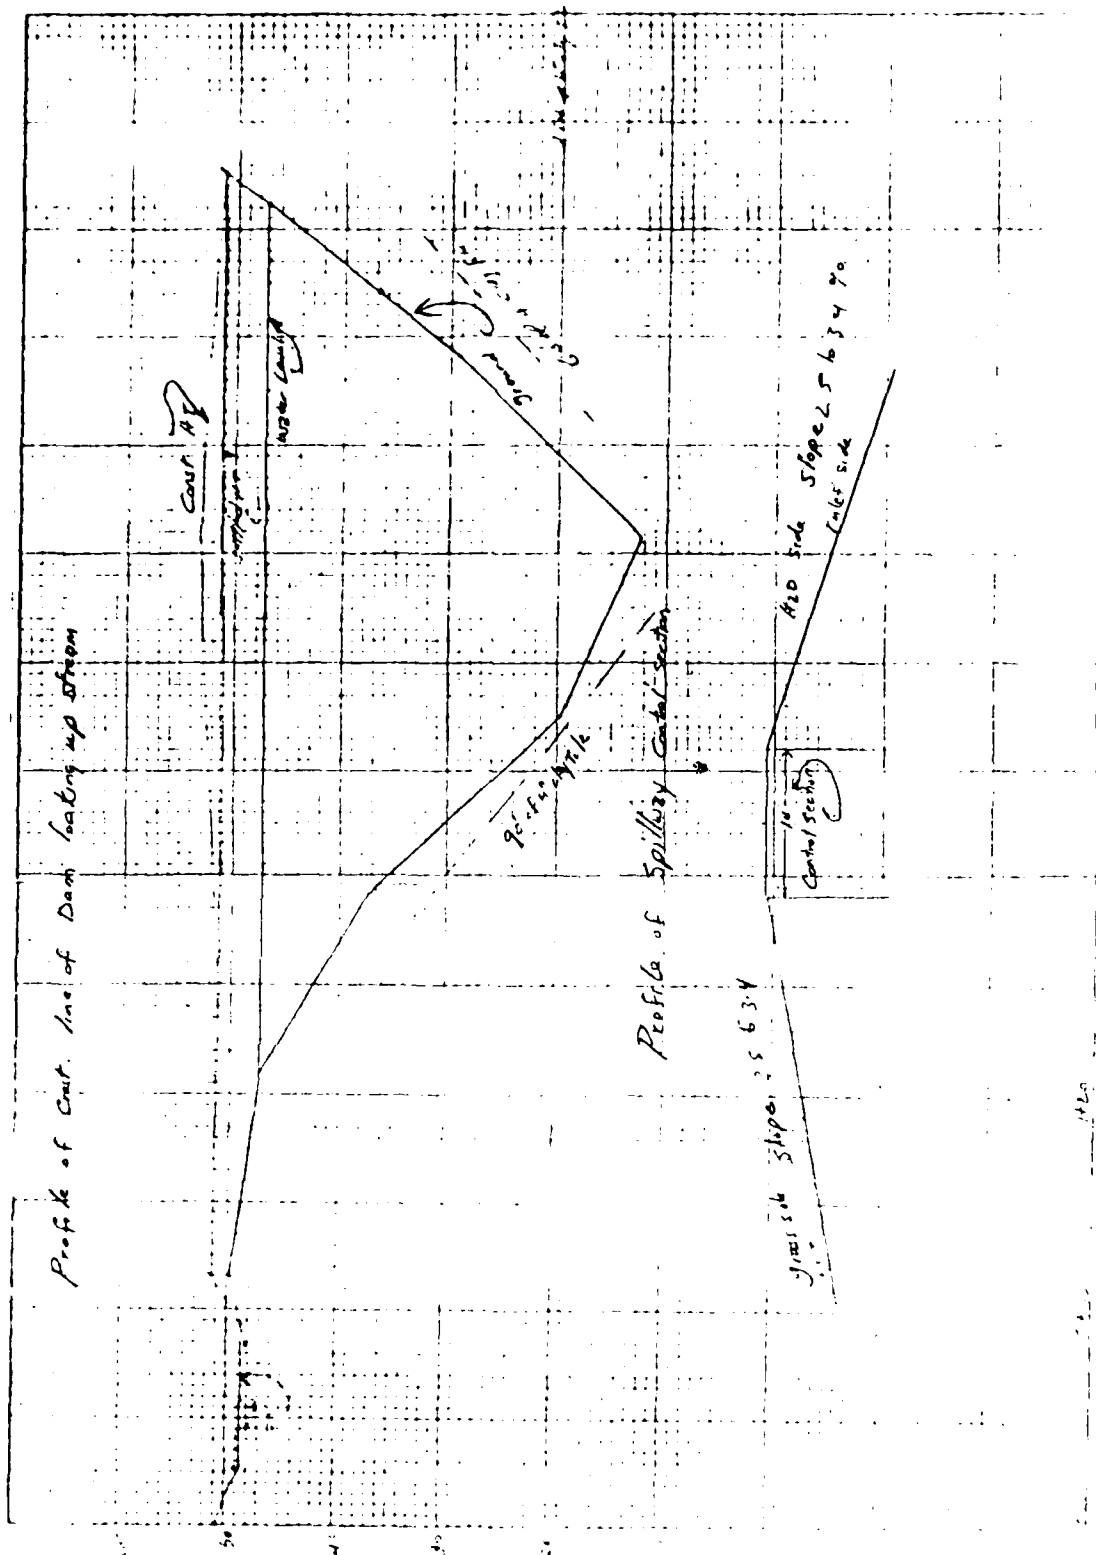
PLATE 3

The emergency spillway (EMS) consists of a vegetated earthen spillway located at the right abutment, with a crest elevation of 852.5 msl. The EMS has a bottom width of 80 ft, 3H:1V to 5H:1V side slopes and a trapezoidal cut section (See Plate 3, Appendix I and Field Sketch 1, Appendix II).

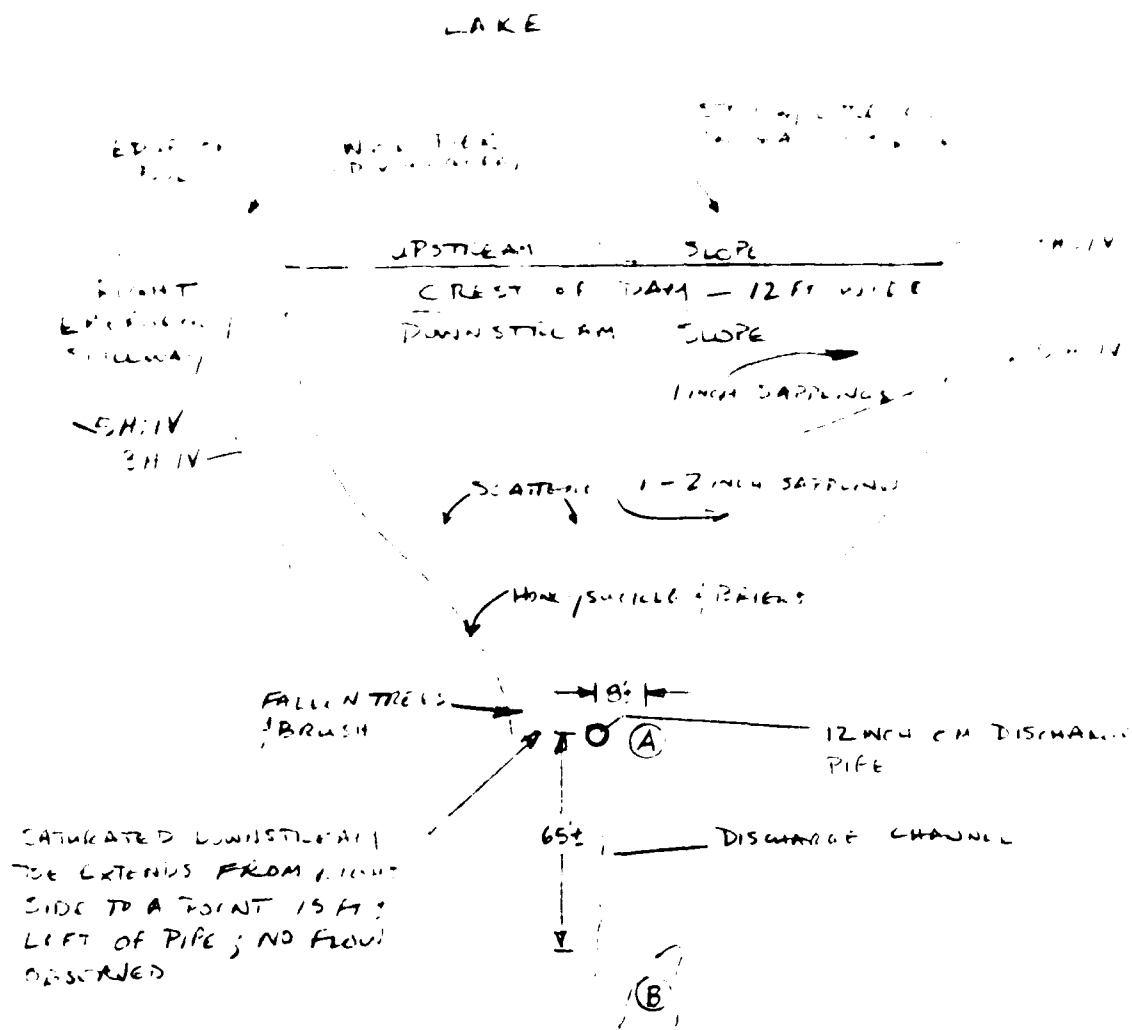
The saturated ground condition present along the downstream toe is believed to be related to flow from the toe drain(s) and also seepage through the dam. Attempts should be made to locate the toe drain or drains and remove any cover material, so as to allow free flow. The two saturated areas observed adjacent to and below the discharge pipe are believed to be related to seepage through the dam even though no flow was observed. This does not necessarily create an unsafe condition; however, these areas should be monitored periodically in attempt to detect any significant increases in flow which may result in piping within the embankment.

- (A) RED IRON STAINED SEC-PAGE; NO FLOW OBSERVED.
- (B) RED IRON STAINED PONDED AREA 40 FT ± LONG AND 10 FT ± WIDE; NO FLOW OBSERVED.

Vehicular traffic should be restricted on the dam and bare areas on the embankment crest should be reseeded. The toe drain outlet(s) should be located, uncovered and allowed to flow freely. The two iron stained wet areas located to the left of and below the principal spillway discharge outlet should be monitored quarterly to detect any flow which could cause

pipng in the embankment. If increased flows should occur, a geotechnical engineering consultant should be engaged to evaluate the problem. Riprap should be placed below the principal spillway discharge outlet to restrict erosion during flooding. A staff gage should be installed to monitor water levels.
