SLABSTER LAKE DAM

LOUDOUN COUNTY, VIRGINIA

VA. NO. 10710

PHASE I INSPECTION REPORT NATIONAL DAM SAFETY PROGRAM

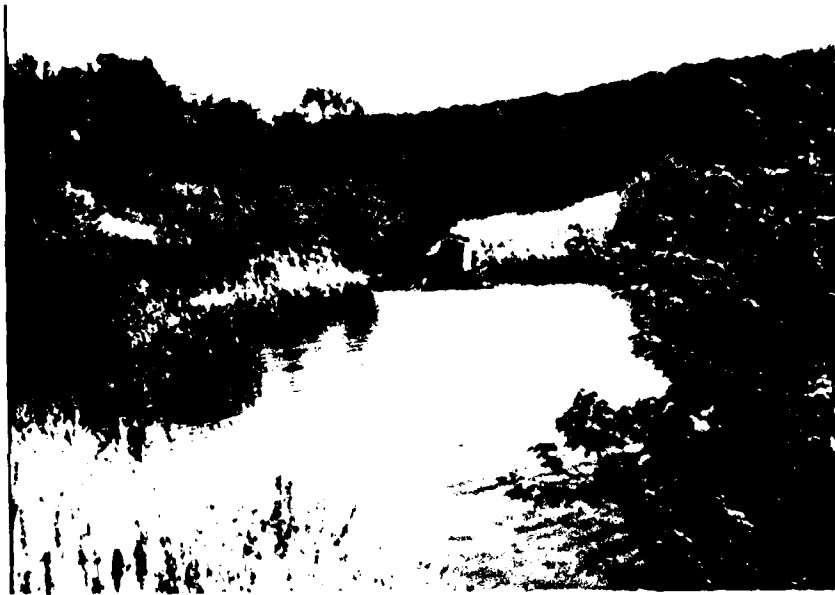
The primary and secondary principal spillway weirs indicated no signs of deterioration or erosion (see photographs No. 3 and 4, Appendix II). The discharge channel below the principal spillway exhibited erosion on the side slopes (Photograph No. 6, Appendix II and field sketch 4, Appendix III). The emergency spillway was heavily overgrown with grass and some 2 - 3 inch trees were located below the control section. Intermittent riprap failures were noted along the shoreline as a result of embankment sloughing and wave action.

Photograph No. 3 - Approach Channel and Weir

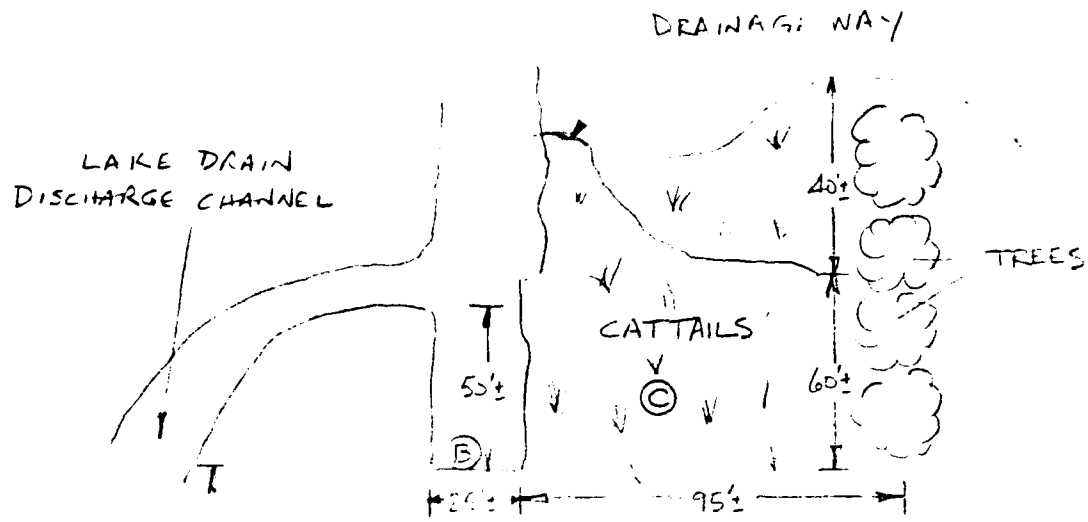
- (A) SCATTERED IRON STAINING
- (B) 3 SMALL BOILS WITHIN 4'± DIAMETER AREA 1 1/2'± BELOW WATER LEVEL. FLOW ESTIMATED @ 5 GPM± FROM RIGHT. THE WATER WAS CLEAR. THIS MAY BE THE CHIMNEY DRAIN OUTLET
- (C) MARSHY, SATURATED AREA LOCATED AT BASE OF RIGHT EMERGENCY SPILLWAY. NO FLOW OR IRON STAINING OBSERVED

7.3.6 Iron stained seepage present below the lake drain discharge pipe should be monitored quarterly to detect any flow. If flows should occur, a Professional Engineer with expertise in Geotechnical Engineering should be contacted to evaluate the problem and make recommendations for required corrective measures.
