PRECISION DYNAMICS LAKE DAM

LOUDOUN COUNTY, VIRGINIA

VA. NO. 10711

PHASE I INSPECTION REPORT

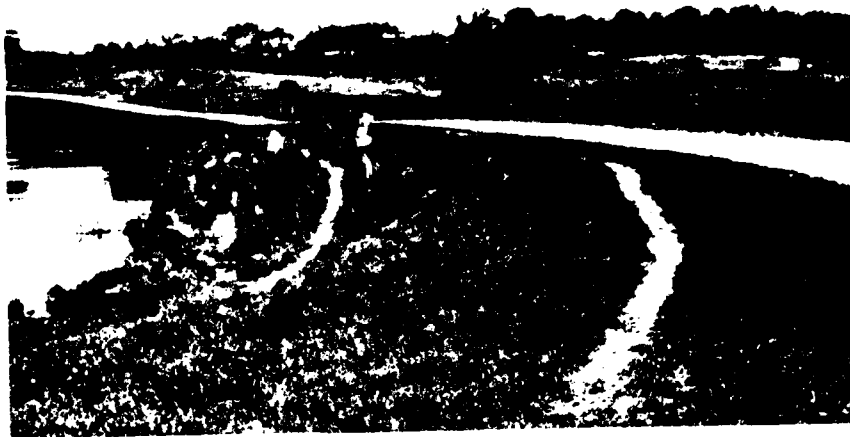
Some sloughing was noted on the upstream slope in line with the intake structure. The only erosion observed was in the form of cattle paths traversing both the upstream and downstream slopes. Several animal burrows were encountered across the embankment.

Photograph No. 1 - Upstream Face of Dam
(Note worn cattle paths)

The cattle paths are not considered detrimental to the proper performance of the dam. Riprap should be placed around the plunge pool to reduce erosion during periods of flooding. The animal burrows do not presently create an unsafe condition; however, future burrowing could result in numerous voids in the embankment which could be potentially hazardous under certain conditions. It is recommended that existing burrows be backfilled. Sloughing observed on the upstream slope in line with the intake structure should be corrected and reseeded.

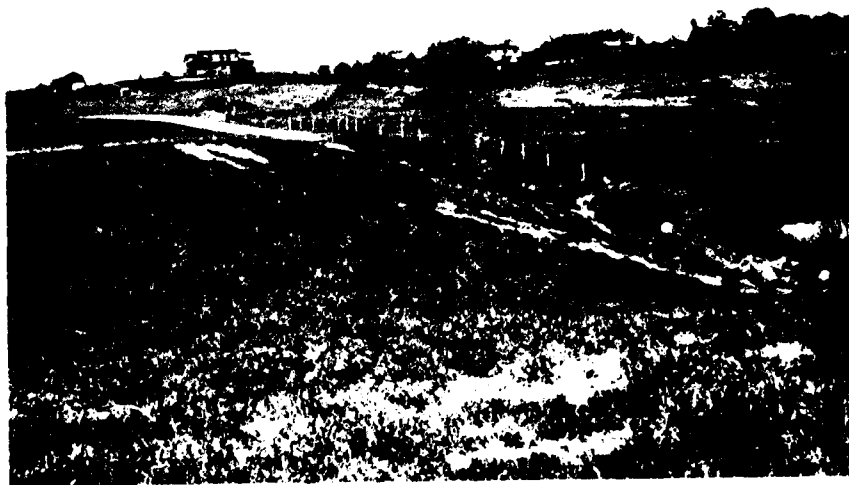
Photograph No. 2 - Downstream Face of Dam

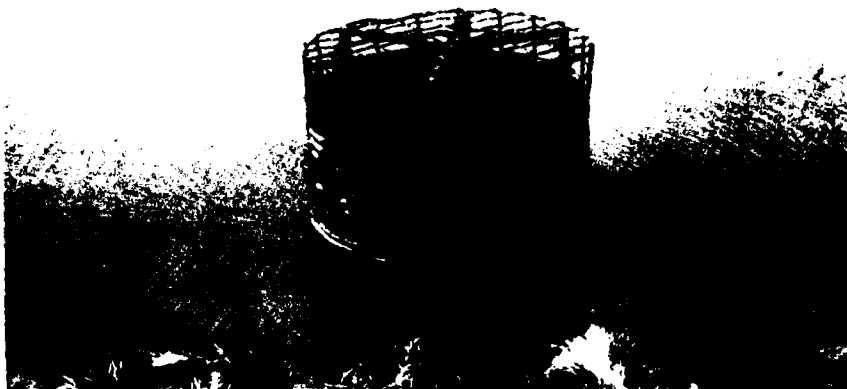
The outlet pipe and intake structure are in good structural condition. A staff gage should be installed to monitor water levels.

Photograph No. 3 - Intake Structure

7.3.3 Sloughing observed on the upstream slope in line with the intake structure should be corrected and reseeded.

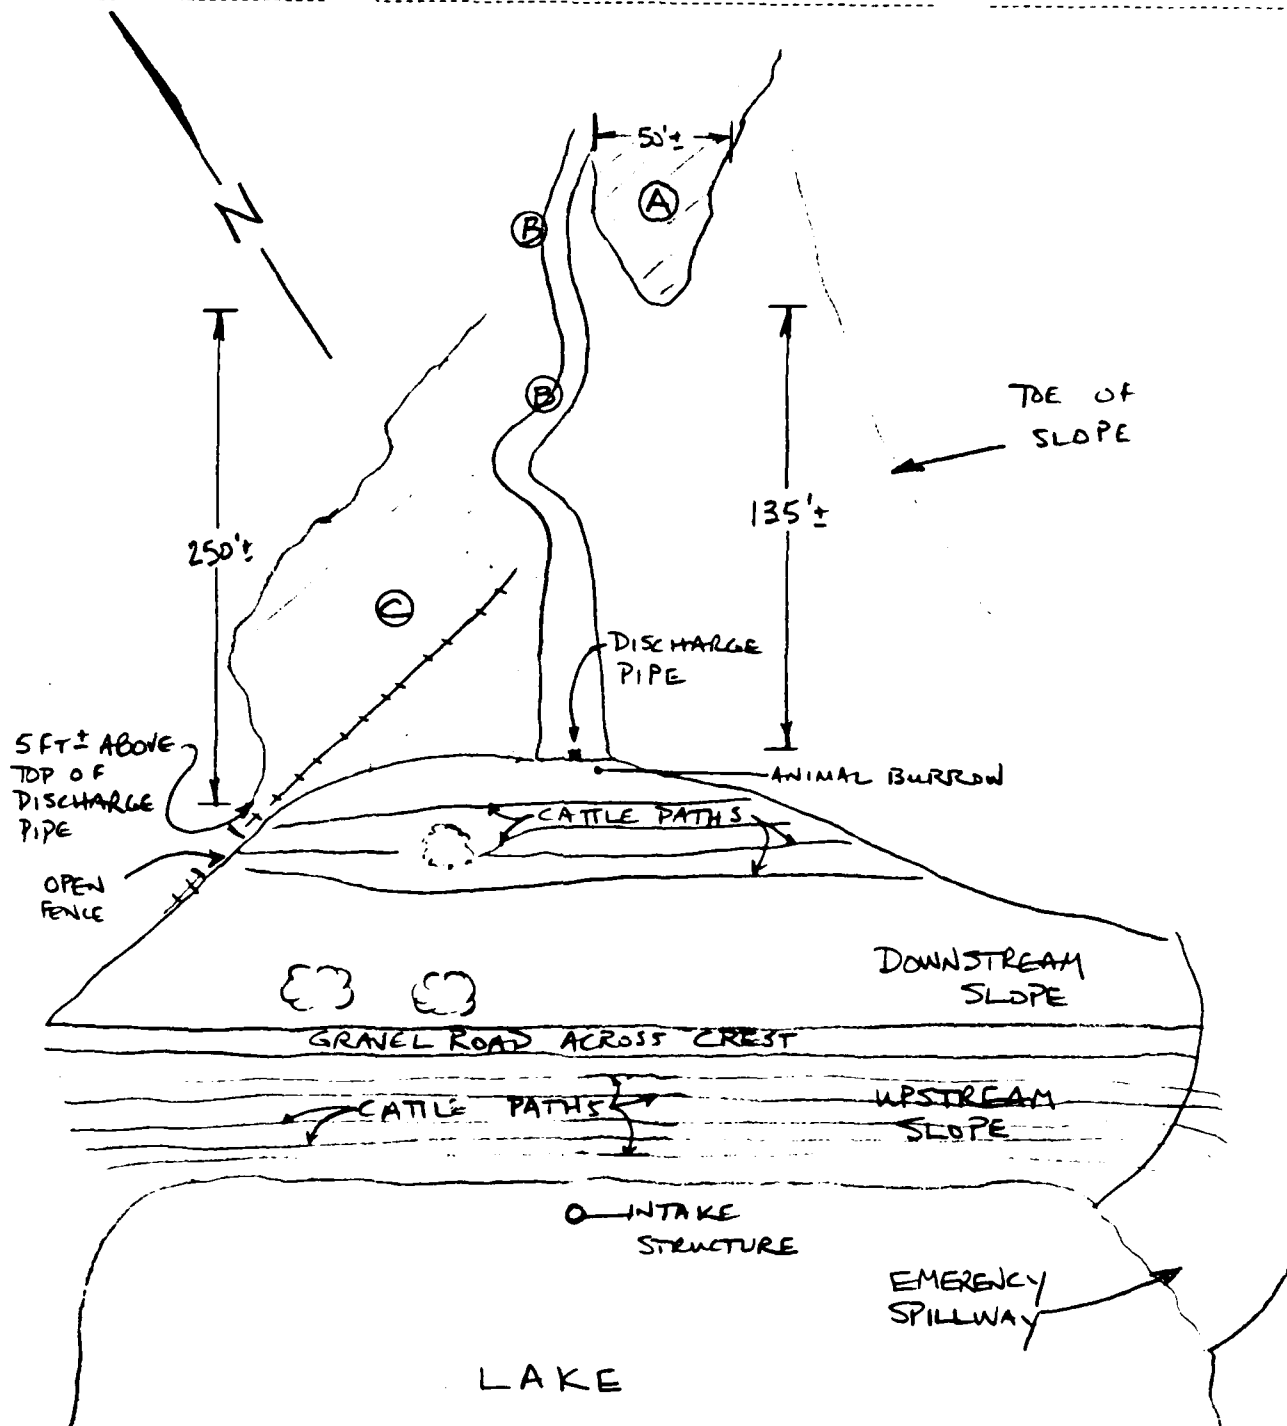
SUBJECT FIELD DITCH
PRECISION DYNAMICS DAM

Along the left downstream toe the ground is saturated and includes scattered marsh grass. This area extends to a point 8 ft above the discharge pool along the left abutment/embankment contact. Scattered iron staining and the presence of films on some ponded areas were noted, however, no flow was observed. Some iron staining was also encountered 100 ft⁺ below the discharge pipe along the stream channel. A ⁺ 200 ft long saturated, marshy area occurs along the right side of the stream approximately 135 ft below the dam (Field Sketch 3, Appendix III).

Two marshy saturated areas were encountered below the dam on the right and left sides of the stream channel. According to SCS personnel, these areas existed prior to construction of the dam and are related to spring activity. Scattered iron staining observed in the left marsh is believed to be related to seepage through the dam.

The marshy saturated areas located below the downstream slope on the left and right sides of the discharge channel are believed to be related to spring activity. Iron stained areas observed on the left side may be related to seepage through the dam near the left downstream abutment-

embankment contact. This does not necessarily create an unsafe condition; however, these iron stained areas should be monitored periodically in attempt to detect any significant increases in flow which may result in piping within the embankment.

- (A) SCATTERED MARSH GRASS AND SATURATED GROUND; EXTENDS SEVERAL 100' DOWNSTREAM, SOUTH END OF AREA IS 5 FT ABOVE TOP OF DISCHARGE PIPE. NO FLOW OBSERVED.
- (B) SCATTERED IRON STAINING ALONG BOTH SIDES OF STREAM NO FLOW OBSERVED.
- (C) MARSHY AREA WITH CATTAILS OCCUPYING THE UPPER 75'± OF THE AREA. GROUND IS SATURATED. SCATTERED IRON STAINS AND FILMS ON STANDING WATER NOTICED. NO FLOW OBSERVED.

7.3.5 Iron stained seepage present in the marshy area below the left downstream abutment-embankment contact should be monitored quarterly to detect any increase which may cause piping within the embankment.
