LAKE FRONT ROYAL DAM

WARREN COUNTY, VIRGINIA

# PHASE I INSPECTION REPORT NATIONAL DAM SAFETY PROGRAM

MAY 1981

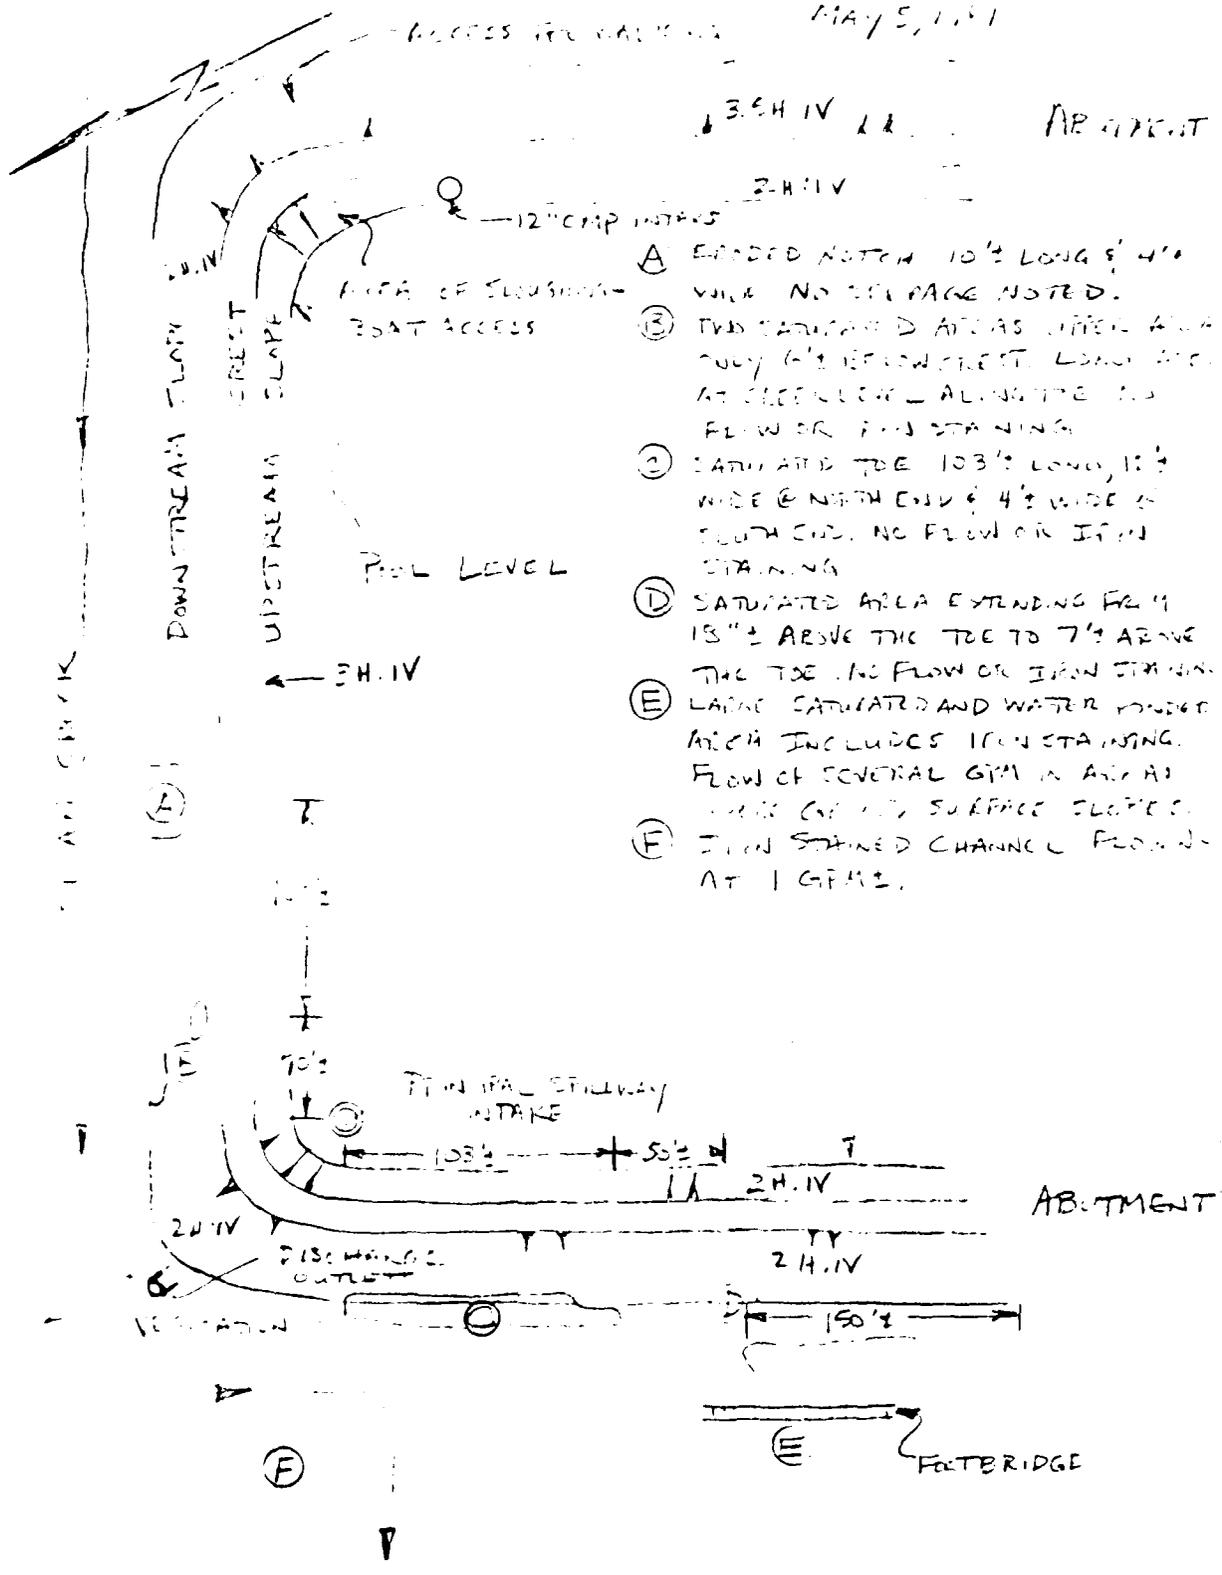
The two saturated areas observed on the downstream slope (areas B and D, Field Sketch III) are of concern because they occur above the downstream toe and are believed to be related to seepage through the dam. It is recommended that a Professional Engineer with expertise in Geotechnical Engineering be contacted to evaluate these two areas and make recommendations for any required remedial measures. The other saturated and/or iron stained areas (C, E and F, Appendix III) do not present a hindrance to the normal functioning of the dam, however, it is recommended that they also be reviewed, particularly the iron stained areas (E and F), by the Geotechnical Engineer to verify that no problem exists. The saturated grassy area along the right downstream slope is the result of ponded spring water and does not require any attention.

The two saturated areas observed on the downstream slope (areas B and D, Field Sketch 3, Appendix III) are of concern because they occur above the downstream toe and are believed to be related to seepage through the dam. It is recommended that a Professional Engineer with an expertise in Geotechnical Engineering be contacted to evaluate these two areas and make recommendations for any required remedial measures. Although other described iron stained and saturated areas are considered less serious, it is recommended they also be examined by the Geotechnical Engineer to verify that a problem does not exist.

- (A) ERODED NOTCH 10' LONG & 4" DEEP WITH NO SLOPE NOTED.
- (B) TWO SATURATED AREAS UNDER AREA TOULY 6' BELOW CREST. LEAKAGE AREA AT CREST LEVEL ALONG THE TOULY FLOW OR IRON STAINING.
- (C) SATURATED TOE 103' LONG, 12' WIDE @ NORTH END & 4' WIDE @ SOUTH END. NO FLOW OR IRON STAINING.
- (D) SATURATED AREA EXTENDING FROM 13" ABOVE THE TOE TO 7' ABOVE THE TOE. NO FLOW OR IRON STAINING.
- (E) LARGE SATURATED AND WATER RIDDEN AREA INCLUDING IRON STAINING. FLOW OF SEVERAL GPM IN AREA AS INDICATED BY SURFACE SLOPE.
- (F) IRON STAINED CHANNEL FLOWING AT 1 GPM.

7.2.1 The USACE should hire a consultant to conduct a geotechnical investigation to evaluate the two saturated areas present on the downstream slope above the toe of the dam and make necessary recommendations. It is recommended that other described saturated and non-saturated areas be examined to verify that no problem exists. Furthermore, the stability of the left upstream embankment slope should also be evaluated and monitored as necessary.
