NAME OF DAM: DALEY DAM
LOCATION: LOUDOUN COUNTY, VIRGINIA
INVENTORY NUMBER: VA 10709

PHASE I INSPECTION REPORT
NATIONAL DAM SAFETY PROGRAM

National Dam Safety Program. Daley
Dam (Inventory Number VA 10709),
Potomac River Basin, Loudoun County,
Virginia. Phase I Inspection Report.

APR 1981

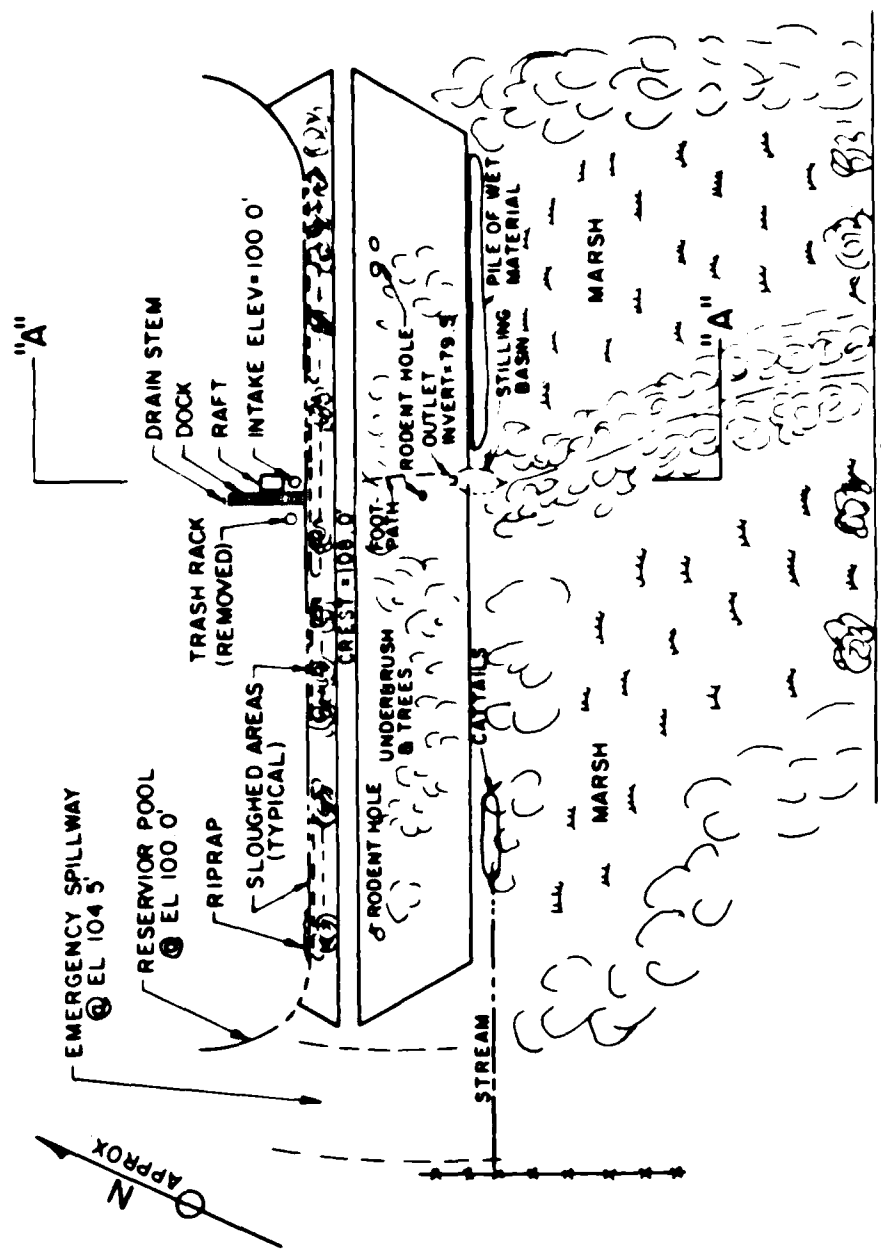
PLATE III

There are no signs of surface cracks, unusual movement, sloughing or misalignment on the crest or downstream face. However, most of the upstream face has experienced slope failure. The failure consists of areas of minor sloughing and areas of large failure surfaces with 4 feet of slip plane exposed. Several footpaths run down both the upstream and downstream faces from the crest. There is minor erosion around the principal spillway outlet pipe. Several animal burrows are located on the downstream face. (See Plate III, Appendix I and Photos No. 2, 3, 4 & 6, Appendix II).

The portions of the upstream slope that have not failed are riprapped. The riprap extends from about 3 feet below pool elevation to about 12 feet up the slope. Evidence of riprap is visible on the slope in the areas of minor sloughing, however, there is no evidence of riprap in the areas of large failure surfaces. Apparently, the whole upstream slope was riprapped but the slope failure carried some of the riprap far enough down the slope, beneath the water surface, to be unobservable (See Plate III, Appendix I).

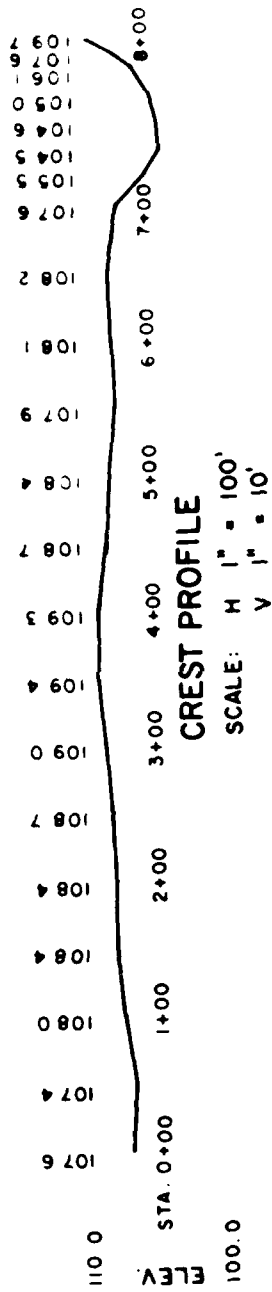
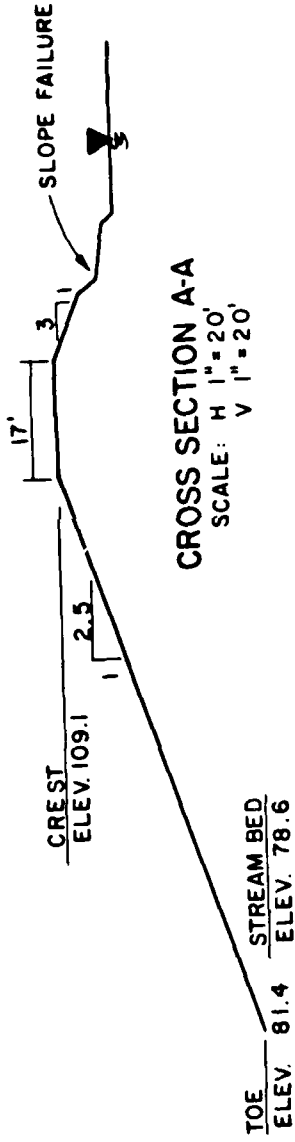
DALEY DAM
LOUDOUN COUNTY, VIRGINIA
30 APRIL 1981
PLATE IV

3.1.2 Embankment: The embankment is in fair condition. Sketches showing a plan view, a profile and a cross section at the time of the inspection are provided on Plates III & IV, Appendix I. An overall view of the dam is provided at the beginning of the report.
