DOVER LAKE DAM

GOOCHLAND COUNTY, VIRGINIA

VA. NO. 07503

PHASE I INSPECTION REPORT NATIONAL DAM SAFETY PROGRAM

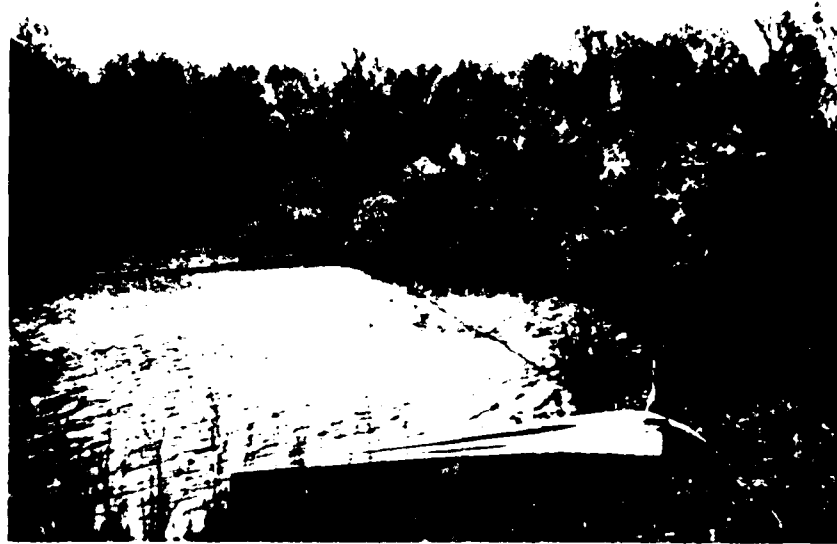
Photograph No. 1 - Upstream Face of Dam
(Arrow Indicates Intake Pipes)

Along the upstream slope numerous erosional notches occur at water level. These notches are cut a maximum of 3 ft into the embankment, 1 to 10 ft wide and occur along the entire length of the upstream embankment. The notches occur between stands of $\frac{1}{2}$ to 2" diameter trees which also occur along the entire upstream slope along the water line. Several groundhog holes were observed along the bottom 10 ft of the downstream slope, approximately 90 ft from the left abutment. Both embankment slopes are 2.5H:1V. The 8 ft wide berm shown on the design drawings on the upstream slope was submerged.

Considerable erosion was noted on the embankment along the upstream slope due to wave activity. It is recommended this erosion be corrected and that riprap be placed along the upstream slope to provide embankment protection. Riprap should also be placed in the plunge pool to prevent erosion. The groundhog holes do not presently create an unsafe condition; however, future borrowing could result in numerous voids in the embankment which could be potentially hazardous under certain conditions. It is recommended that existing burrows be backfilled. The eroded area observed in the discharge section of the right emergency spillway should be backfilled and reseeded. Erosion noted on the right side slope does not require any special attention.

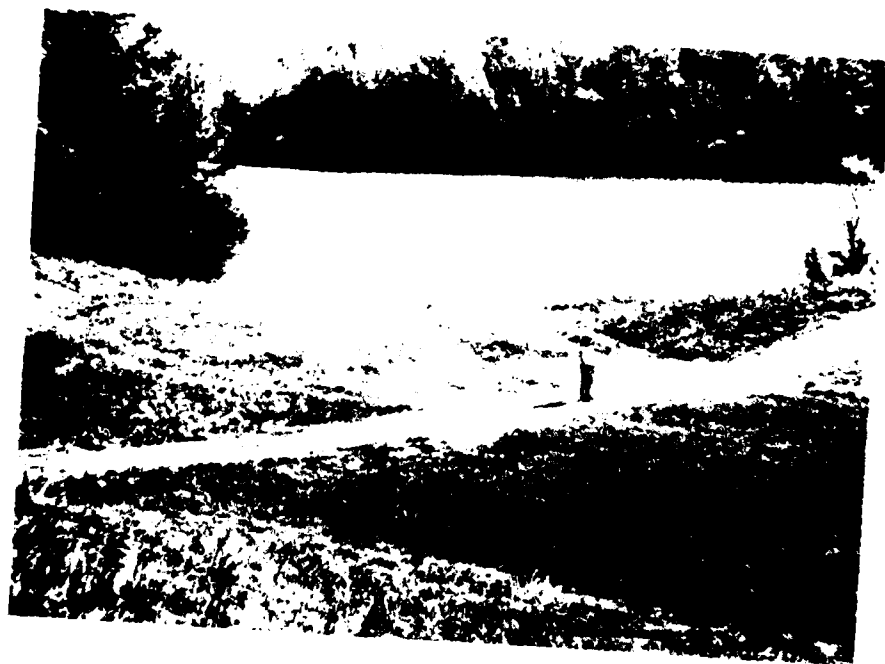
No sloughing or erosion was noted on the downstream slope; however, numerous erosional notches occur between the trees along the entire upstream slope at pool level. These notches extend approximately 3 ft into the embankment and range from 1 to 10 ft in width. Several groundhog holes were observed along the bottom 10 ft of the downstream slope, approximately 90 ft from the left abutment. Some erosion or washing consisting of a flow path 1 to 2 ft deep and 1 ft wide was noted in the discharge section of the right emergency spillway. Some erosion was also noted on the right spillway side slope.

Photograph No. 4 - Emergency Spillway
at Right Abutment

- f) The eroded area observed in the discharge section of the emergency spillway should be backfilled and reseeded.

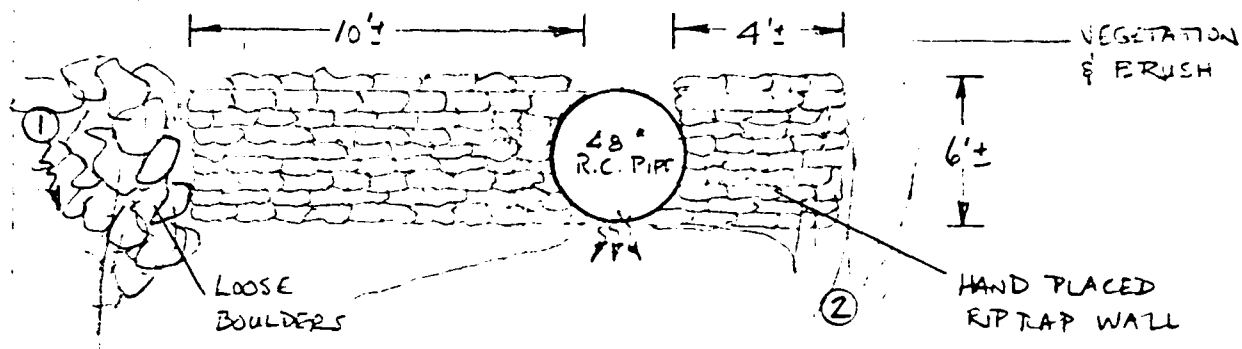
DOWNSTREAM SLOPE

The only seepage encountered was in the vicinity of the discharge pipe. (See Field Sketch, Sheet 1, Appendix III). Iron stained seepage was observed flowing at an estimated 2-3 gpm from the base of a rock pile 12 to 14 ft downstream of the right end of pipe. No turbidity was noted. Iron staining was also encountered two locations below the left side of the pipe, 5 ft⁺ and 50 ft⁺ beyond the end of the pipe. No flow was observed at either location. The toe of the downstream slope was dry.

- ① IRON STAINED SEEPAGE FLOWING @ ESTIMATED 2-3 gpm FROM BASE OF ROCK, ABOUT SAME ELEVATION AS TOP OF DISCHARGE PIPE. LOCATED 12-14' FROM RIGHT END OF WALL. NO TURBIDITY WAS NOTED.
- ② IRON STAINED SATURATED AREA LOCATED 5'± BEYOND DISCHARGE PIPE; NO FLOW OBSERVED.
- ③ IRON STAINED SATURATED AREA LOCATED 50'± BEYOND DISCHARGE PIPE; NO FLOW OBSERVED.

- e) Seepage present below the discharge pipe should be monitored quarterly to detect any increase in flow rates which may cause piping within the embankment. If increased flows should occur, a Professional Engineer with expertise in Geotechnical Engineering should be contacted to evaluate the problem and make recommendations for required corrective measures.
