Name Of Dam: **CAMP HYDAWAY**
Location: **CAMPBELL COUNTY**
Inventory Number: **VA. 03113**

**PHASE I INSPECTION REPORT
NATIONAL DAM SAFETY PROGRAM**

Name of Dam: Camp Hydaway Dam
State: Virginia
Location: Campbell County
USGS Quad Sheet: City Farm, Virginia
Stream: Opossum Creek
Date of Inspection: 2 April 1981

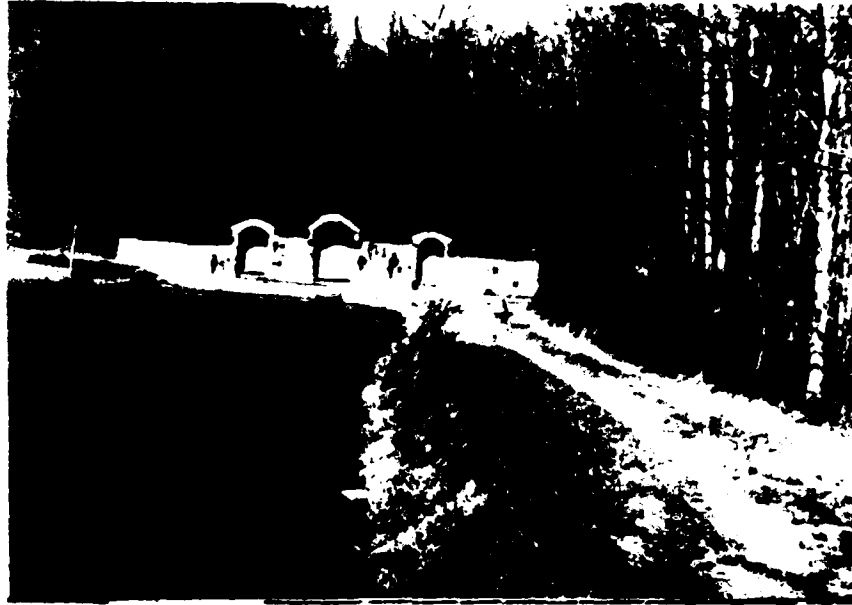
CREST

The embankment crest and upstream face are in good condition. There are no signs of surface cracks, unusual movement, or misalignment. A good grass cover exists on the upstream face. Riprap was observed on the upstream face of the dam at the water level. The riprap appeared to have settled into the embankment. A gravel covered roadway, bordered by a satisfactory grass cover, traverses the crest of the dam. The downstream face is covered with underbrush and hardwood trees with diameters of up to one foot.

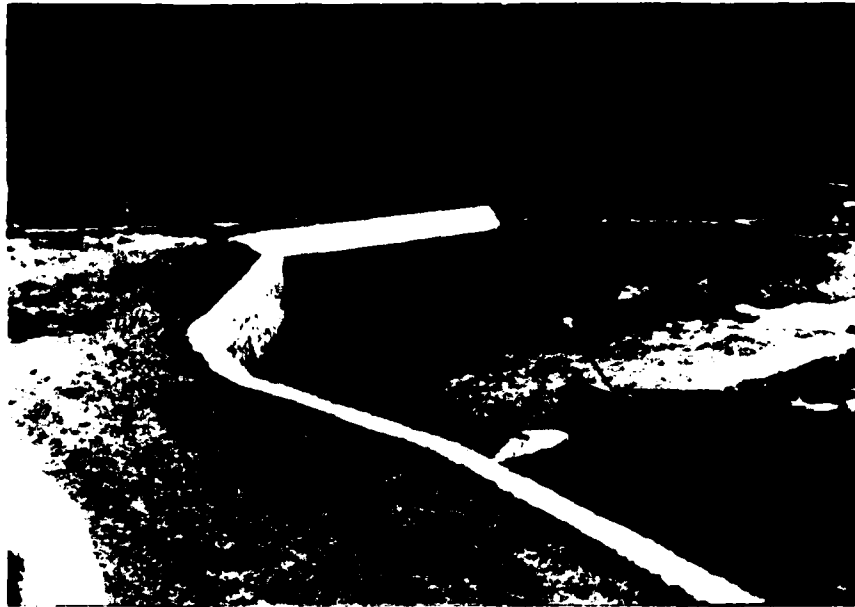
3.1.3 Spillway: The spillway consists of a 10-inch cast iron pipe riser located in the reservoir (pipe spillway) and an open channel in the left abutment. A 23-inch diameter drum, supported by metal fingers atop the 10-inch riser, forms the trash guard. The riser is connected to a 10-inch cast iron pipe which passes through the embankment at a low level and discharges into a stilling basin at the toe of the dam. The outlet to this pipe was submerged and partially blocked by rock and debris. The open channel in the left abutment has a control section consisting of a masonry sill approximately 2 feet wide and 39 feet long. In the left side of the sill is a 2-foot section slightly lower than the rest of the sill. This 2-foot section is at the same elevation as the cast iron riser. The side channel has a masonry training wall on its left side directing flow beneath a concrete and steel bridge, crossing the channel approximately 20 feet below the control section. The bridge

PHOTO #5 SPILLWAY (ONE OF TWO)

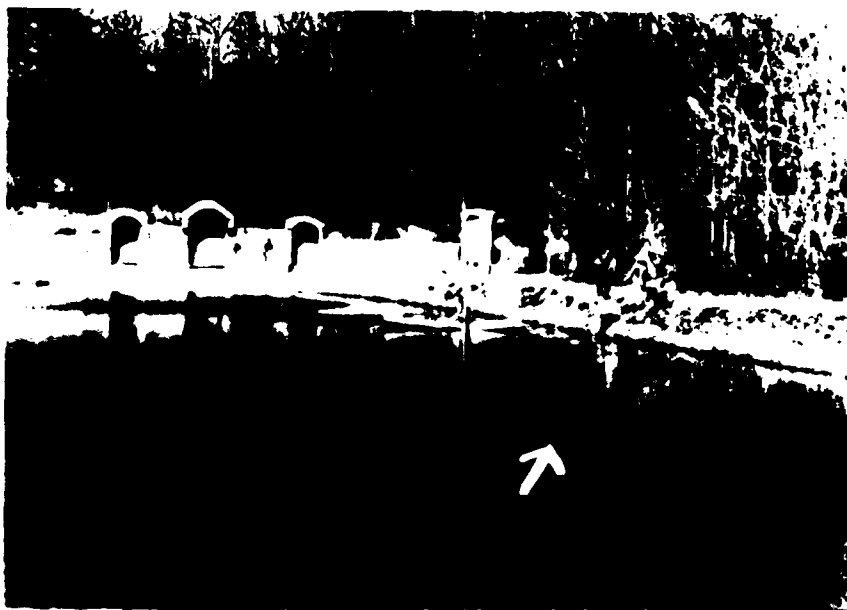
PHOTO #6 SPILLWAY INTAKE STRUCTURE
