RIVANNA RIVER BASIN

Name Of Dam: GREENE MOUNTAIN LAKE DAM  
Location: GREENE COUNTY, VIRGINIA  
Inventory Number: VA. NO. 07915

# PHASE I INSPECTION REPORT NATIONAL DAM SAFETY PROGRAM

MAY 1981

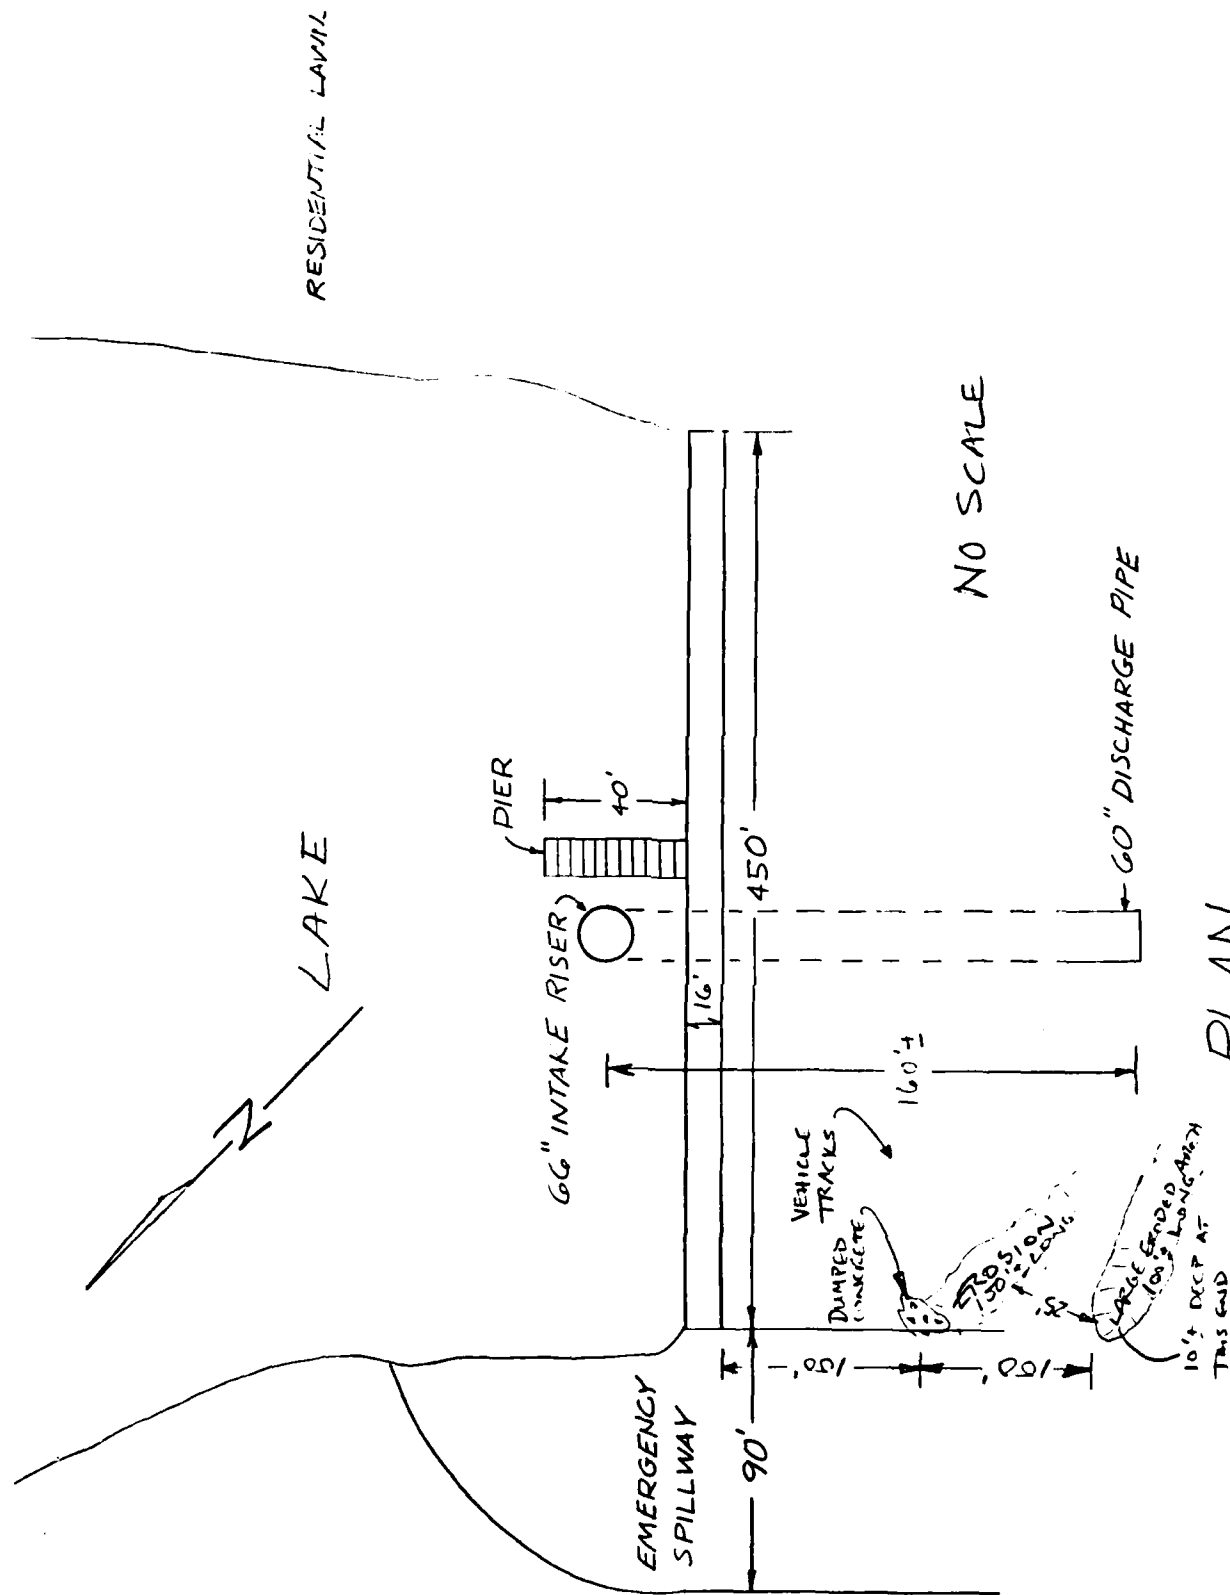
PLAN  
 GREEN MOUNTAIN LAKE  
 FIELD SKETCH 1  
 6 MAY 1981

In good condition except for last joint. See Field Sheets 1 and 3

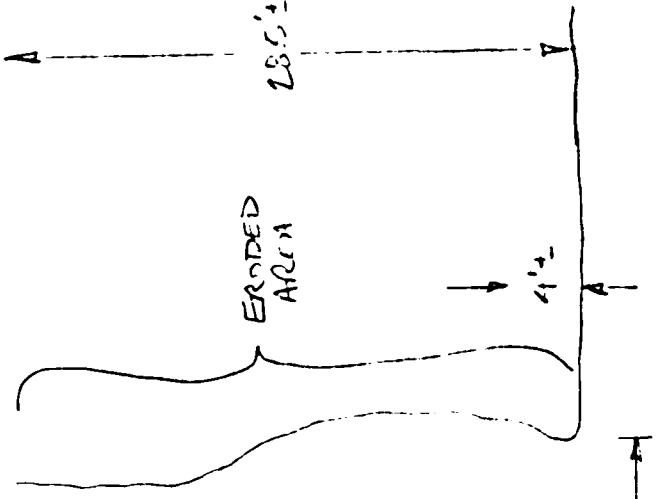
NOTE:  
THE EROSIONAL BULGE APPEARS TO BE  
THE RESULT OF EMBANKMENT SLOUGHING  
IT IS GRASSED OVER AND INCLUDES  
SEVERAL SMALL TREES AND BRICCS.

present on the upstream slope near the embankment crest and the two eroded areas along the emergency spillway discharge channel should be backfilled and reseeded. It is further recommended that the bulge or area of embankment sloughing present on the downstream slope 118 ft<sup>±</sup> to the left of the discharge outlet be regraded and reseeded. Vehicular traffic should be prohibited on the downstream slope and across the embankment crest. It is recommended that the crest be reseeded.
