PHASE I INSPECTION REPORT NATIONAL DAM SAFETY PROGRAM

JULY 1981

NAME OF DAM: BLACK CREEK LAKE
LOCATION: WISE COUNTY
INVENTORY NUMBER: VA 19513

Name of Dam: Black Creek Lake Dam
State: Virginia
Location: Wise County
USGS Quad Sheet: Norton, Virginia
Stream: Black Creek
Date of Inspection: 9 June 1981

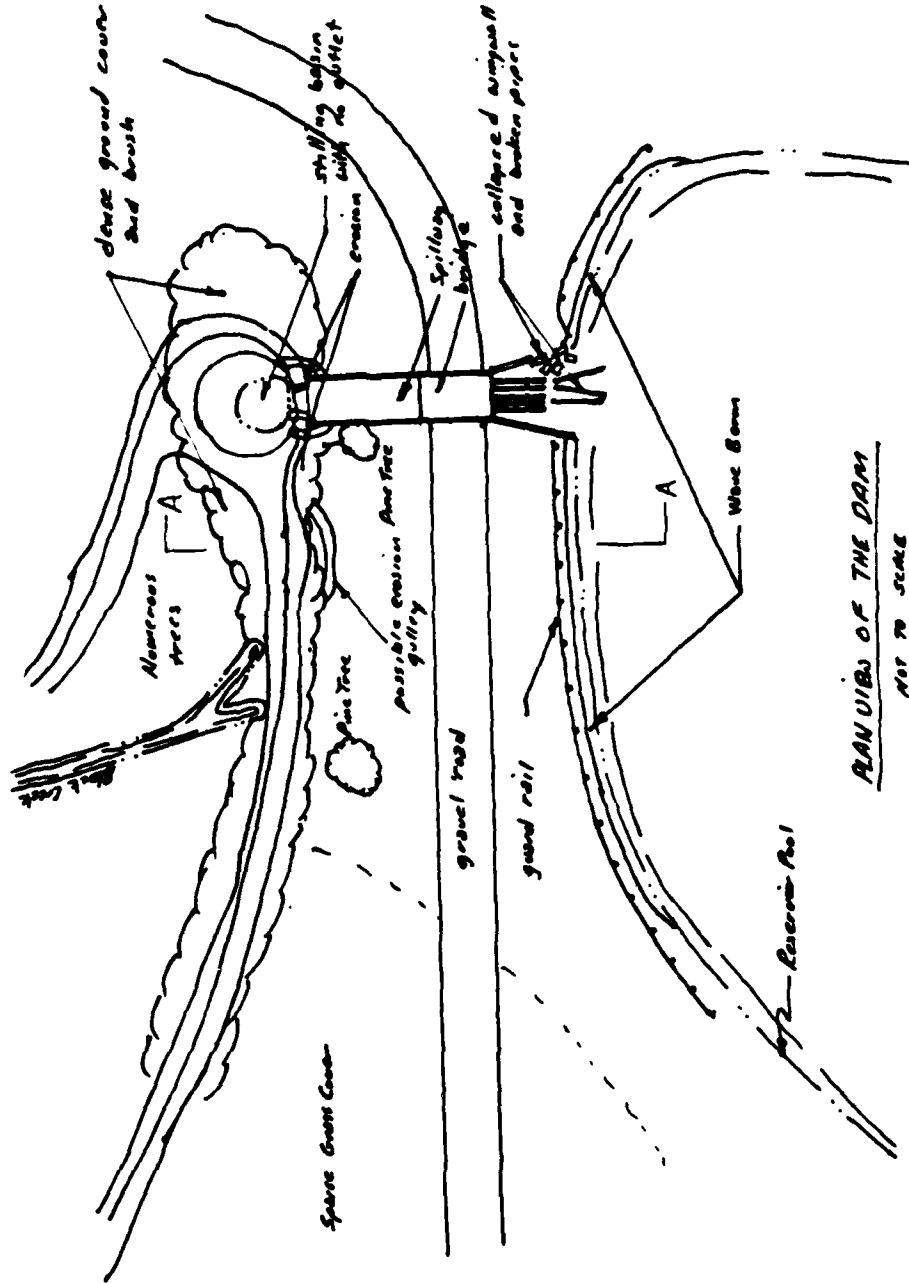
BLACK CREEK LAKE DAM
 WISE COUNTY
 9 JUNE 1981
 PLATE II

3.1.2 Embankment: The embankment is in good condition. A sketch showing a plan view and cross section is provided on Plate II, Appendix I. An overall view of the dam is provided at the beginning of the report.
