NATIONAL DAM SAFETY PROGRAM, FAWN LAKE DAM (INVENTORY NUMBER VA--ETC(U)

PHASE I INSPECTION REPORT

NATIONAL DAM SAFETY PROGRAM

4. TITLE and Subtitle Phase I Inspection Report National Dam Safety Program Fawn Lake Dam Spotsylvania County, VA		5. TYPE OF REPORT & PERIOD COVERED Final

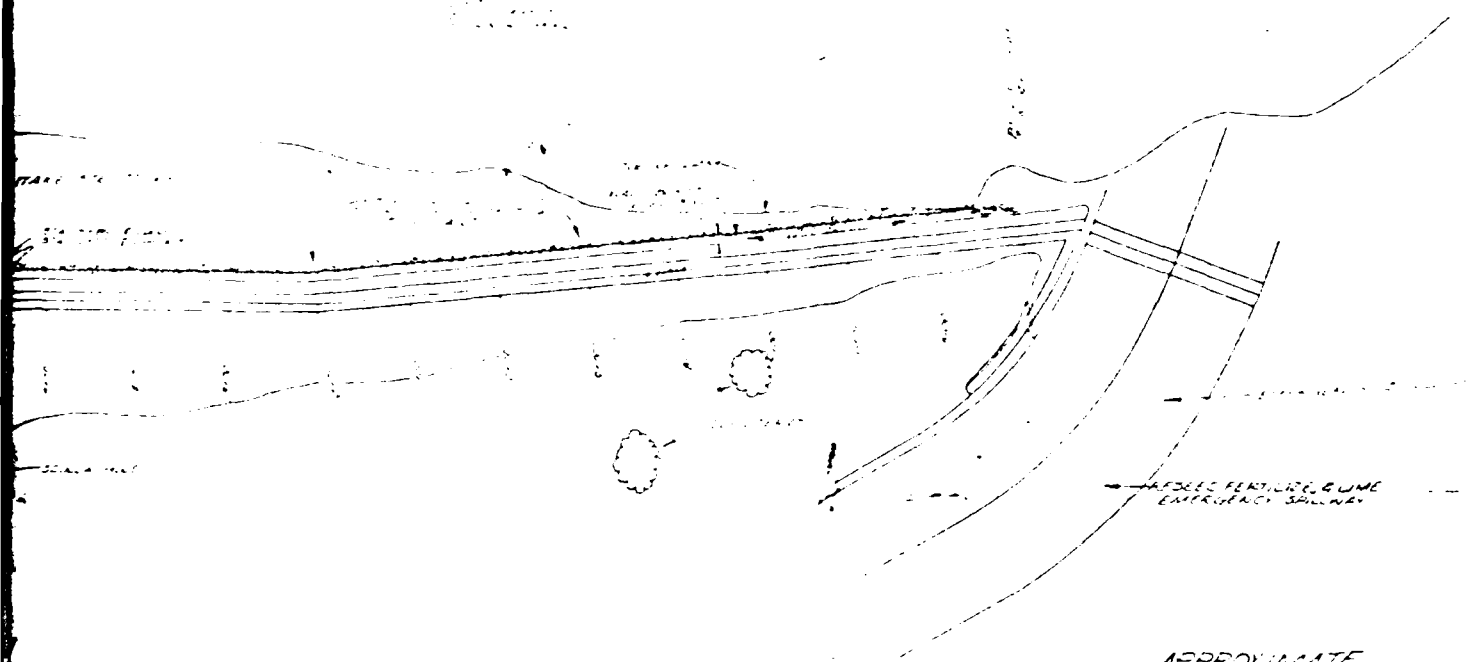
During a 1979 dam inspection requested by the owner, considerable erosion at pool level was observed. It was recommended that the riprap be placed on the upstream slope to provide slope protection. In compliance with this recommendation, J. K. Timmons and Associates, Inc., were contracted for design of the riprap (See Plate 9, Appendix I). The riprap was installed in the summer of 1980.

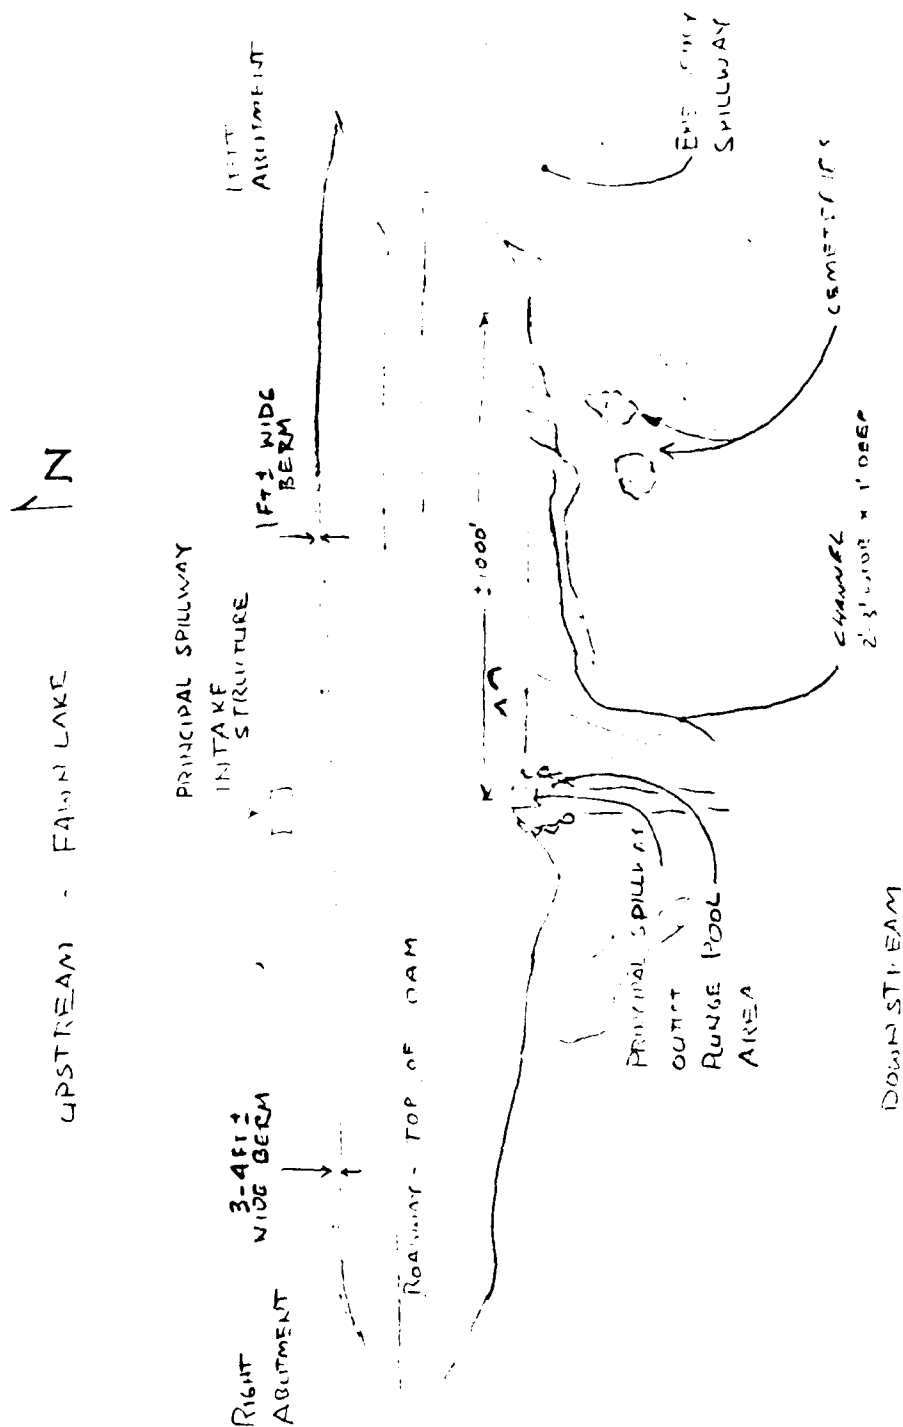
FAWN LAKE DAM FIELD SKETCH NO. 1

A continuous wet area approximately 1000 ft in length occurs along the left downstream toe (see Field Sketch, Sheet 1, Appendix III). Scattered clusters of cattails and marsh grass are present in this area. No flow was observed except where natural sloping ground conditions exist. The water was generally clear and little or no iron staining was observed. This area was of initial concern during the 1979 inspection. During that inspection several hand auger holes were drilled along the left toe of the dam near the cemeteries, beside wet areas. These holes did not fill with water and it was, therefore, concluded that water was not passing through or under the embankment at those locations. At other nearby locations water was standing at elevations estimated several feet above and beyond the toe of the dam. Wet conditions are probably related to springs which were reportedly in existence prior to construction.

Seepage was also observed along the right downstream toe in the same area it was encountered in the 1979 inspection (see Field Sketch, Sheet 1, Appendix III). This area reportedly bounds the former stream channel. Essentially no erosion was encountered on the embankment. The presence of dead trees make this area suspect as to whether this seepage is related to previously existing springs or in fact related

7.3.4 Seepage observed along the right downstream toe should be monitored quarterly for increased flows and turbidity. If these conditions should occur, a Professional Engineer with an expertise in Geotechnical Engineering should be contacted to evaluate the problem and make recommendations for required corrective measures. The importance of this precaution cannot be overemphasized since seepage occurring along the former stream channel poses a potential for piping, and thus embankment failure. Seepage observed along the left downstream toe appears to be related to spring seepage, however, a periodic examination of this area is suggested to insure that migration of saturation and erosion of the downstream toe does not occur here.

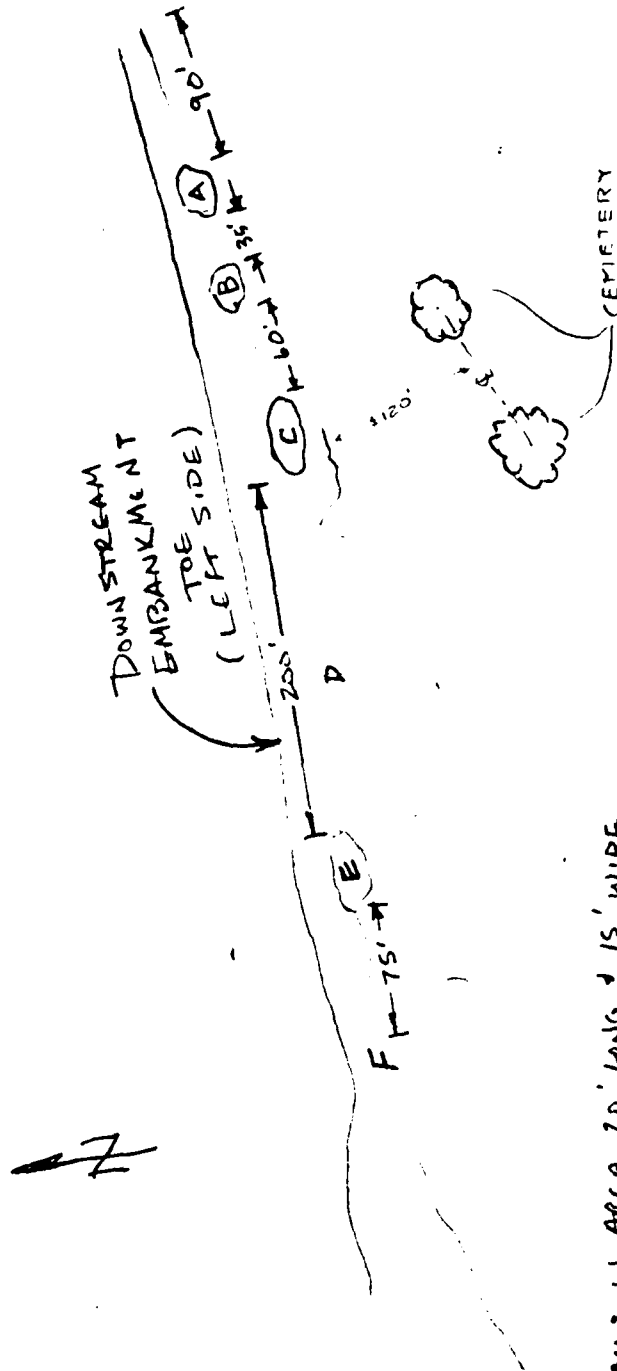
FAWN LAKE DAM FIELD SKETCH No 2

LIMITS OF HAZARDOUS AREAS - SOFT SATURATED GROUND, MAY INCREASE SEE SKETCH NO. 2

SLoughing OR BEHOOO AREAS ± 20' WIDE NO SCALE

- A. CAT TAILS IN AREA 20' LONG & 15' WIDE
- B. CAT TAILS IN AREA 15' LONG & 10' WIDE
- C. CAT TAILS IN AREA 10' LONG & 15' WIDE
- D. APPROXIMATELY 100' BELOW CEMETERY, AN ERODED CHANNEL 2' DEEP FORMS; FLOW OF SEVERAL CPM
- E. CAT TAILS IN AREA 45' LONG & 25' WIDE
- F. SURFACE CHANNEL MOVES AWAY FROM EMBANKMENT TOE AT THIS LOCATION; SOME MARSH GRASS PRESENT 150' BELOW PT. F. 300' BELOW PT. F THE CHANNEL IS 15' FROM THE TOE WHERE IT TURNS ABRUPTLY DOWNSTREAM PARALLELING THE COURSE OF THE OUTFALL CHANNEL; 405' TO ϕ OF PRINCIPAL SPILLWAY PIPE
