Name Of Dam: **CAGE**
Location: **HALIFAX COUNTY**
Inventory Number: **VA 08335**

PHASE I INSPECTION REPORT NATIONAL DAM SAFETY PROGRAM

NAME OF DAM: CAGE DAM
LOCATION: HALIFAX COUNTY, VIRGINIA
INVENTORY NUMBER: VA 08335

Name of Dam: Cage Dam
State: Virginia
Location: Halifax County
USGS Quad Sheet: South Boston, Virginia
Stream: Rocky Branch of the Dan River
Date of Inspection: 1 May 1981

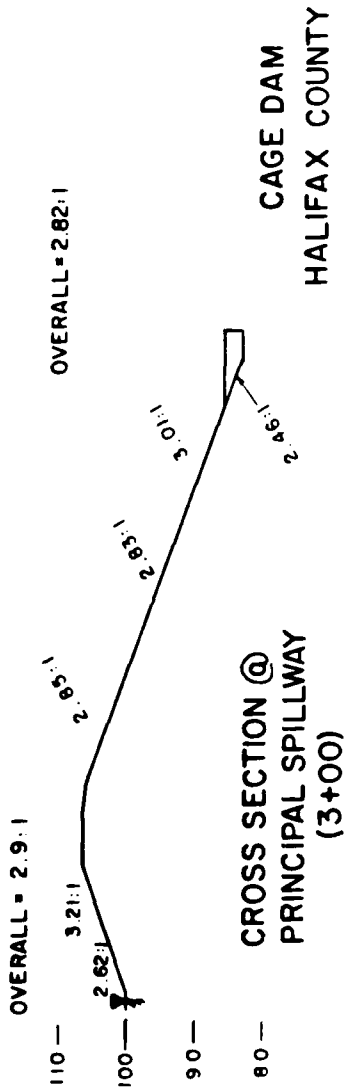
**CROSS SECTION @
 PRINCIPAL SPILLWAY
 (3+00)**

6.2.2 Stability: There are no available stability calculations. The dam is 26.3 feet high and 13 feet wide at the crest. A upstream slope is 2.9H:1V and the downstream average slope is 2.8H:1V. The existing pool is approximately 2.9 feet below maximum control storage pool, which is at the crest of the emergency spillway. The reservoir experienced once, fifteen years ago, a pool level in excess of the maximum control storage pool. The dam is subject to a drawdown rate of 1.5 feet per day which is in excess of the recommended rate of .5 per day.

According to the guideline presented in Design of Small Dam, U.S. Department of the Interior, Bureau of Reclamation, the slopes recommended for a homogeneous small dam of similar material subjected to a rapid drawdown are 3.5H:1V upstream and 2.5H:1V downstream. The recommended crest width is 15 feet. Based on these guidelines, the Cage Dam has an inadequate upstream slope and an adequate downstream slope. The crest of the Cage Dam is inadequate also.
