Scotts Millpond Dam (Inventory Number VA 05706 Rappahannock River Basin.  
Essex County, Commonwealth of Virginia.  
Phase I Inspection Report.

PHASE I INSPECTION REPORT  
NATIONAL DAM SAFETY PROGRAM

NAME OF DAM: SCOTTS MILLPOND DAM

Name of Dam: Scotts Millpond Dam  
State: Commonwealth of Virginia  
County: Essex  
USGS 7.5 Minute Quadrangle: Mount Landing, Virginia  
Stream: Hoskins Creek  
Date of Inspection: 14 November 1980

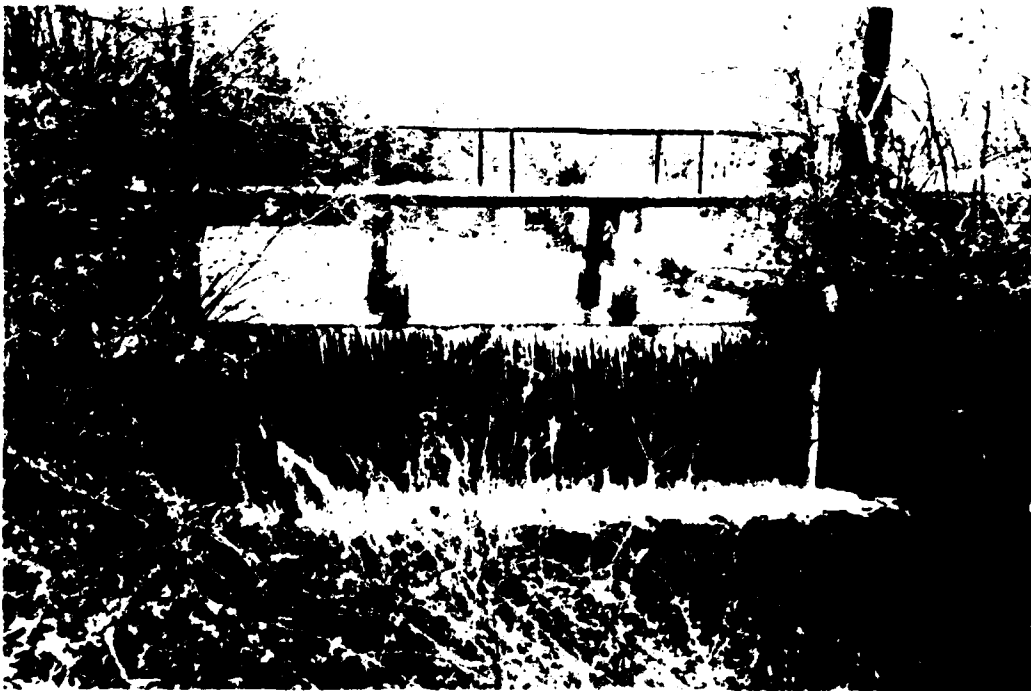
**PHOTO 2. Principal Spillway Outlet**

The spillway outlet is a concrete channel with concrete and brick sides. There is a footbridge over the channel with four concrete piers in the channel. The concrete and brick are in good condition, but there is some minor debris along the channel sides.

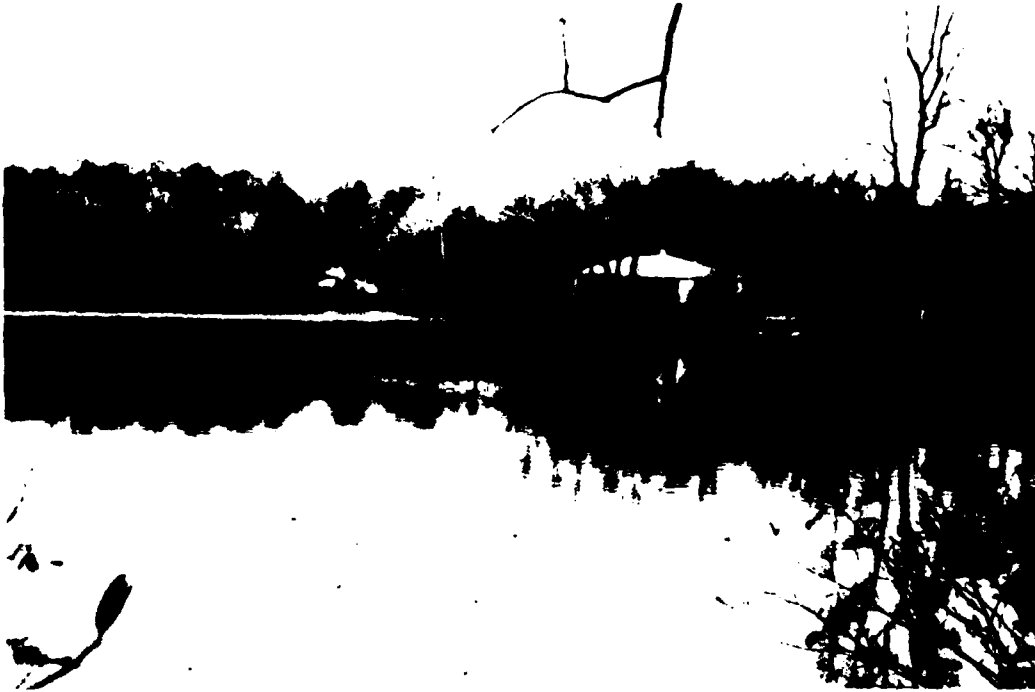
**PHOTO 5. Natural Knoll, Left Embankment, Principal Spillway to Right of House**
