Name of Dam: Airtie Dam

Inventory Number: VA 08115

**PHASE I INSPECTION REPORT  
NATIONAL DAM SAFETY PROGRAM**

May 1981

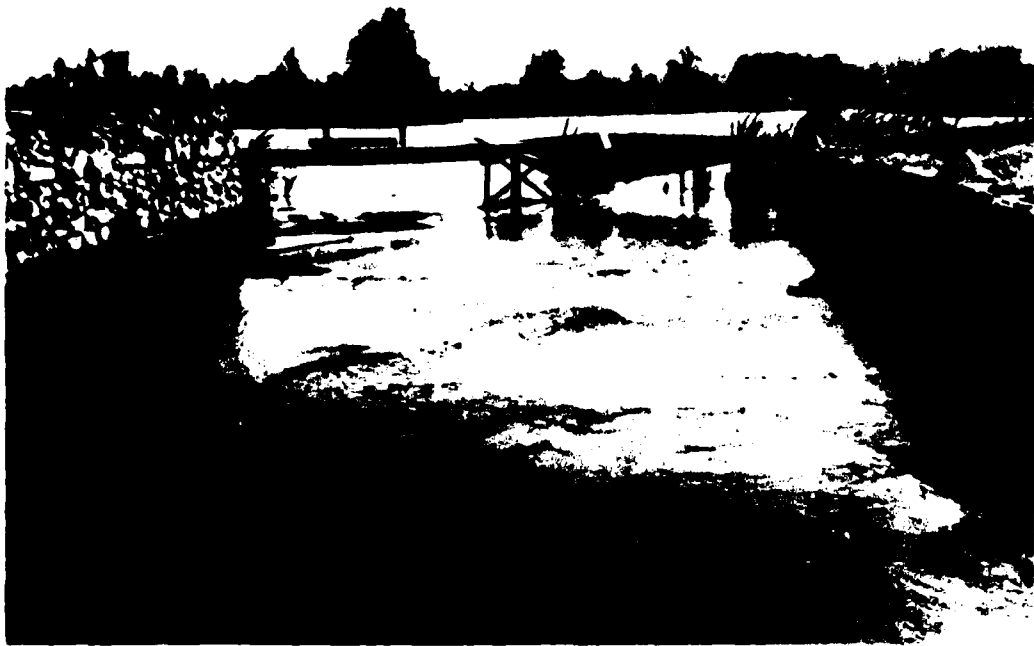
The spillway is a 55-foot long rectangular channel with a concrete and slate bottom and cemented masonry training walls. The upstream section of both training walls at the entrance to the spillway have been separated from the main sections of the walls by a 0.5 inch vertical crack in both walls. The separated sections are approximately 4 feet long.

The reservoir bottom slopes up to the channel entrance. There is a dilapidated wooden foot-bridge across the channel which may restrict flow through the spillway. Flow through the spillway plunges 16 feet to a large stilling basin which is roughly circular in shape. Cemented masonry walls form the basin training walls. The walls are in generally good condition; however, there is flow under the walls in several locations (see field sketch). A concrete slab has been poured along the outside sections of the walls to carry the flow which comes under the walls. Flow under the left section of the wall has created a large void behind the wall which is approximately 3-5 feet deep, 1-3 feet wide, and approximately 6 feet long. There is a 12-inch CMP at the downstream end of the basin which acts as a low level stilling basin outlet. This pipe is clogged.

**PHOTO 4. Spillway Channel**

The spillway training walls should be repaired. The bridge across the spillway approach channel should be repaired or removed. The flow under the stilling basin training walls is not considered to be a serious problem at this time because it is occurring either at the extreme downstream toe of the embankment or beyond the toe. Therefore, this problem is not considered to have a significant impact on the embankment. The void area created behind the left section of the training walls, however, in the downstream face of the embankment should be repaired. The walls should be monitored to ensure that this condition does not become more serious. The outlet pipe from the stilling basin should be unplugged.
