**WELCH LAKE DAM**

**BOONE COUNTY, MISSOURI**

**MO 10733**

**PHASE 1 INSPECTION REPORT  
NATIONAL DAM SAFETY PROGRAM**

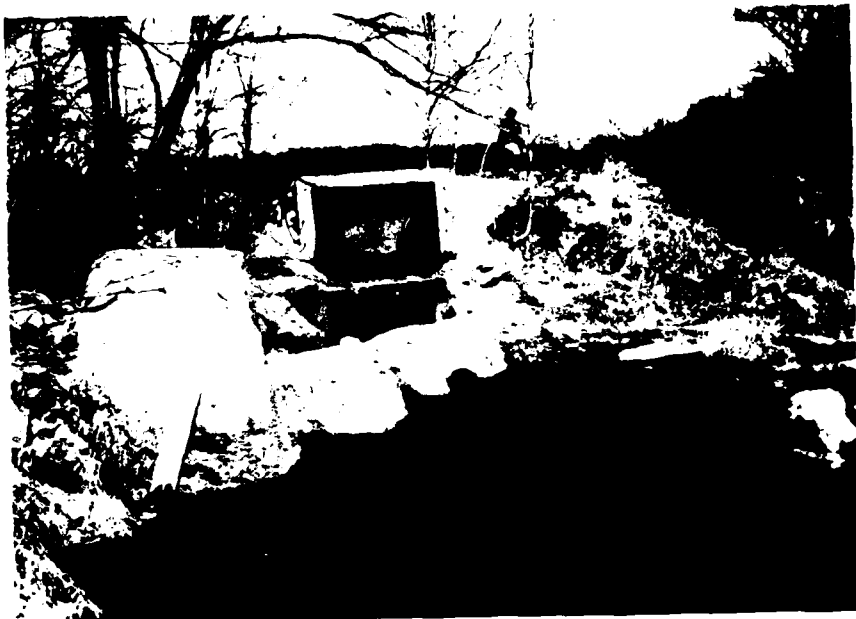
at both upstream and downstream ends, (Photos 4 & 5). Some repair efforts have been made by pouring concrete grout in the eroded areas. The foundation of the box at the outlet end has been undermined by erosion. The box appeared to have been displaced from its original alignment and grade. The plunge pool and downstream channel were badly eroded and cluttered with fallen trees and rubble, (Photo 6).

PHOTO 5: DOWNSTREAM END OF PRINCIPAL SPILLWAY CULVERT

(3) The areas of erosion noted in sections 3.1.b and 3.1.c should be repaired.

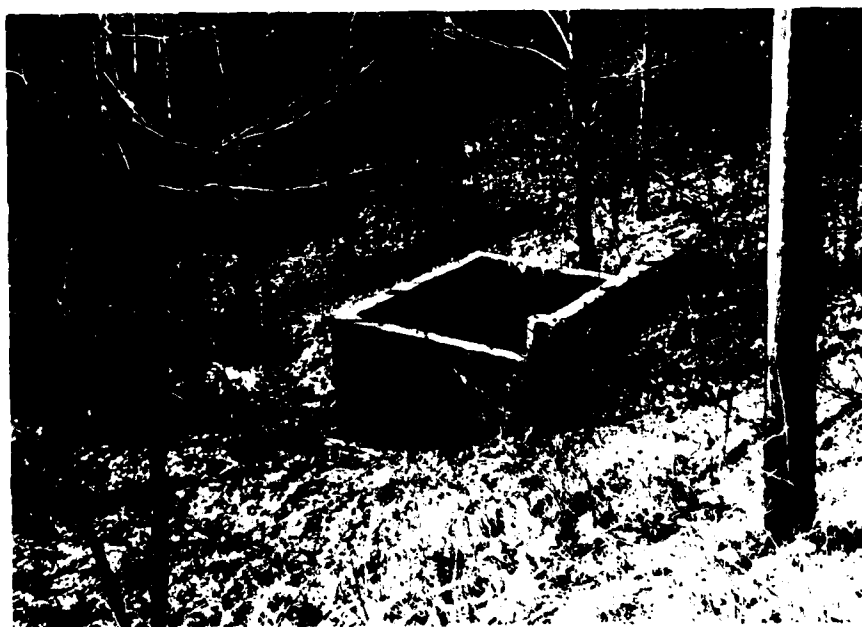
An abandoned rectangular concrete tank was observed on the downstream face of the dam, (Photo 12). There is a pipe through the upstream wall and another one through the downstream wall. A valve box is located just upstream of the tank. It is suspected that the tank once served as a wet well and pump house foundation for drawing water from Welch Lake. No inlet pipe was observed in the lake.

PHOTO 12: CONCRETE TANK ON DOWNSTREAM FACE OF DAM
