**SUNNY SHORES DAM  
JACKSON COUNTY, MISSOURI  
MO 20237**

## **PHASE 1 INSPECTION REPORT NATIONAL DAM SAFETY PROGRAM**

PHASE I INSPECTION REPORT  
NATIONAL DAM SAFETY PROGRAM

Name of Dam	Sunny Shores Lake Dam
State Located	Missouri
County Located	Jackson County
Stream	Tributary to Little Blue River
Date of Inspection	12 September 1978

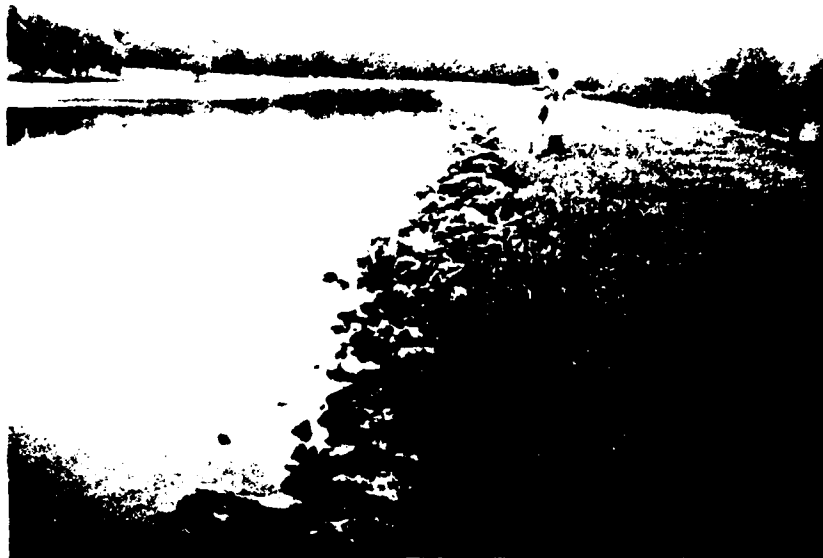
PHOTO 1: UPSTREAM FACE (LOOKING EAST)

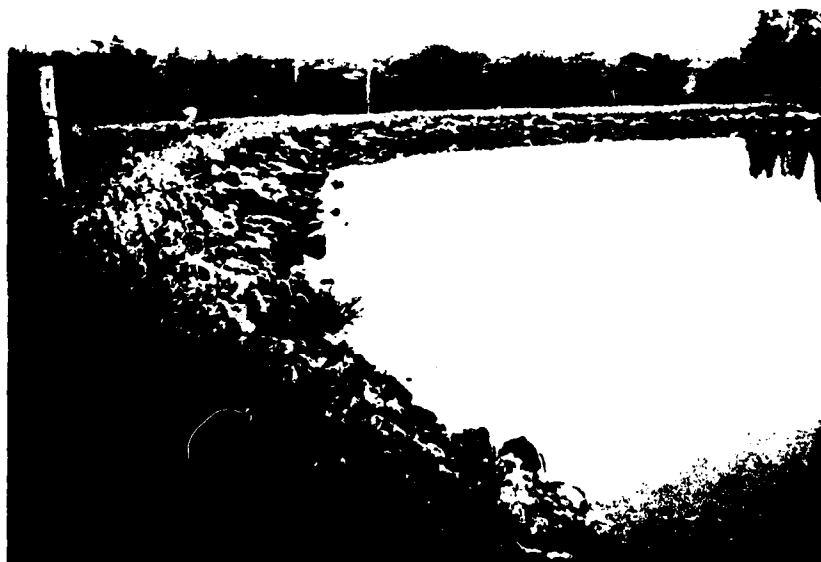
PHOTO 2: UPSTREAM FACE (LOOKING SOUTH)

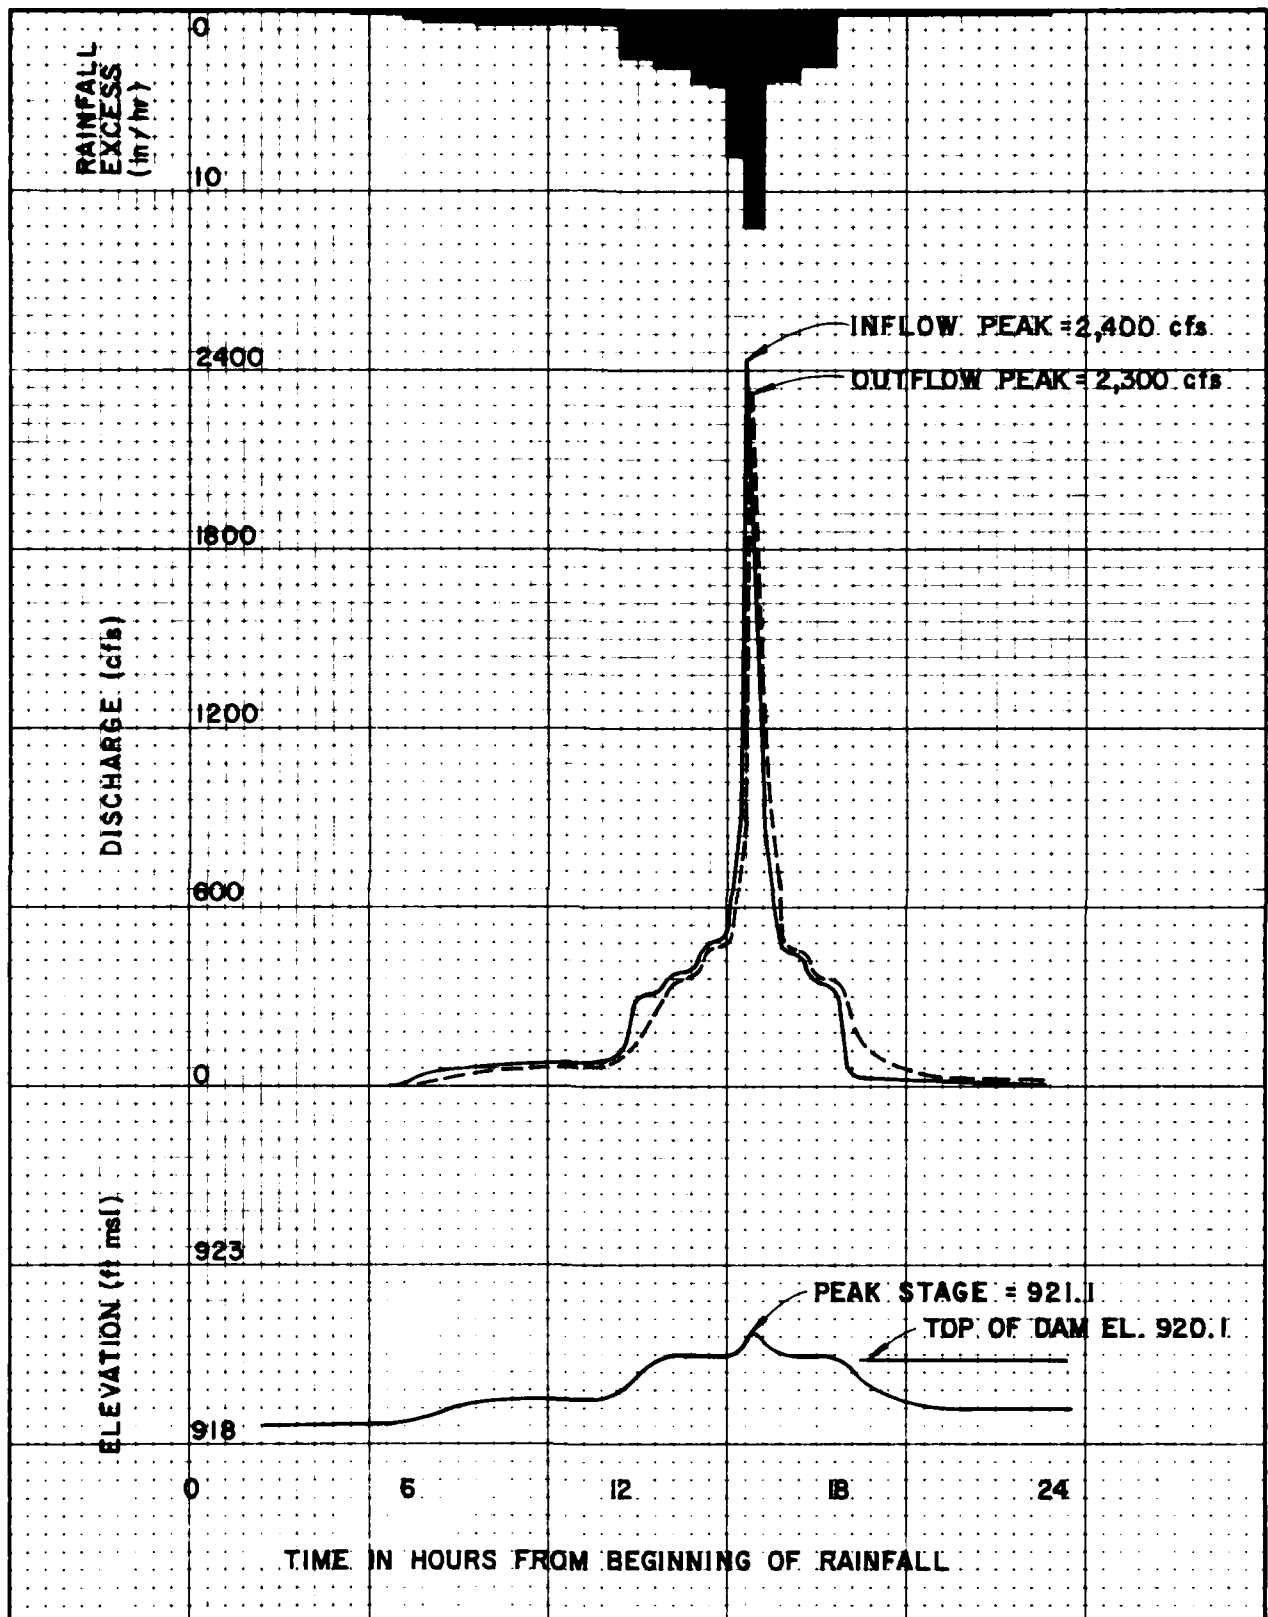
d. Overtopping Potential. The spillway will not pass 50 to 100 percent of the probable maximum flood, which is the spillway design flood recommended by the guidelines, without overtopping. The probable maximum flood is defined as the flood discharge that may be expected from the most severe combination of critical meteorologic and hydrologic conditions that are reasonably possible in the region. The spillway will pass 10 percent of the probable maximum flood without overtopping. This flood is less than the 100-year estimated according to the methodology outlined by the USGS in "Technique for Estimating the Magnitude and Frequency of Missouri Floods". According to the recommended guidelines from the Department of the Army, Office of the Chief of Engineers, a high hazard dam of small size should pass 50 to 100 percent of the probable maximum flood. Considering the small volume of water impounded and the large flood plain downstream from the dam, one-half the probable maximum flood is the appropriate spillway design flood. The portion of the estimated peak discharge of the probable maximum flood overtopping the dam would be 2,100 cfs of the total discharge from the reservoir of 2,300 cfs. The estimated depth over the dam is 1.0 foot and duration of overtopping is 5.1 hours. The portion of the estimated peak discharge of 50 percent of the probable maximum flood overtopping the dam would be 900 cfs of the total discharge of the reservoir of 1,100 cfs. The estimated depth over the dam is 0.75 foot and duration of overtopping is 1.6 hours.

**SUNNY SHORES  
PROBABLE MAXIMUM FLOOD  
HYETOGRAPH, HYDROGRAPHS  
AND STAGE - TIME CURVE**

a. Alternatives. The present spillway has capacity to pass 10 percent of the probable maximum flood without overtopping the dam. In order to pass 50 to 100 percent of the probable maximum flood as required by the Recommended Guidelines, the spillway size and/or height of dam would need to be increased.

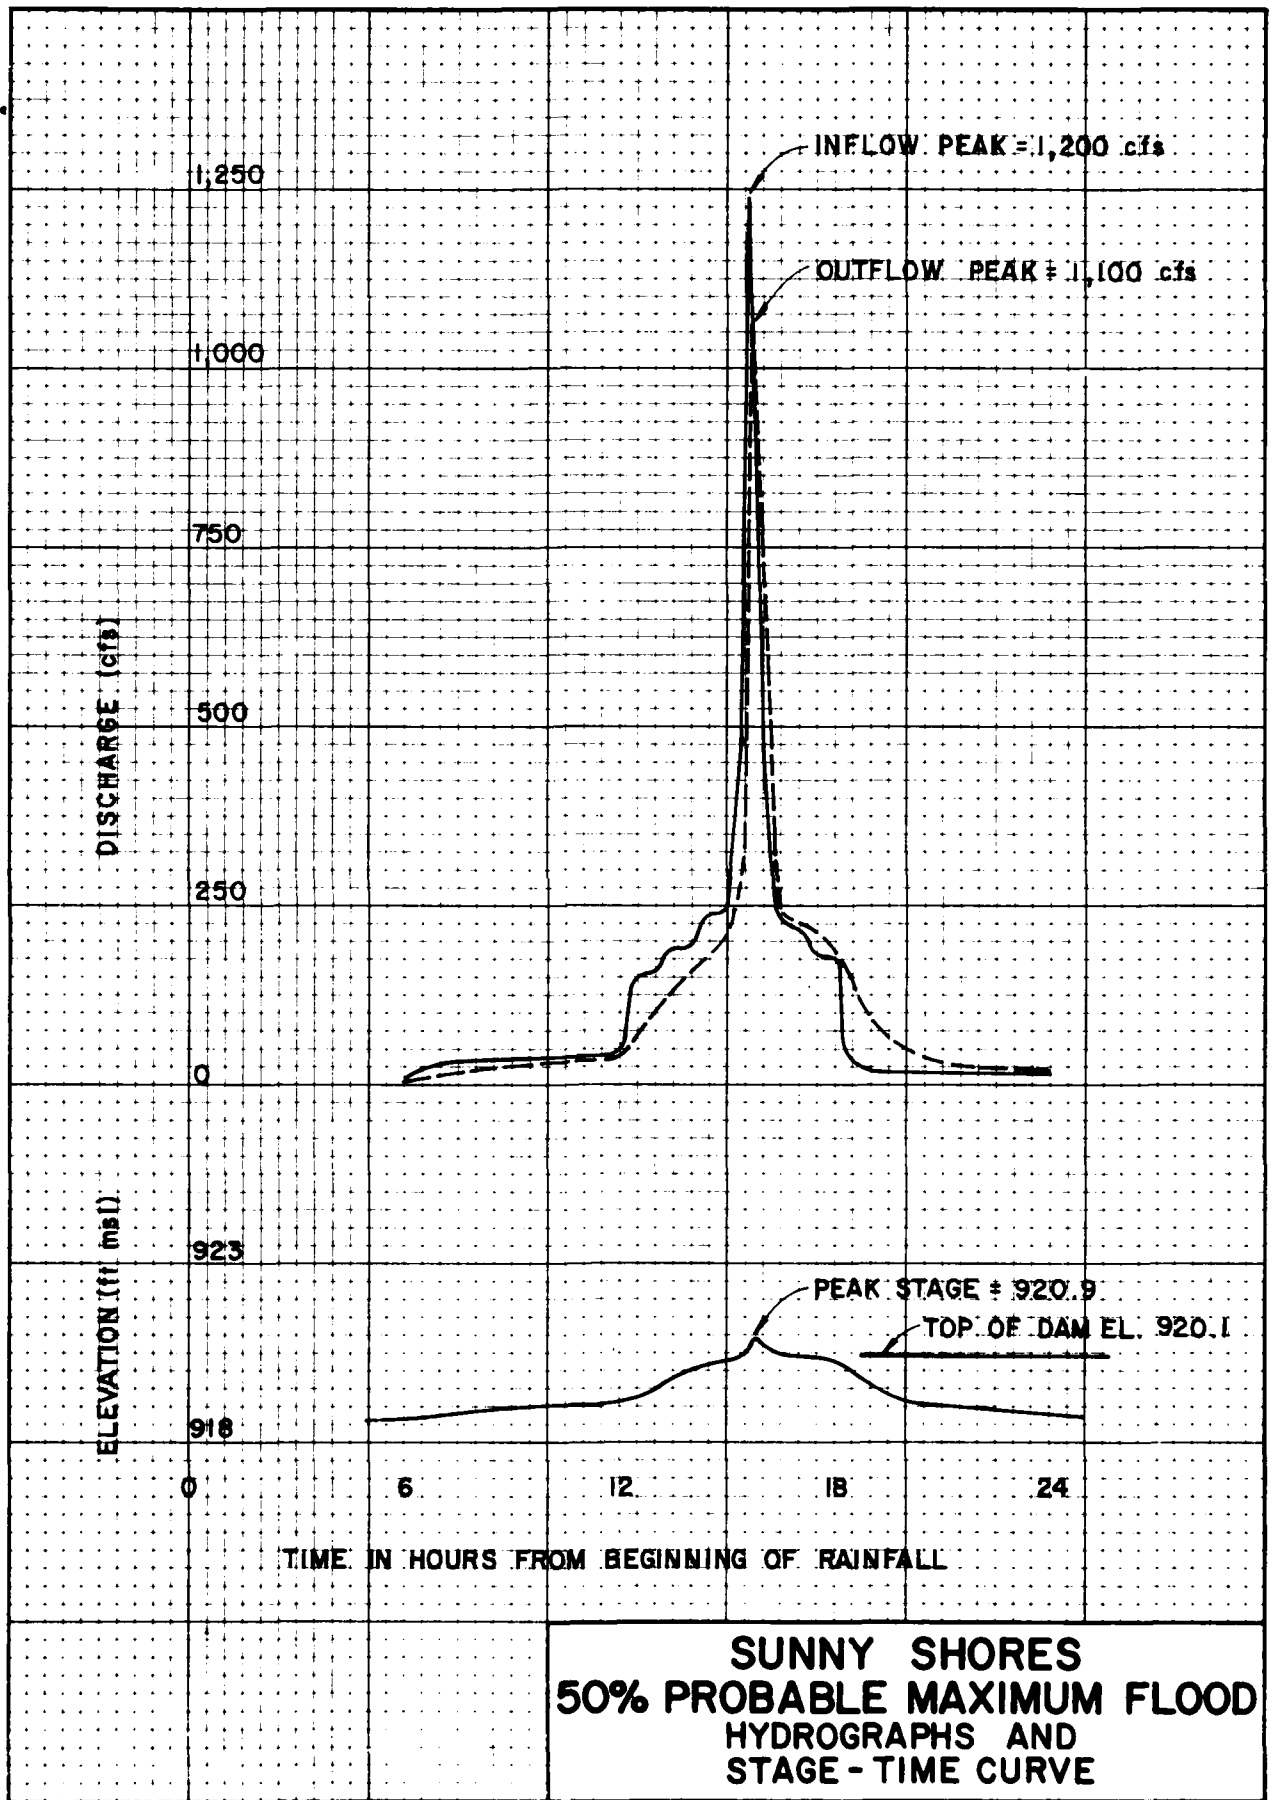
**SUNNY SHORES  
50% PROBABLE MAXIMUM FLOOD  
HYDROGRAPHS AND  
STAGE - TIME CURVE**

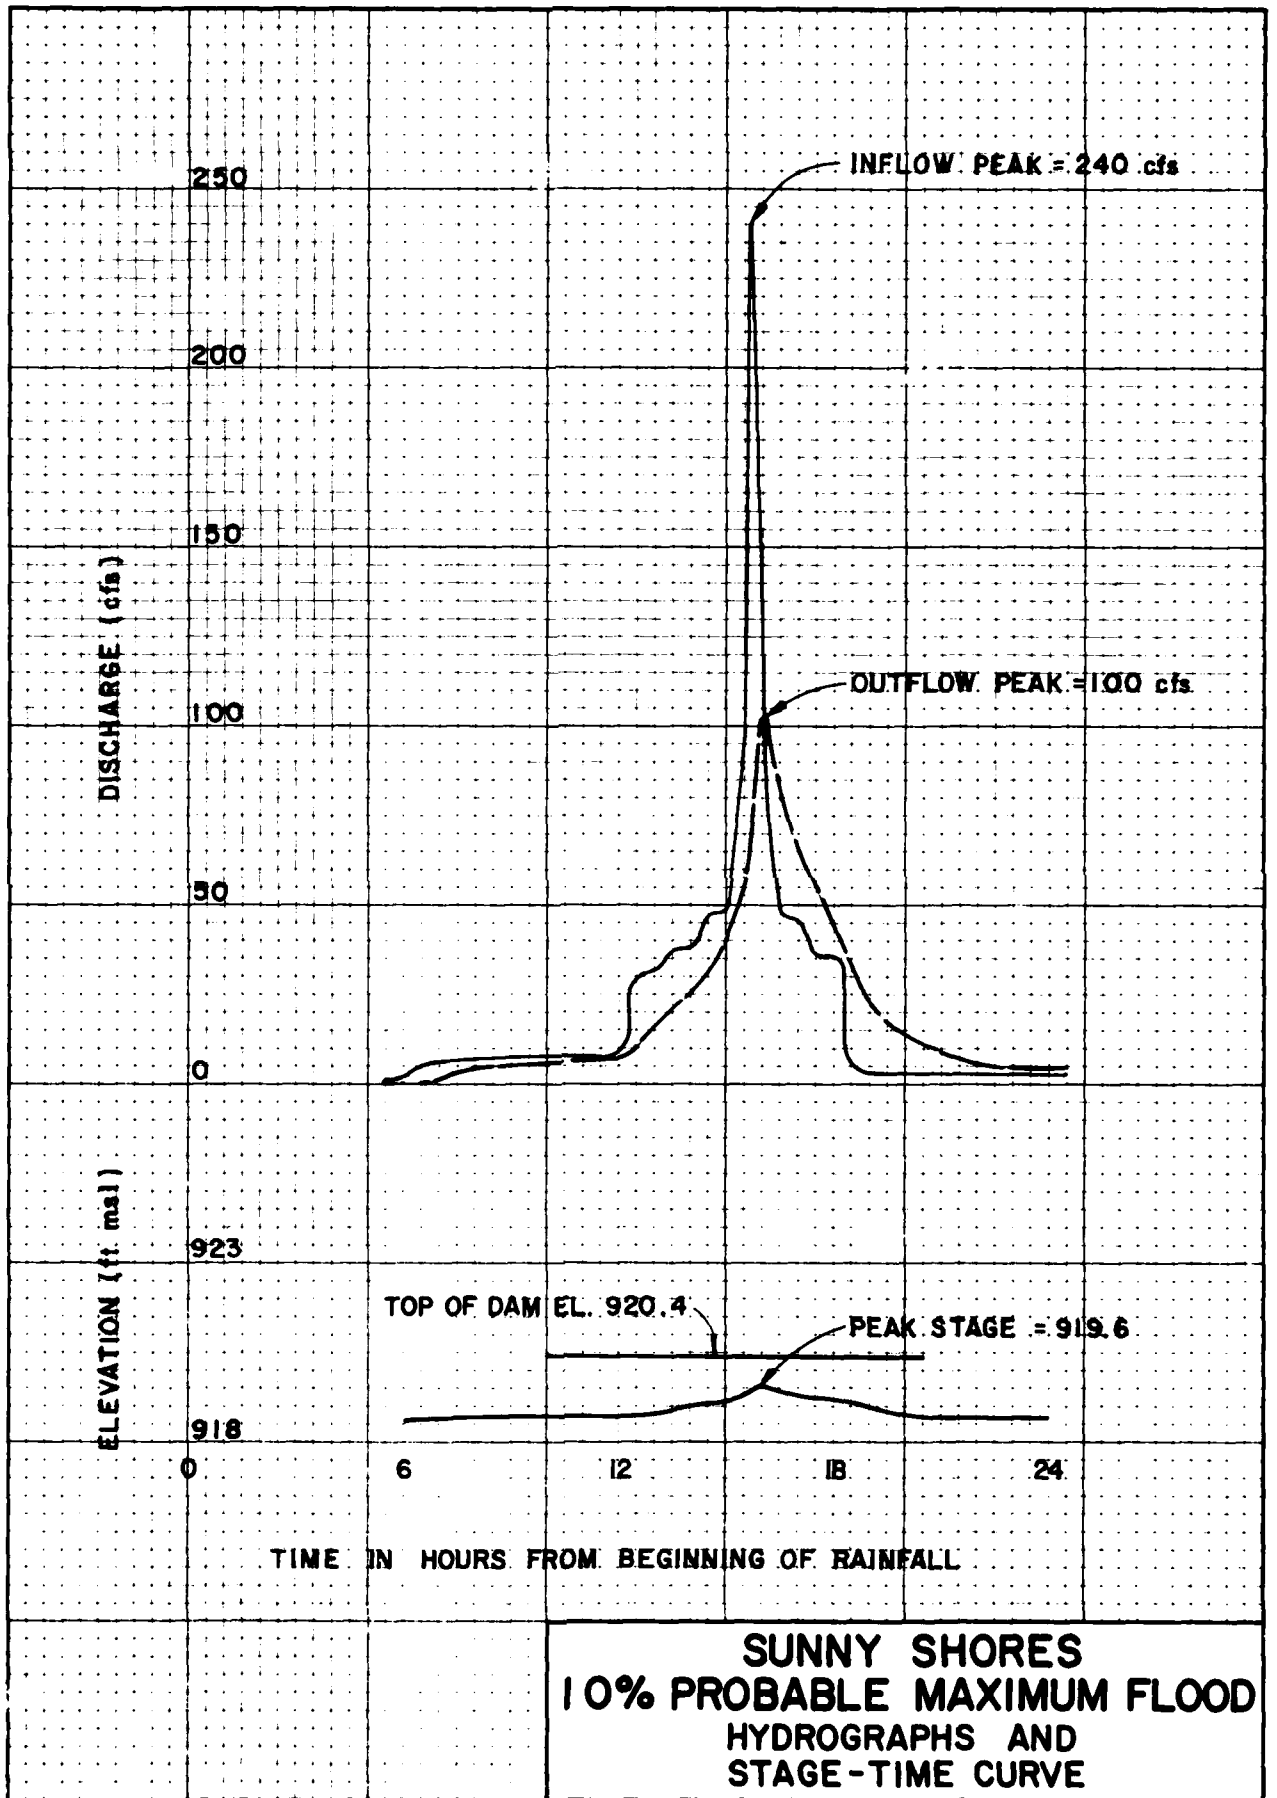
**SUNNY SHORES  
10% PROBABLE MAXIMUM FLOOD  
HYDROGRAPHS AND  
STAGE-TIME CURVE**
