NONAME 91  
JACKSON COUNTY, MISSOURI  
MO 20144

## PHASE 1 INSPECTION REPORT NATIONAL DAM SAFETY PROGRAM

BLACK & VEATCH  
CONSULTING ENGINEERS  
KANSAS CITY, MISSOURI

AUGUST 1978

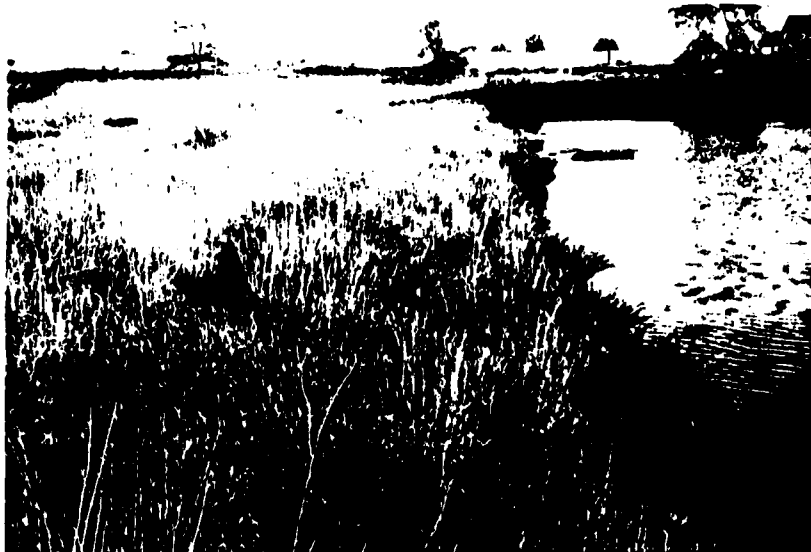
PHOTO 1: UPSTREAM FACE OF DAM (LOOKING NORTH)

b. Dam. The inspection team observed the following items at the dam. Some erosion was noted near the right abutment on the downstream embankment. The upstream slope has no slope protection other than vegetation; however, there was very little erosion evident. Soil types in the area are predominantly clays. Observations of the spillway discharge channel indicate the dam foundation may be comprised of limestone and shale. No animal burrows, sliding, cracking, settlement, or sinkholes were observed. The crest of the dam sloped irregularly from the upstream to the downstream face. This sloping probably resulted from the operation of farm equipment during wet periods and/or the failure of the crest to be initially constructed to uniform grades. No evidence of sliding or sloughing was observed.

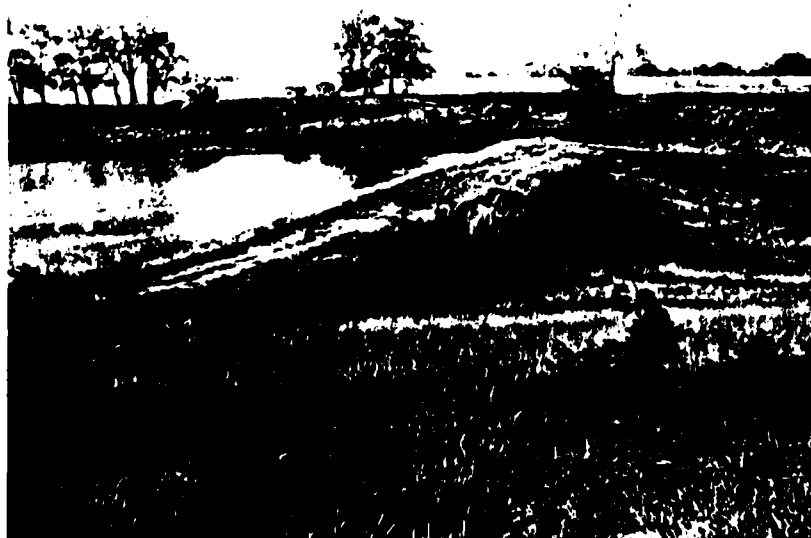
PHOTO 2: DOWNSTREAM FACE OF DAM (LOOKING SOUTH)

Existing erosion observed on the downstream side of the dam, although minor, increases the potential for failure and warrants regular monitoring and control.

a. Safety. The only item of concern that was noted during the visual inspection which should be monitored or controlled was the presence of some minor erosion on the downstream embankment.

(1) Check the downstream face of the dam periodically for further erosion problems. If increased erosion is observed, the dam should be inspected and the pending condition evaluated by an engineer experienced in design and construction of earthen dams.
