**INDIAN CREEK MINE DAMS
WASHINGTON COUNTY, MISSOURI
MO 30717 & 31036**

**PHASE 1 INSPECTION REPORT
NATIONAL DAM SAFETY PROGRAM**

PHASE I INSPECTION REPORT
NATIONAL DAM SAFETY PROGRAM
INDIAN CREEK MINE DAMS
I.D. NOS. 30717 (LOWER DAM)
AND 31036 (UPPER DAM)

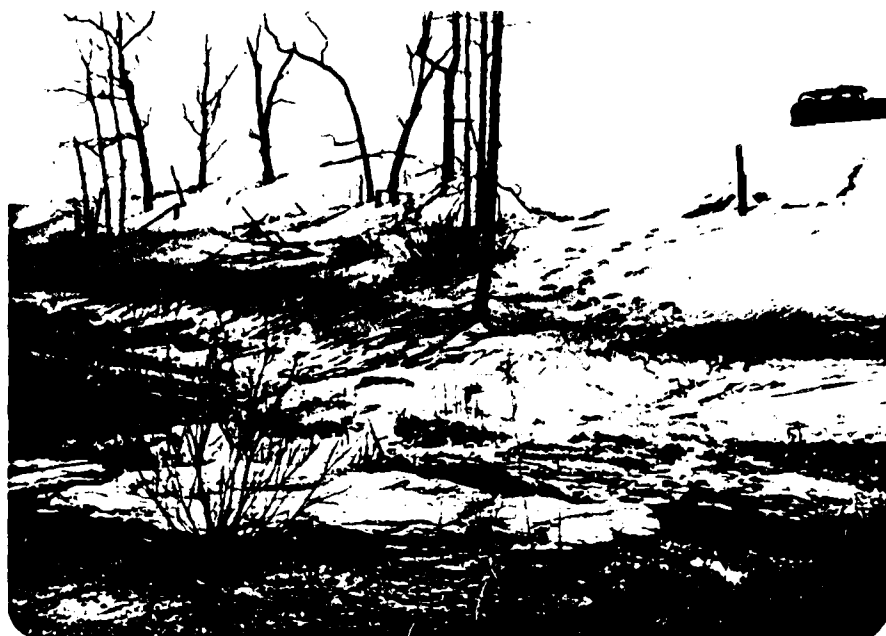
<u>Photo No.</u>	<u>Description</u>
1	Toe of tailings embankment near right abutment. Note seepage near toe and bedrock exposure.
2	View of dam toe along rock buttress at maximum section. Note erosion.
3	Toe of dam at maximum section. Note erosion and marshy ground.
4	View downstream from crest toward area behind left abutment. Note seepage wetting line, abandoned spigot line supports, and erosion rills at edge of the old dam.
5	Diverted drainage ponded behind left abutment. Note seepage through diversion dike.
6	Typical sloughing of embankment tailings from seepage.
7	Area below toe of starter dam. Note eroded materials and marshy ground.
8	View toward right abutment showing downstream slope and toe of starter dam. Note rock buttress, eroded materials and marshy ground at toe.
9	Spillway channel downstream from bridge. Note condition of slopes and materials.
10	Entrance to spillway channel.
