OLD WOLF DAM
WASHINGTON COUNTY, MISSOURI
MO 31118

**PHASE 1 INSPECTION REPORT
NATIONAL DAM SAFETY PROGRAM**

OLD WOLF DAM
WASHINGTON COUNTY, MISSOURI

PHASE I INSPECTION REPORT
NATIONAL DAM SAFETY PROGRAM

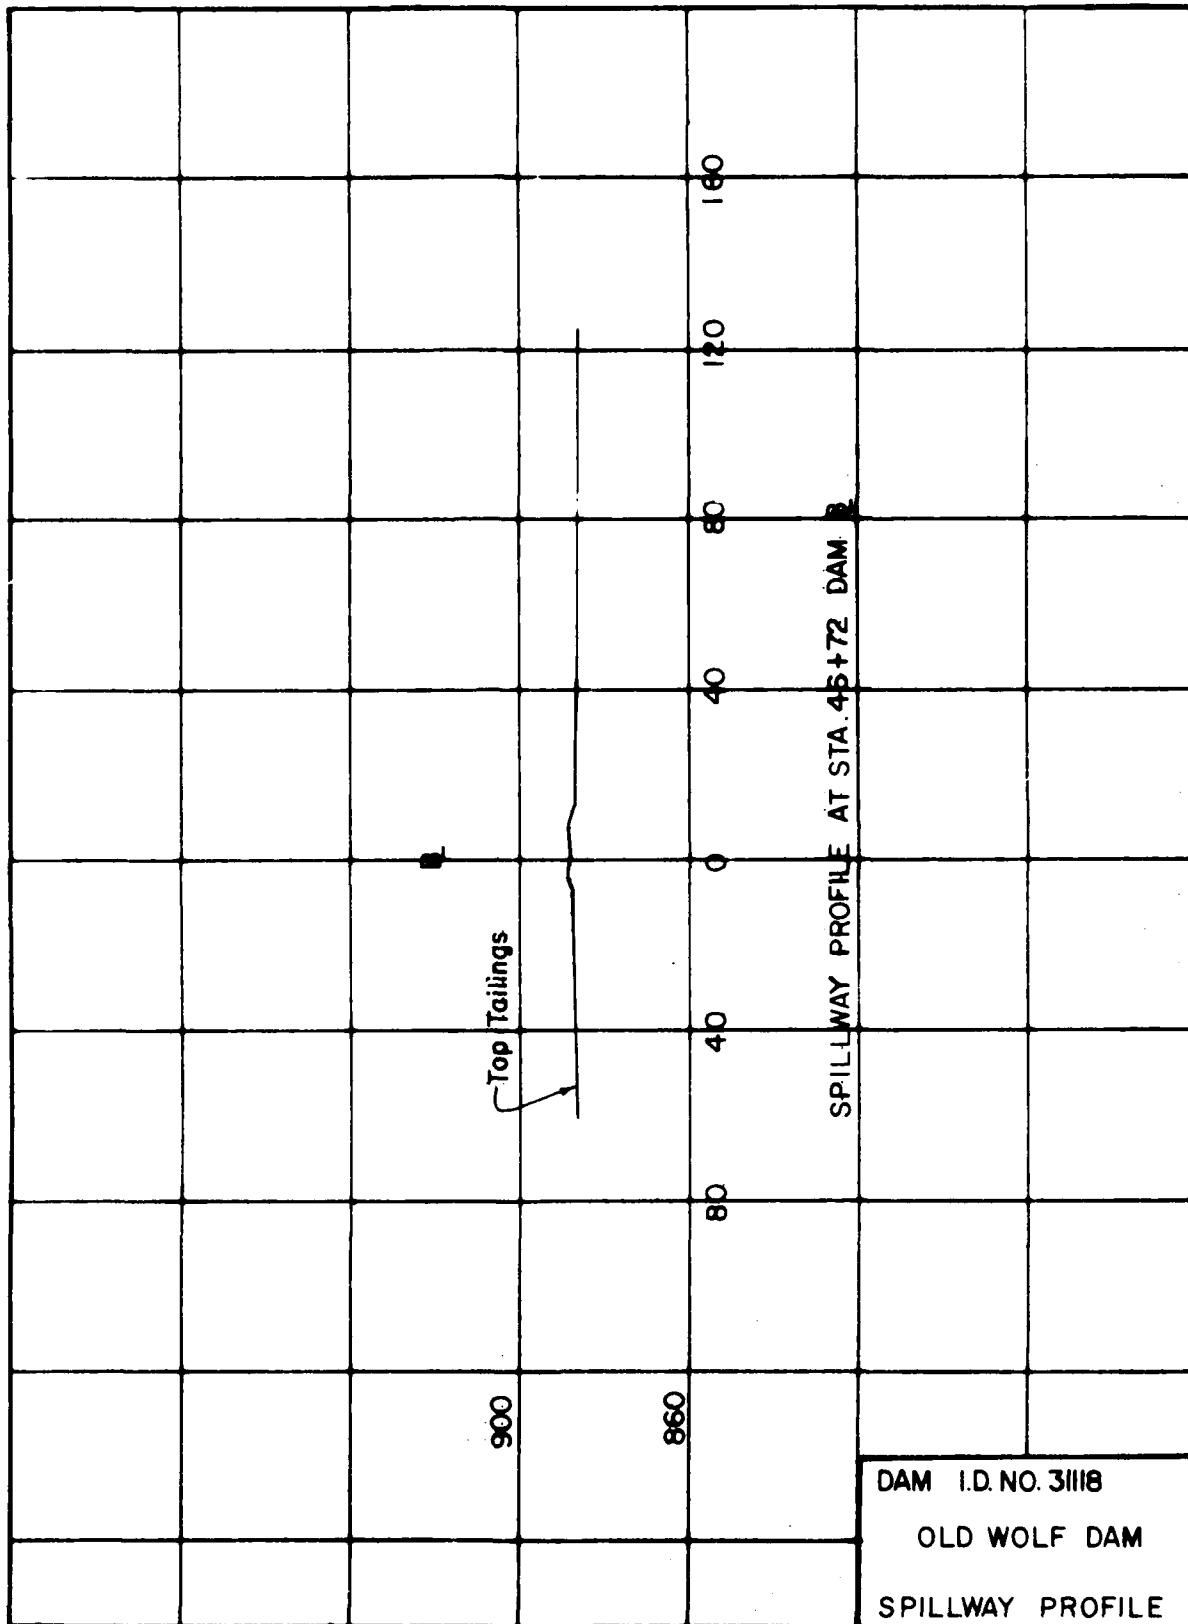
PLATE 6

The low spot on the dam crest (El. 888.3 feet) is lower than the elevation at the spillway crest (El. 888.4 feet).

The spillway appears to be incapable of functioning due to lack of freeboard available over the spillway crest elevation.
