**LAKE TAPAWINGO DAM
JACKSON COUNTY, MISSOURI
MO. 20127**

PHASE 1 INSPECTION REPORT NATIONAL DAM SAFETY PROGRAM

Name of Dam	Lake Tapawingo Dam
State Located	Missouri
County Located	Jackson County
Stream	Tributary to East Fork Little Blue River
Date of Inspection	22 August 1978

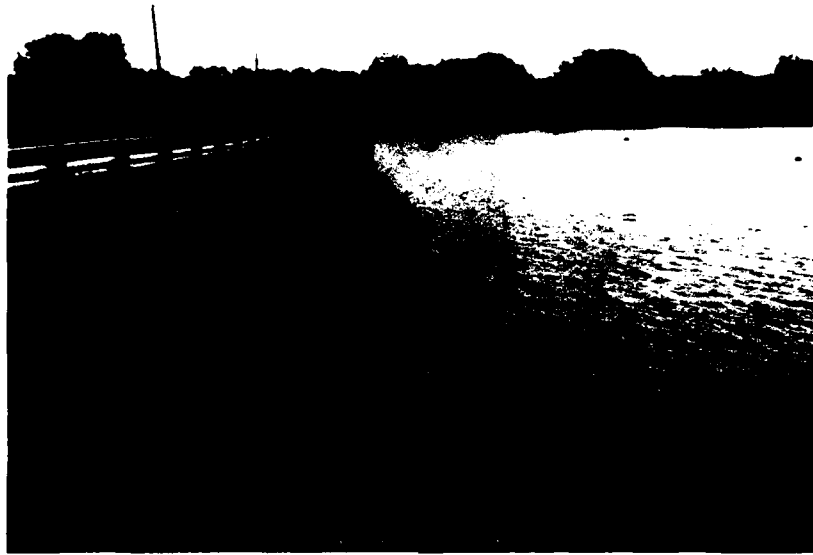
b. Dam. The inspection team observed the following items at the dam. The upstream slope above the water level is very steep. The riprap has been covered with asphalt. Voids were observed between the riprap in several areas but their extent and severity could not be determined due to the asphalt overburden. A crack in the asphalt overlay was observed at the junction of the crest and the upstream slope of the dam, however, it could not be determined if the crack extended deeply into the embankment material. Seepage through the embankment was observed at several locations. The observed seepage did not indicate that piping was occurring. Minor seepage was observed at the junction of the dam and the left natural abutment material. Sloughing of the embankment was observed about 200 feet right of the left abutment. The sloughing was probably the result of erosion near the toe of the dam caused by discharges from the emergency spillway. There were numerous small trees and a heavy stand of weeds on the downstream slope.

PHOTO 1: UPSTREAM FACE OF DAM (LOOKING EAST)
