**HELVELY PARK DAM**

**CLAY COUNTY, MISSOURI**

**MO 10584**

# **PHASE 1 INSPECTION REPORT NATIONAL DAM SAFETY INSPECTION**

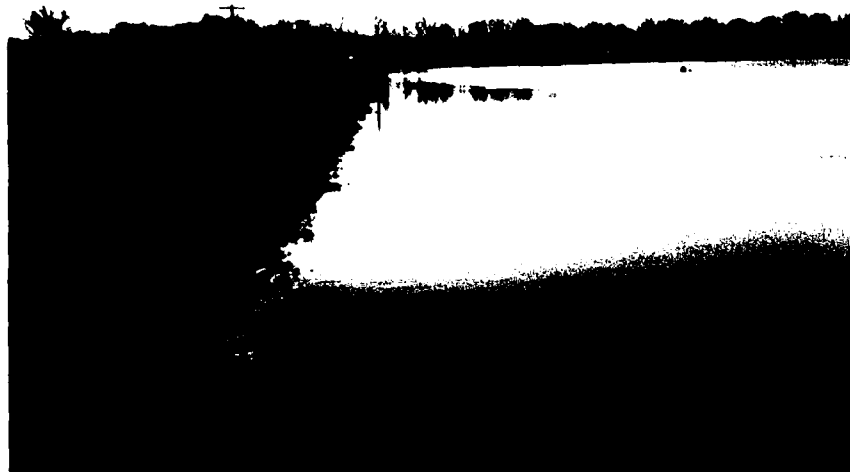
PHOTO 4: UPSTREAM FACE OF DAM FROM NORTHWEST END
