**RAY COUNTY DAM NO. C-1**

**RAY COUNTY, MISSOURI**

**PHASE 1 INSPECTION REPORT  
NATIONAL DAM SAFETY INSPECTION**

Name of Dam	Ray County Dam No. C-1
State Located	Missouri
County Located	Ray County
Stream	Tributary to Willow Creek
Date of Inspection	17 May 1979

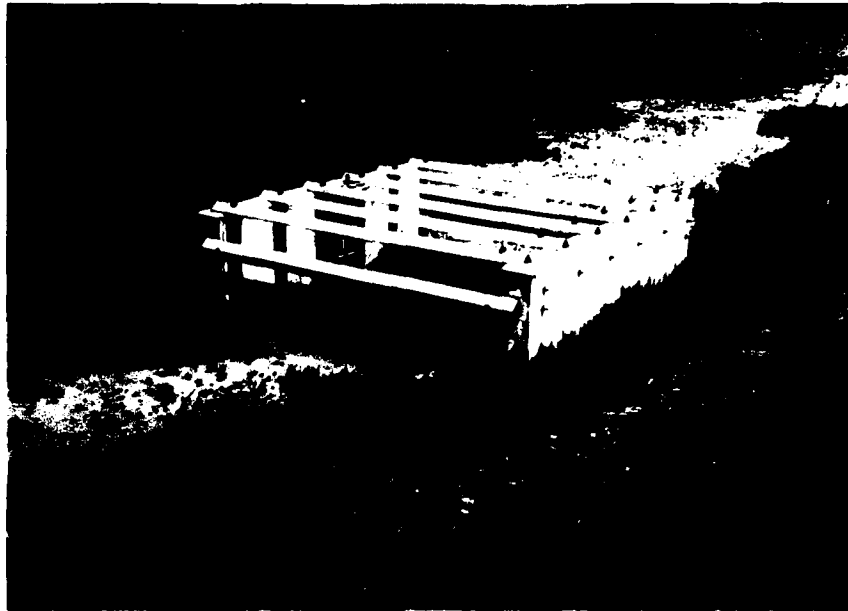
PHOTO 3: PRINCIPAL SPILLWAY WITH RACK

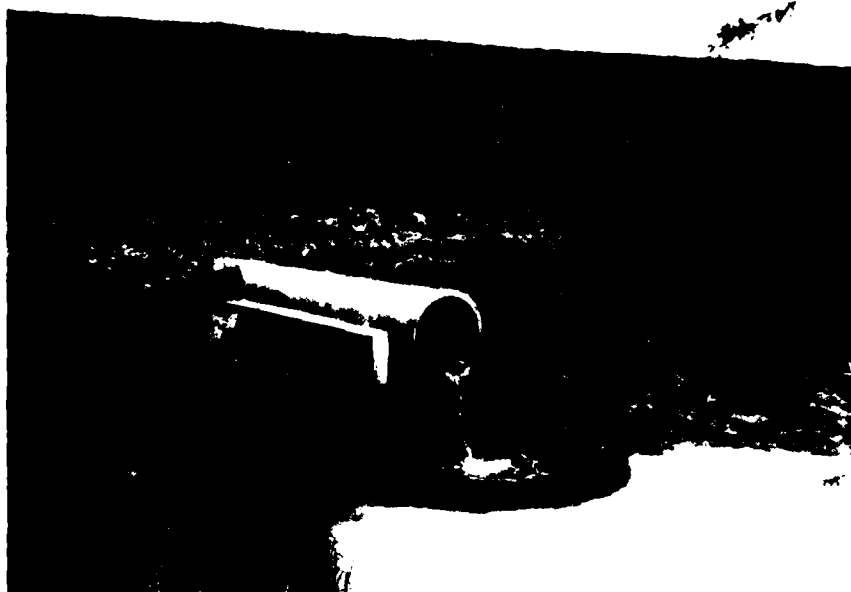
PHOTO 6: PRINCIPAL SPILLWAY DISCHARGE PIPE
