ODESSA HILLS LAKE DAM

MO 10534

**PHASE 1 INSPECTION REPORT
NATIONAL DAM SAFETY PROGRAM**

MAY 1980

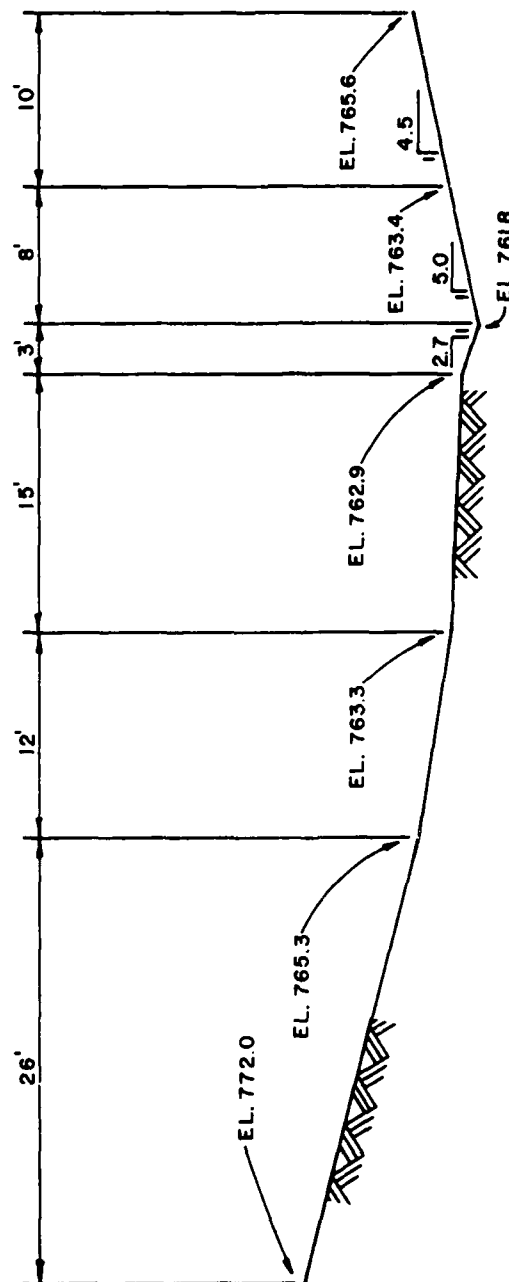
ODESSA HILLS LAKE DAM EMERGENCY SPILLWAY CROSS SECTION

NOTE:
CROSS SECTION TAKEN
NEAR STATION 1+50
LOOKING DOWNSTREAM

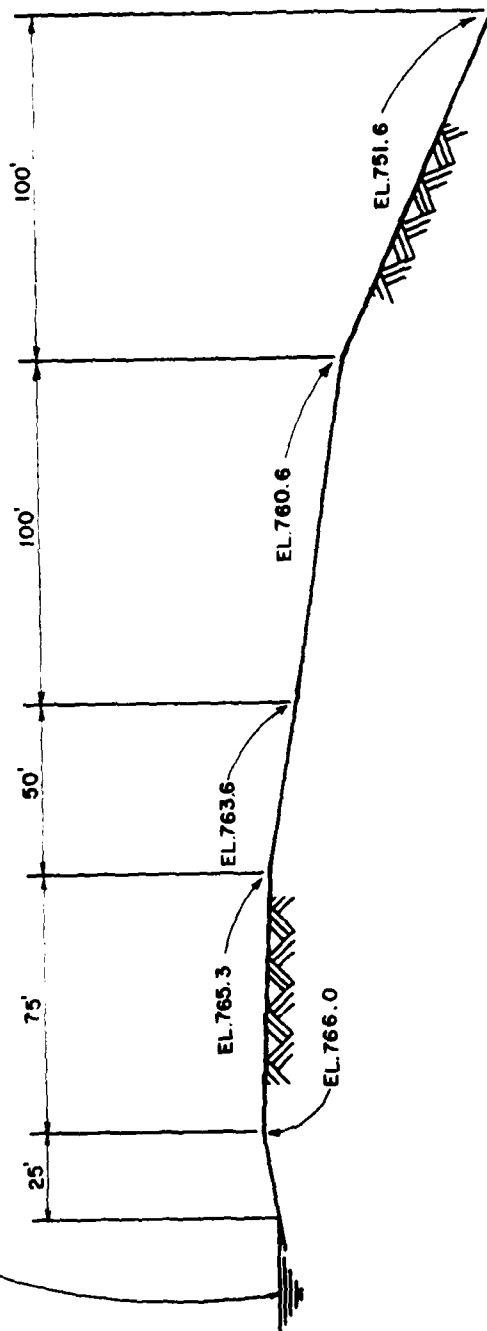
ODESSA HILLS LAKE DAM EMERGENCY SPILLWAY PROFILE

ODESSA HILLS LAKE LEVEL
AT TIME OF INSPECTION
EL. 7650
