MONONAME 819 DAM  
CAPE GIRARDEAU COUNTY, MISSOURI

MISSOURI INVENTORY NO. 30211

PHASE I INSPECTION REPORT  
NATIONAL DAM SAFETY PROGRAM

PHASE I INSPECTION REPORT  
NATIONAL DAM SAFETY PROGRAM  
MONONAME 819 DAM - ID NO. 30211

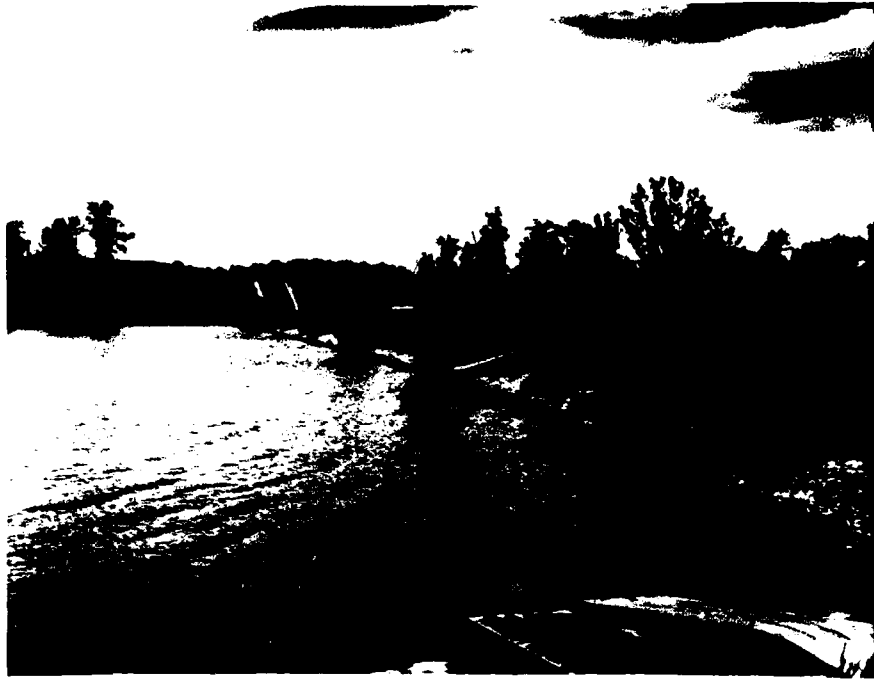
The upstream slope is protected by riprap to within 10 feet of the crown of the dam. The upstream slope above the riprap is well covered with grass. Small trees are growing along the water's edge (see Photos 3 and 5). Only slight erosion exists on the upstream slope and one erosion gully has been repaired with riprap at Station 8+85 (see Photo 6). No wavewash was present on the upstream slope. In the right abutment a concrete boat ramp has been constructed.

PHOTO 5: Growth on Upstream Slope

(1) Remove trees and brush on the upstream embankment slope. Care should be taken during removal not to destroy the existing conditions of the upstream embankment.

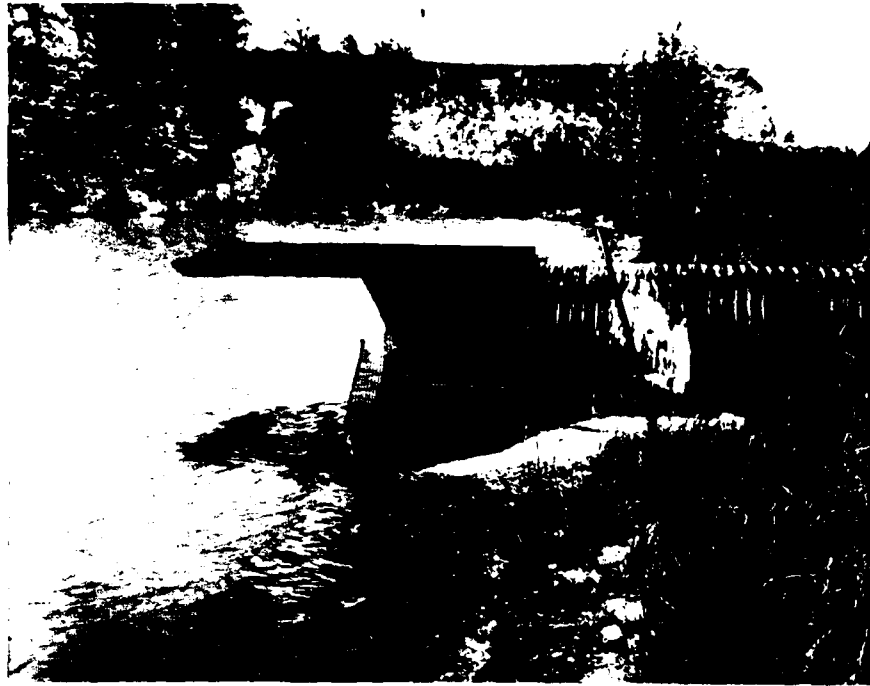
PHOTO 7: Hooded Inlet Structure

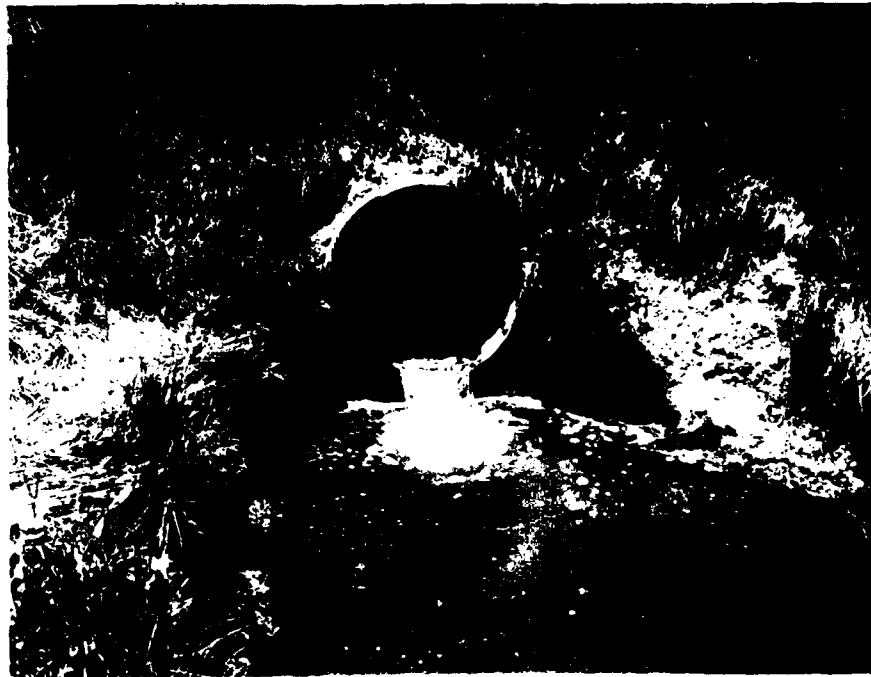
PHOTO 8: Outlet Structure and Stilling Basin

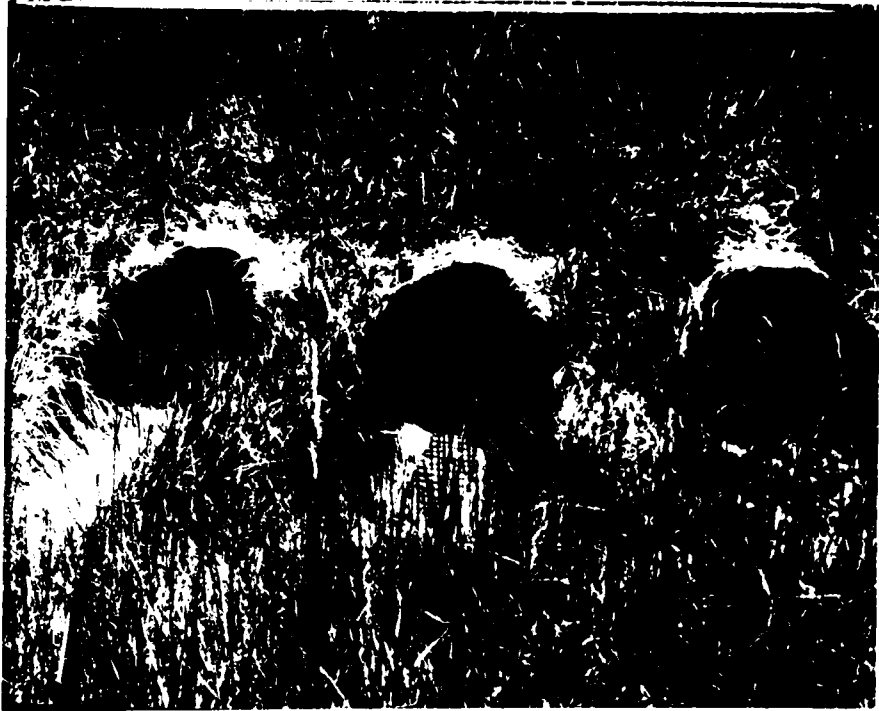
An emergency spillway exists near the left abutment of the dam. The emergency spillway consists of three uncontrolled 24-inch bituminous coated CMP which extend horizontally through the dam embankment for approximately 48 feet. The inlet invert elevation of the culverts is 461.6 N.G.V.D. and the outlet invert elevation is 461.2 N.G.V.D. The three culverts appear to be in relatively good condition (see Photo 11).

PHOTO 11: Inlets of the Culverts Composing the Emergency Spillway

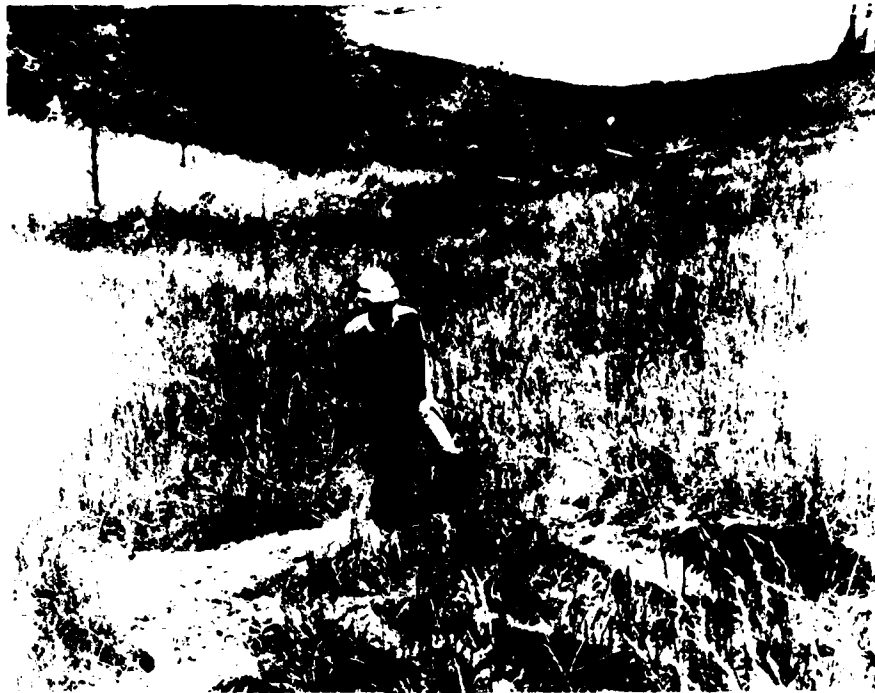
Erosion exists below the outlets (see Photos 12 and 14). The erosion gulley is approximately 10 feet long and 2 feet deep. The erosion is the result of discharge from the emergency spillway being directed onto the downstream face of the dam. There is no existing outfall channel for flow from the culverts of the emergency spillway (see Photo 13).

PHOTO 13: Emergency Spillway Outfall

(2) The downstream face of the dam below the three culverts which comprise the emergency spillway should be repaired. To prevent future erosion which could threaten the integrity of the dam, some form of erosion protection should be placed on the face of the dam below the emergency spillway or the emergency spillway should be relocated in the abutment of the dam so that discharge from the spillway can be directed away from the face of the dam.

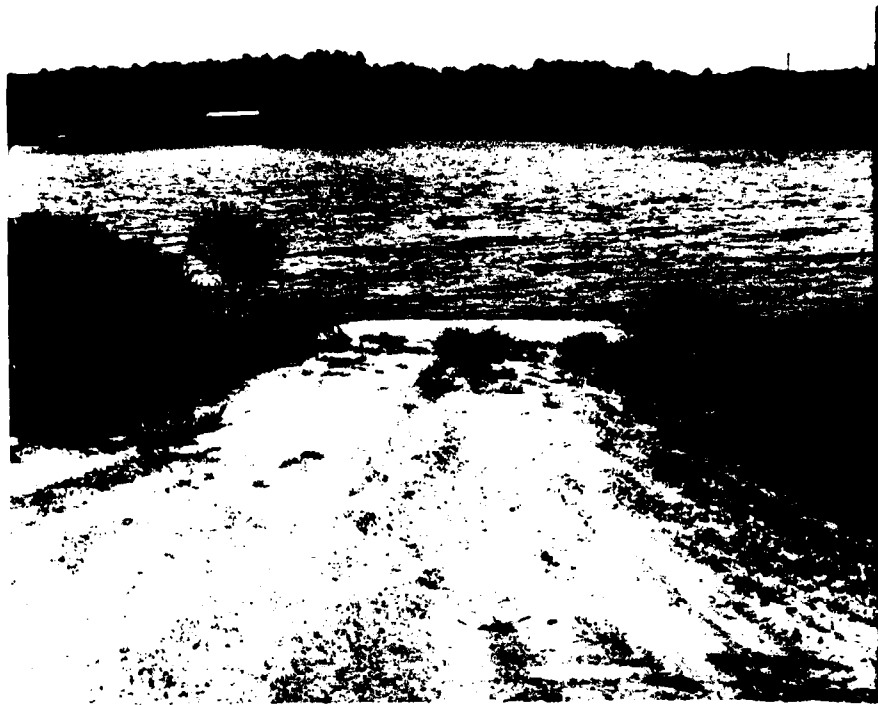
PHOTO 15: Boat Runway in Right Abutment

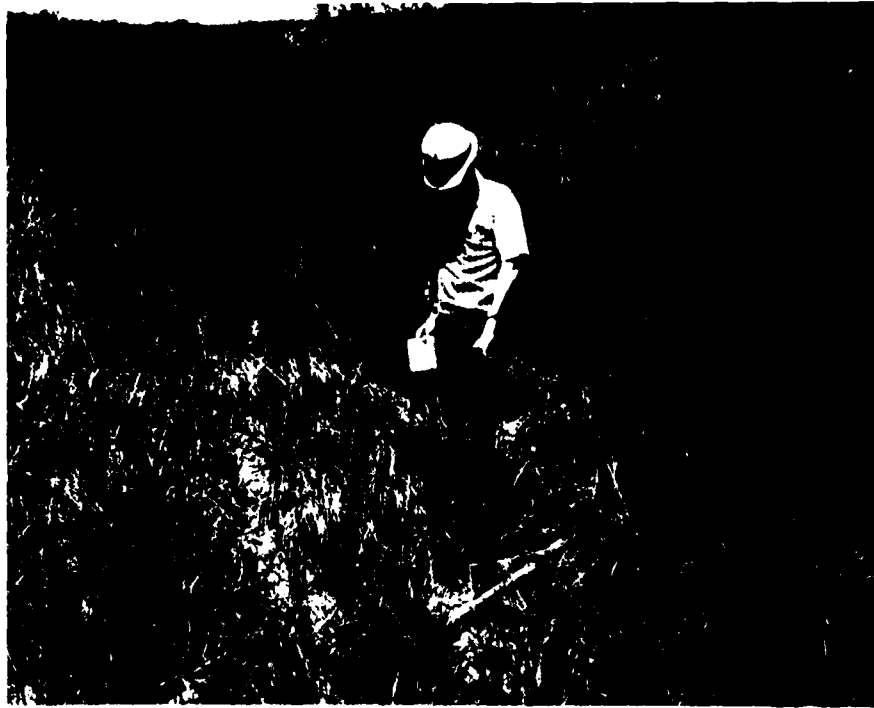
PHOTO 16: Wash Area on Downstream Slope of Left Abutment

PHOTO 17: Wash Area on Downstream Slope of Left Abutment

(3) Repair the erosion gulleys in both abutments of the downstream slope.
